San Joaquin River Restoration Program Fish Passage Evaluation

Draft Technical Memorandum

Evaluation of Partial Fish Passage Barriers

July 2012

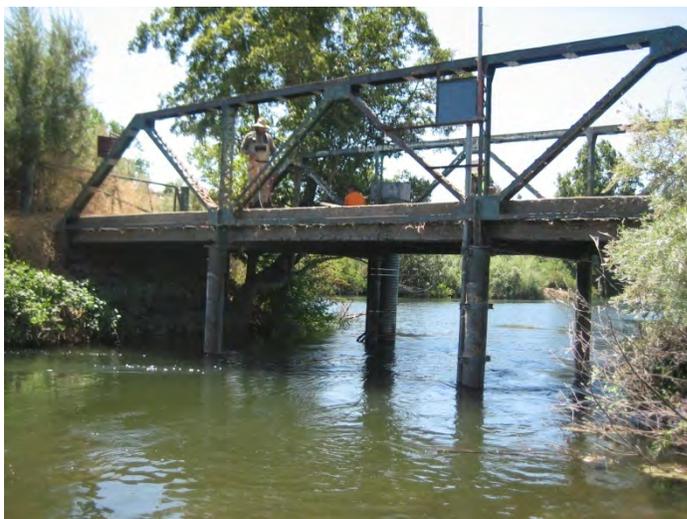
Donny Bridge looking downstream

The Bridge is located on the San Joaquin River downstream of Highway 99. It is not publicly accessible and use is limited. The bridge opening does not extend the width of the channel and causes flows to contract prior to flowing under the bridge. The capacity of the bridge opening is at around 3,000 cfs after which flows continue to hit the bridge deck and eventually overtop the bridge. Jump was not evaluated since the channel bed under the bridge is natural substrate at grade. Depth is basically the depth that is present in the channel upstream and downstream the bridge. Depth at 25 cfs exceeds 1.2 feet so depth under the structure is not impeding passage.

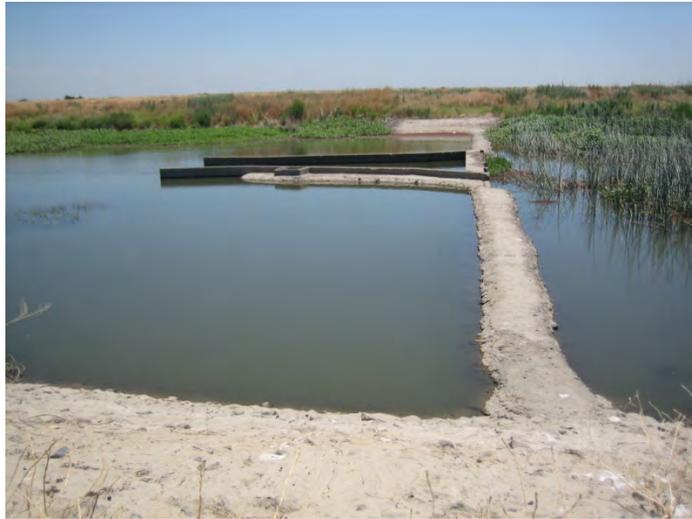
Sand Slough Connector looking south

The structure is located in Sand Slough just downstream the Reach 4B headgates. Since the headgates are not operational all flows from the San Joaquin River from Reach 4A flow through the Sand Slough Connector to the Eastside Bypass. The structure is basically a broad crested weir with a flume designed to have stop logs inserted at the inlet, but has not been observed with stop logs in place. The model assumes that the boards are out. According to the model, the weir

is overtopped at flows just less than 200 cfs and the inlet is overtopped at flows above 400 cfs. The structure was evaluated as a culvert for flows under 400 cfs, because of the hardened bottom and flume sides. Flows over 400 cfs are basically weir flow, so burst speeds of 10.8 fps can be used to access the velocities at the weir when it is overtopped since the weir can be jumped or passed through the submerged inlet. Velocities of 6 fps are not exceeded for flows under 400 cfs at the inlet or the outlet.

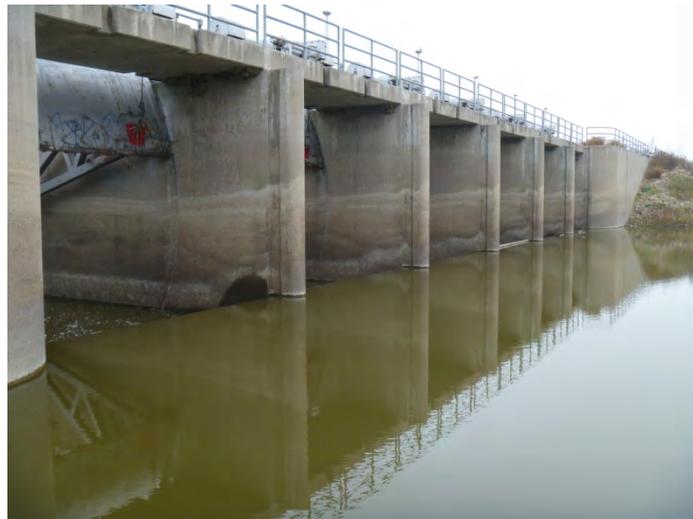
Eastside Bypass Control Structure inlet looking east

The Eastside Bypass Control Structure is at the Mariposa Bypass Bifurcation structure and is located on the Eastside Bypass just upstream the Mariposa Bypass control structure. The structure was evaluated for passage for two scenarios that did not consider gate operations so gates are fully open. Full gate closure would cause this structure to become a fish barrier at all flows.

The first scenario is the existing condition, which is assuming the stop logs are in place at the inlet (Boards-in). The second scenario is assuming the stop logs are removed (Boards-out). The structure becomes the controlling feature in this reach of the Eastside Bypass at the inlet for the boards-in scenario and at the outlet for the boards-out scenario.

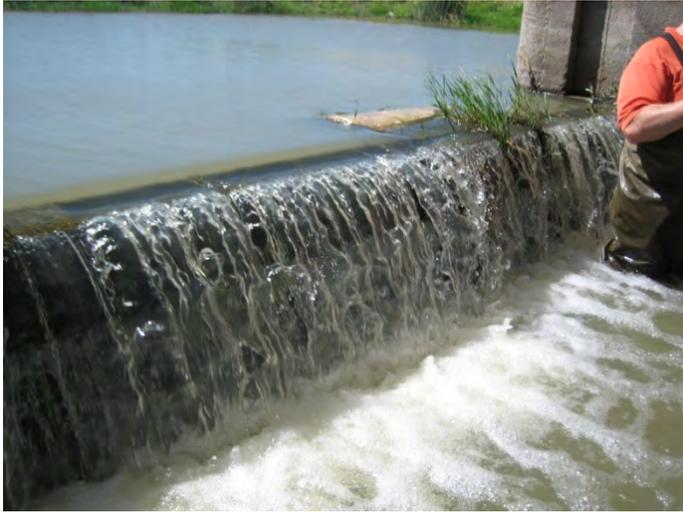
Eastside Bypass Control Structure inlet looking upstream from inside bay

For both evaluations, the initial staging pool is located about 30 feet downstream the sill and is 8 feet deep on average. Riprap has been placed downstream the sill in the channel for protection from scour and erosion. To account for the riprap the slope of the staging pool was compared with the distance to the minimum pool depth needed for the adult Chinook salmon to jump the sill based on the jump height per flow (WSE just downstream the sill subtracted by the WSE just upstream the sill). The parabolic jump curves for fish in good condition for the angles at 60 and 40 degrees were assumed to be the most conservative for evaluating jump. An angle of 80 degrees is not possible due to the riprap at the sill. Due to backwatering of the sill there are no minimum depth issues within the structure for both scenarios at all flows. For velocity within the structure, velocities of 5 fps are exceeded for 8,500 cfs so this will be the top end of the passage range. Velocities of 5 fps are exceeded at the baffles for flows between 900-1,000 cfs and flows above 5,500 cfs. Baffles at this structure are two feet deep by two feet wide and four feet in height with a spacing between the baffles of one foot that are located just upstream the outlet of the bay to dissipate the flows prior to exiting the culvert. These structures are not a solid feature and can be traversed at all flows if burst speed is assumed at 10.8 fps; assuming

10.8 fps at the baffles it does not exceed criteria for velocity. The baffles are overtopped between 1,000 cfs and 1,500 cfs.

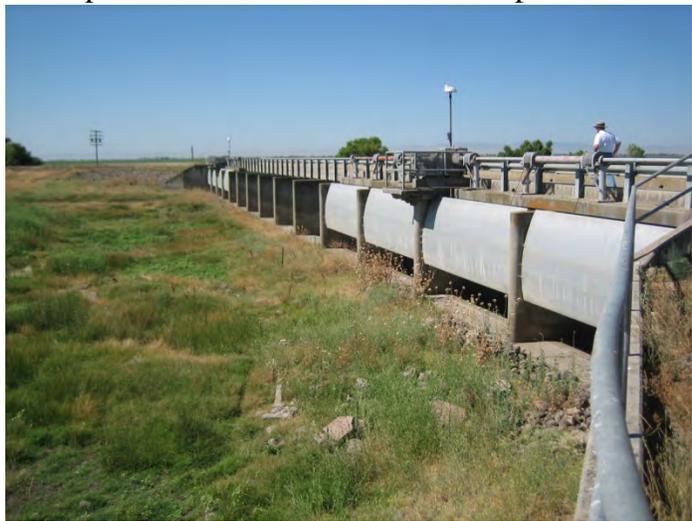
Mariposa Bypass Control Structure at inlet looking south

The Mariposa Bypass control structure is at the head of the Mariposa Bypass just upstream the Eastside Bypass control structure. The structure was modeled assuming gates are closed and only the bays without gates have flow. Partial gate closure for the gated bays was not evaluated. Downstream the outlet is a 45 feet long concrete apron with a sill at the end. The top of the sill is at the same elevation as the channel bottom and has a cobble gabion for scour protection that begins just downstream the sill. Due to the concrete apron there is no staging pool, so jump is dependent on the depth of flow over the apron at the origin of the jump. The opening includes an ogee type spillway and has a 7.5 foot drop from the inlet to the outlet of the structure with no resting pool at the inlet.

The depth of flow at the inlet for flows above 900 cfs would meet criteria of 1.2 feet. The depth of the staging pool is not sufficient for jumping until flows that enter the structure are around 1,500 cfs. Due to the distance needed for the jump, around 9 feet, from the origin for a fish in good condition, jump would not be able to be completed based on the criteria. A fish fresh out of the ocean may be able to complete the jump. Not until flows exceed 2,500 cfs when the inlet elevation is equal to the elevation of the pool it is possible for a fish in good condition to complete a jump.

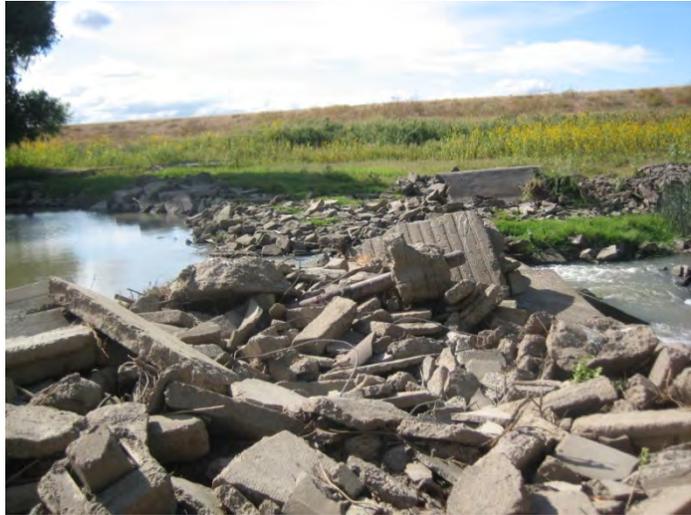
Eastside Bypass Rock Weir looking south at left bank

Chinook salmon can complete a jump as low as 25 cfs assuming fish in good condition, but there is not enough depth to get past the width of the structure. The rock weir is about 30 feet wide at the toe of the structure and about 10 feet wide at the top, so the limiting criterion for passage is depth over the weir.

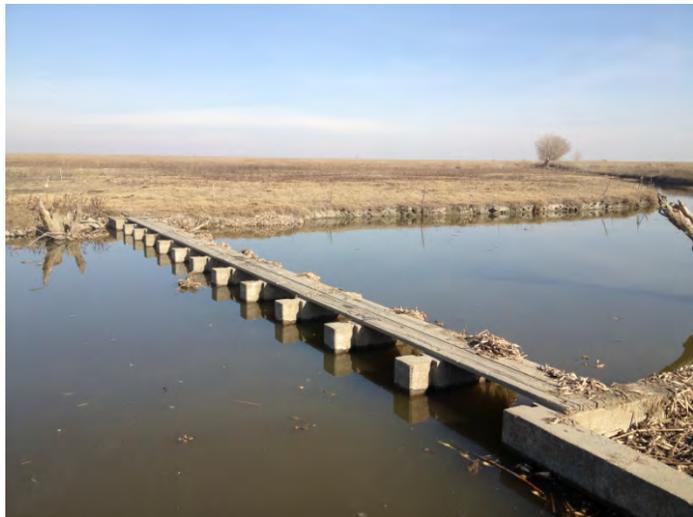
Merced Wildlife Refuge Weir #2 looking east at right bank

When the boards are in at Weir #1 this weir becomes ineffective and completely submerged. At 25 cfs the depth over the weir is around 2.5 feet. The downstream weir boards were removed to see how this would change the water surface elevations at the weir. The stop logs are on the downstream end of the structure so jump may be less hazardous for the salmon. Boards can be installed up to an elevation of 97.0 feet with the top of the deck at 97.65 feet. The deck is overtopped at 100 cfs but does not achieve a depth of 1.2 feet until 700 cfs. Jump is possible at all flows regardless of fish condition. Velocities are less than 6 fps, so the structure is passable at cruising speed or when jumping. To be conservative the weir exceeds criteria until flows exceed 700 cfs due to depth.

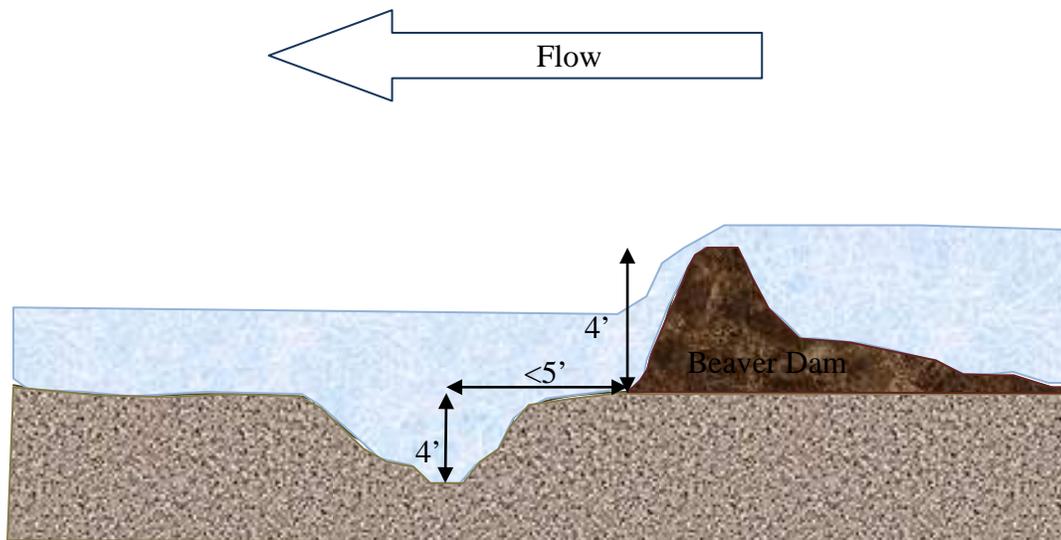
Figure 5. Recommended Beaver Dam Specifications

If dam heights exceed 4 feet from the downstream toe to the dam crest, dam removal or modification may be needed. At some locations that lack a staging pool, constructing a staging pool, dam removal, or modification may be needed to facilitate passage. If the beaver dam height is at or below 3 feet from the downstream toe to the dam crest than most low flows can be jumped without a staging pool.

It is recommended to complete an annual survey of beaver dam locations, heights, and the presence of a staging pool (depth and distance). Modifications are needed if the dam exceeds 3 feet in height and a proper staging pool is not present. Staging pool depth should be about 4 feet below the dam toe elevation and within 5 feet from the toe of the dam. Figure 5 displays the conceptual drawing for the recommended beaver dam specifications.
