# Reach 1A Flow Monitoring Locations

Monitoring Location

SAN JOAQUIN RIVER RESTORATION PROGRAM

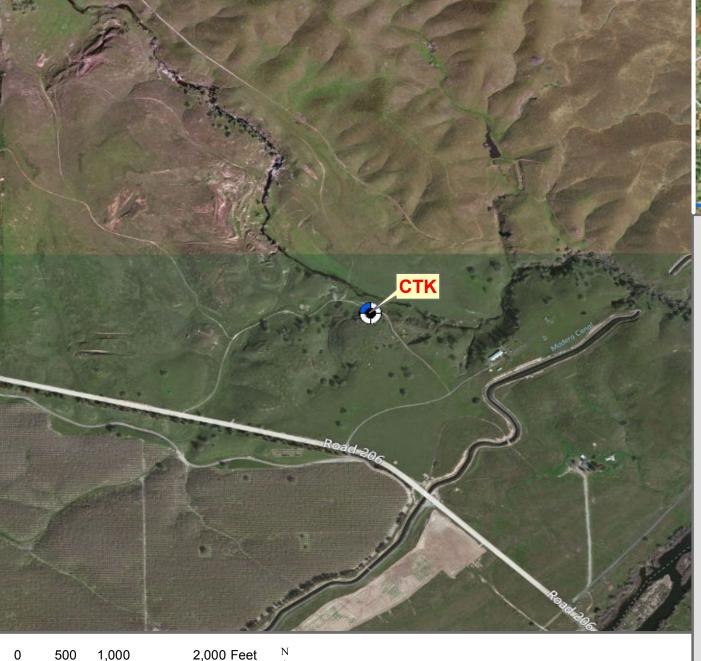
Reach = 1A River Mile = 267.4 X = -119.7200 Y = 37.0010 (Horizontal Datum is NAD83)

Distance From River Centerline (ft)=
Ground Surface Elevation (ft NAVD88) =
Measurement Pt. Elevation (ft NAVD88) = 384.82
Site = Cottonwood Creek near Friant

- 1. Type = Realtime Interval = 15 min Date Range =
- 2. Type = Interval = Date Range =
- 3. Type = Interval = Date Range =

Friant Dam, Madera Canal, Friant Kern Canal

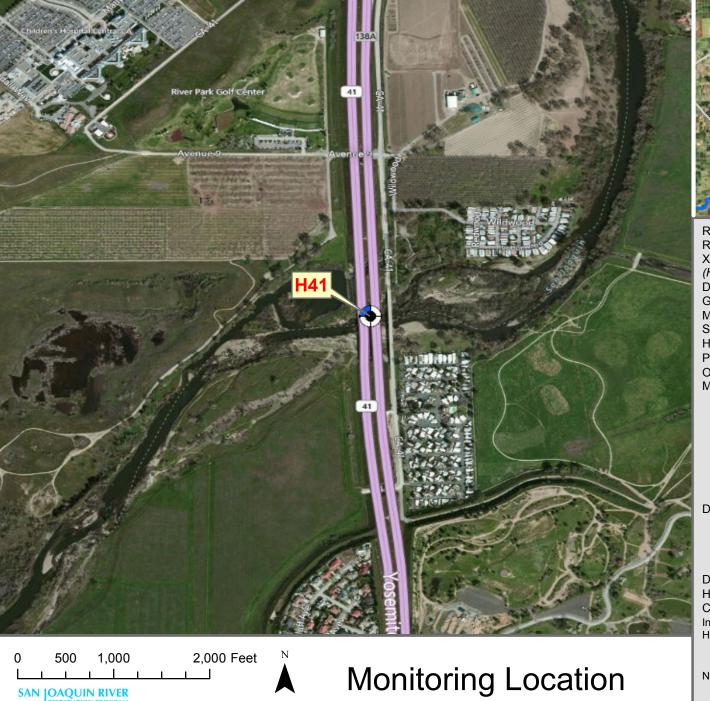
H41

Reach = 1A River Mile = 255.1 X = -119.7926 Y = 36.8763(Horizontal Datum is NAD83)

Ground Surface Elevation (ft NAVD88) = Measurement Pt. Elevation (ft NAVD88) = 290 Site = SJR at Hwy 41

- 1. Type = Measurement Interval =
- Date Range = 2.Type = Interval =

Highway crossing

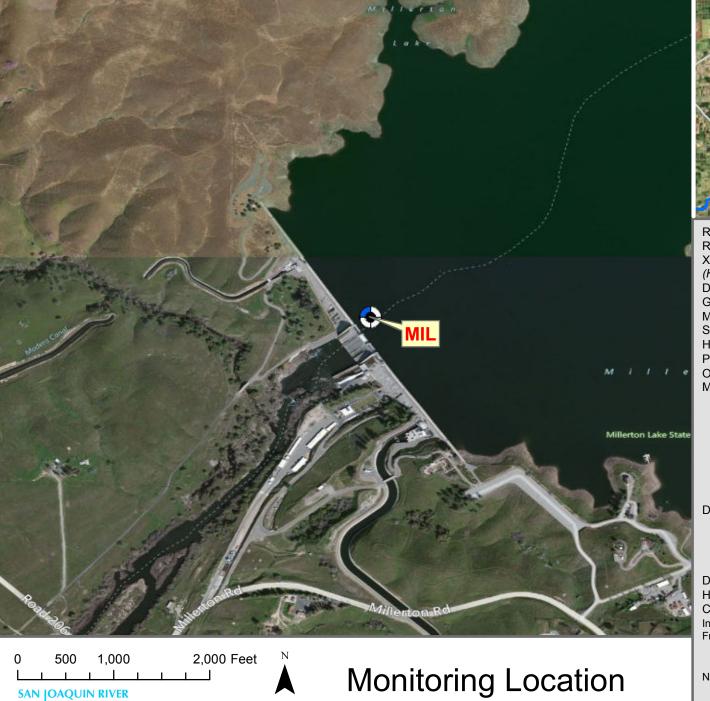
**Monitoring Location** MIL

Reach = 1A River Mile = 267.7  $X = -119.7050 \quad Y = 37.0010$ (Horizontal Datum is NAD83)

Distance From River Centerline (ft)= Ground Surface Elevation (ft NAVD88) = 581 Measurement Pt. Elevation (ft NAVD88) = 587.15 Site = Friant Dam

- 1. Type = Realtime Interval = Hourly Date Range =
- 2. Type = Measurement Interval =
- Date Range =
- 3. Type = Interval = Date Range =

Friant Dam, Madera Canal, Friant Kern Canal

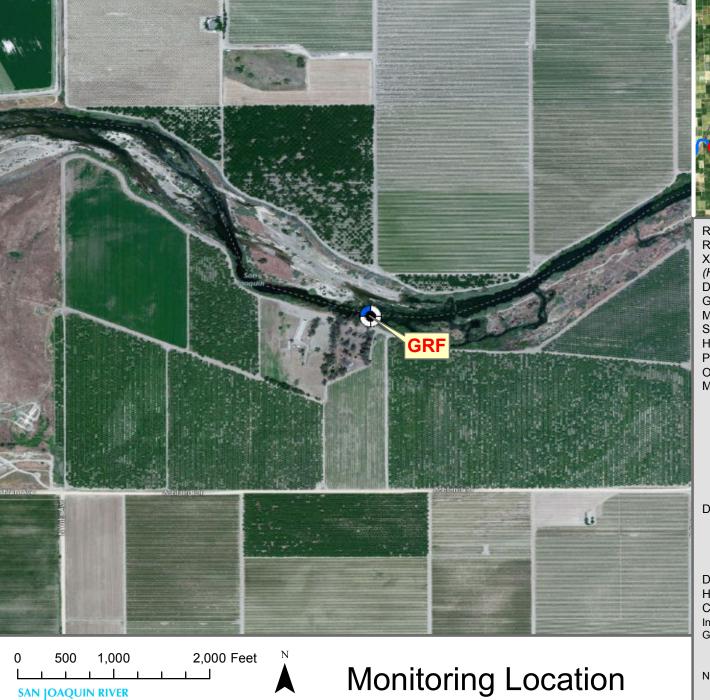
**GRF**

Reach = 1B River Mile = 227.6  $X = -120.1600 \quad Y = 36.7980$ (Horizontal Datum is NAD83)

Ground Surface Elevation (ft NAVD88) = Measurement Pt. Elevation (ft NAVD88) = 184.88

Site = Gravelly Ford

- 1. Type = Realtime Interval = 15 min Date Range =
- 2. Type = Measurement Interval =
- Date Range = 3. Type =
- Interval = Date Range =

Datalogger Type = HEC-RAS Cross-section = Current Rating Curve = Influences: **Gravelly Ford Canal**

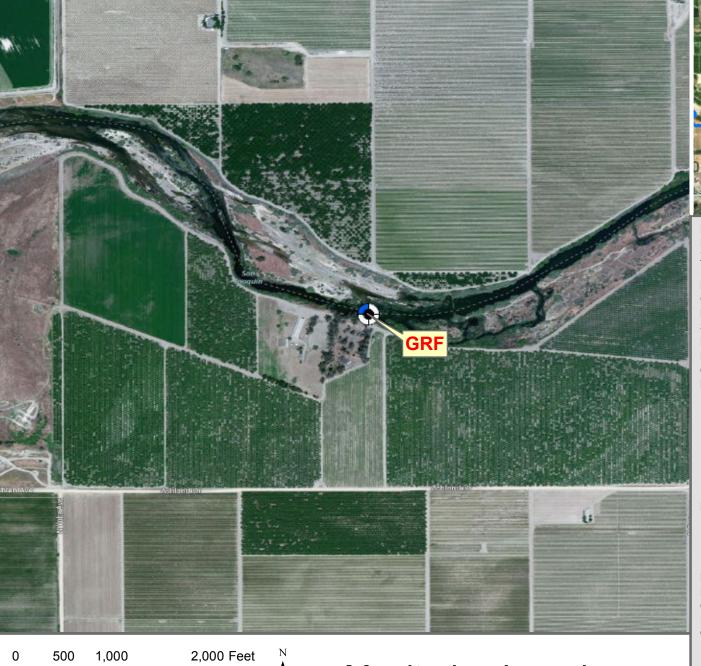
Monitoring Location GRF

Reach = 2A River Mile = 227.6 Fresno County Left Bank Status = Existing

Measurement Pt. Elevation (ft NAVD88) = 184.88

Site = Gravelly Ford

- 1.Type = Realtime Interval = 15 min Date Range =
- 2. Type = Measurement Interval =
- Date Range = 3. Type =
- 3. Type = Interval = Date Range =

Datalogger Type =
HEC-RAS Cross-section =
Current Rating Curve =
Influences:
Gravelly Ford Canal

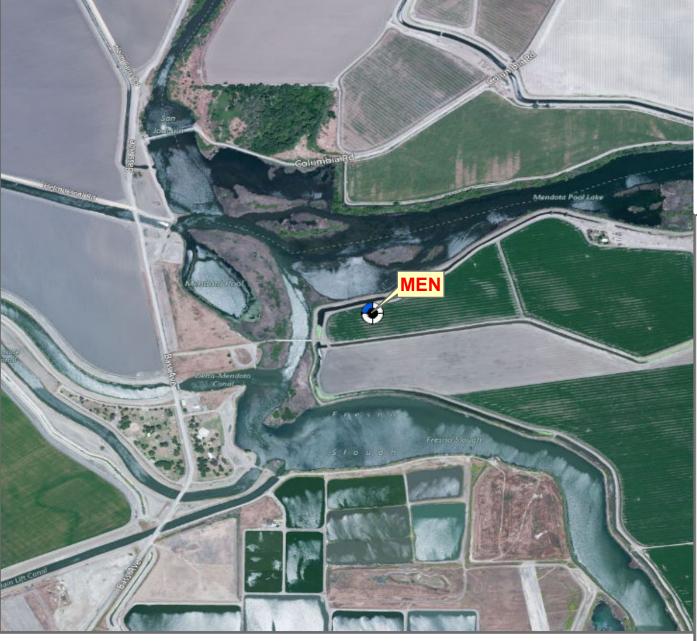
**Monitoring Location MEN**

Reach = 3Fresno County River Mile = 202.1 Left Bank  $X = -120.3670 \quad Y = 36.7830$ Status = Existing (Horizontal Datum is NAD83) Distance From River Centerline (ft)= Ground Surface Elevation (ft NAVD88) = Measurement Pt. Elevation (ft NAVD88) = 155.06 Site = San Joaquin River near Mendota Habitat =

- 1. Type = Realtime Interval = 15 min Date Range =
- 2. Type = Measurement Interval = Date Range =
- 3. Type =
- Interval = Date Range =

Datalogger Type = HEC-RAS Cross-section = Current Rating Curve = Influences: Mendota Diversions
