Appendix D

Reach 2A Sedimentation Evaluation (2011)

April 2012

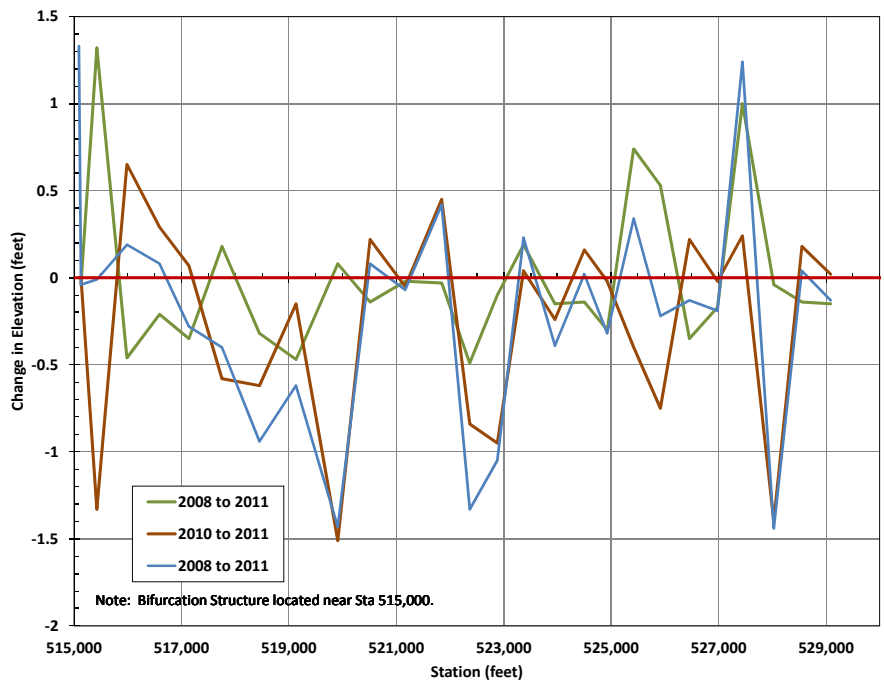
Figure 5b. Change in mean bed elevations in the downstream three miles of Reach 2A based on the 2008 LiDAR mapping, and the November 2010 and November 2011 cross-section surveys.

While the thalweg analysis quantifies the change in elevation of the deepest part of the channel, this is not necessarily a good indication of the overall aggradation/degradation tendency at each location because other parts of a particular cross section can build or degrade in the opposite direction from the thalweg change. Based on the mean bed elevations, net degradation occurred at 17 of the 27 cross sections between 2008 and 2010 and net aggradation occurred at eight cross sections, with the changes ranging from -0.5 to 1.3 feet, and averaging -0.2 feet (Figure 5). Between the 2010 and 2011 surveys, net degradation occurred at 14 of the cross sections, aggradation occurred at nine and three had little or no changes. For the overall period from 2008 to 2011, 16 cross sections degraded and nine aggraded, with an average change in bed elevation of about -0.2 feet over the entire reach.

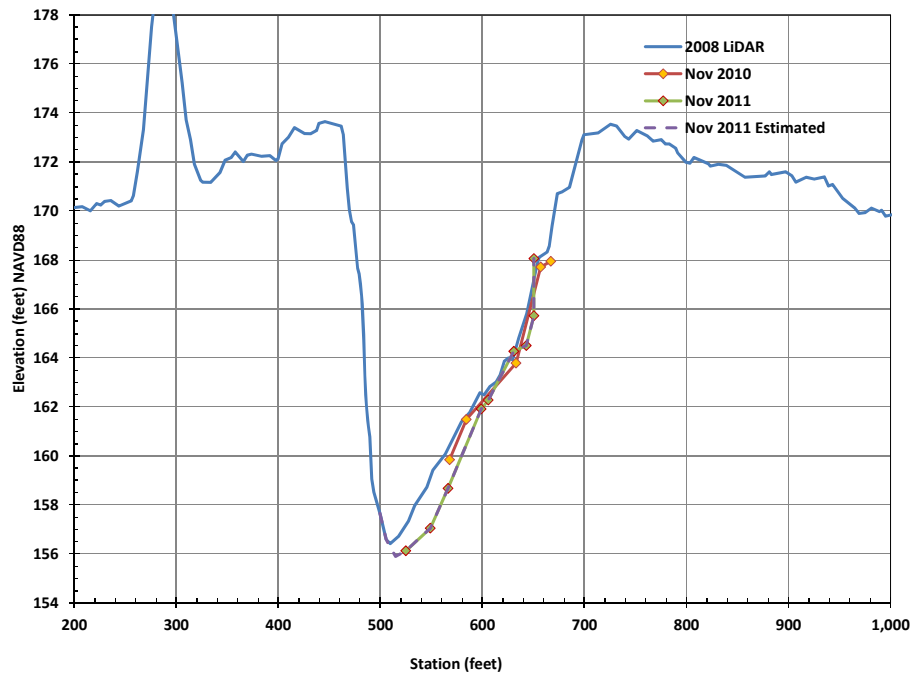
Figure 6. Profiles for XS 517,754 from the 2008 LiDAR and the November 2010 and November 2011 surveys. Also shown is the estimated profile for the missing portion of the 2011 profile used to compare thalweg and mean bed elevations.

The mean bed elevation was computed by subtracting the hydraulic depth for a common reference elevation at each cross section from the reference elevation. In some cases, it was not possible to resurvey a portion of the cross section where the thalweg was located at the base of an eroding bank due to safety issues. With two exceptions, it was assumed that the missing part of the cross section was the same as the 2008 LiDAR survey. Although there is obviously uncertainty in this assumption, the general shape of the surveyed part of the cross section was similar to the earlier profile; thus, the assumption is believed to be reasonable. The two exceptions occurred in the November 2011 surveys at XS 517,754 and XS 521,884. At XS 517,754, the toe of the left bank appears to have eroded laterally and the thalweg lowered by about 0.5 feet from 2008 (**Figure 6**). At XS 521,884, it is clear from the 2011 data that the low-flow channel filled in, raising the thalweg by over 2 feet (**Figure 7**). In both cases, the missing part of the 2011 cross-section profile was estimated based on the shape of the remainder of the cross sections.

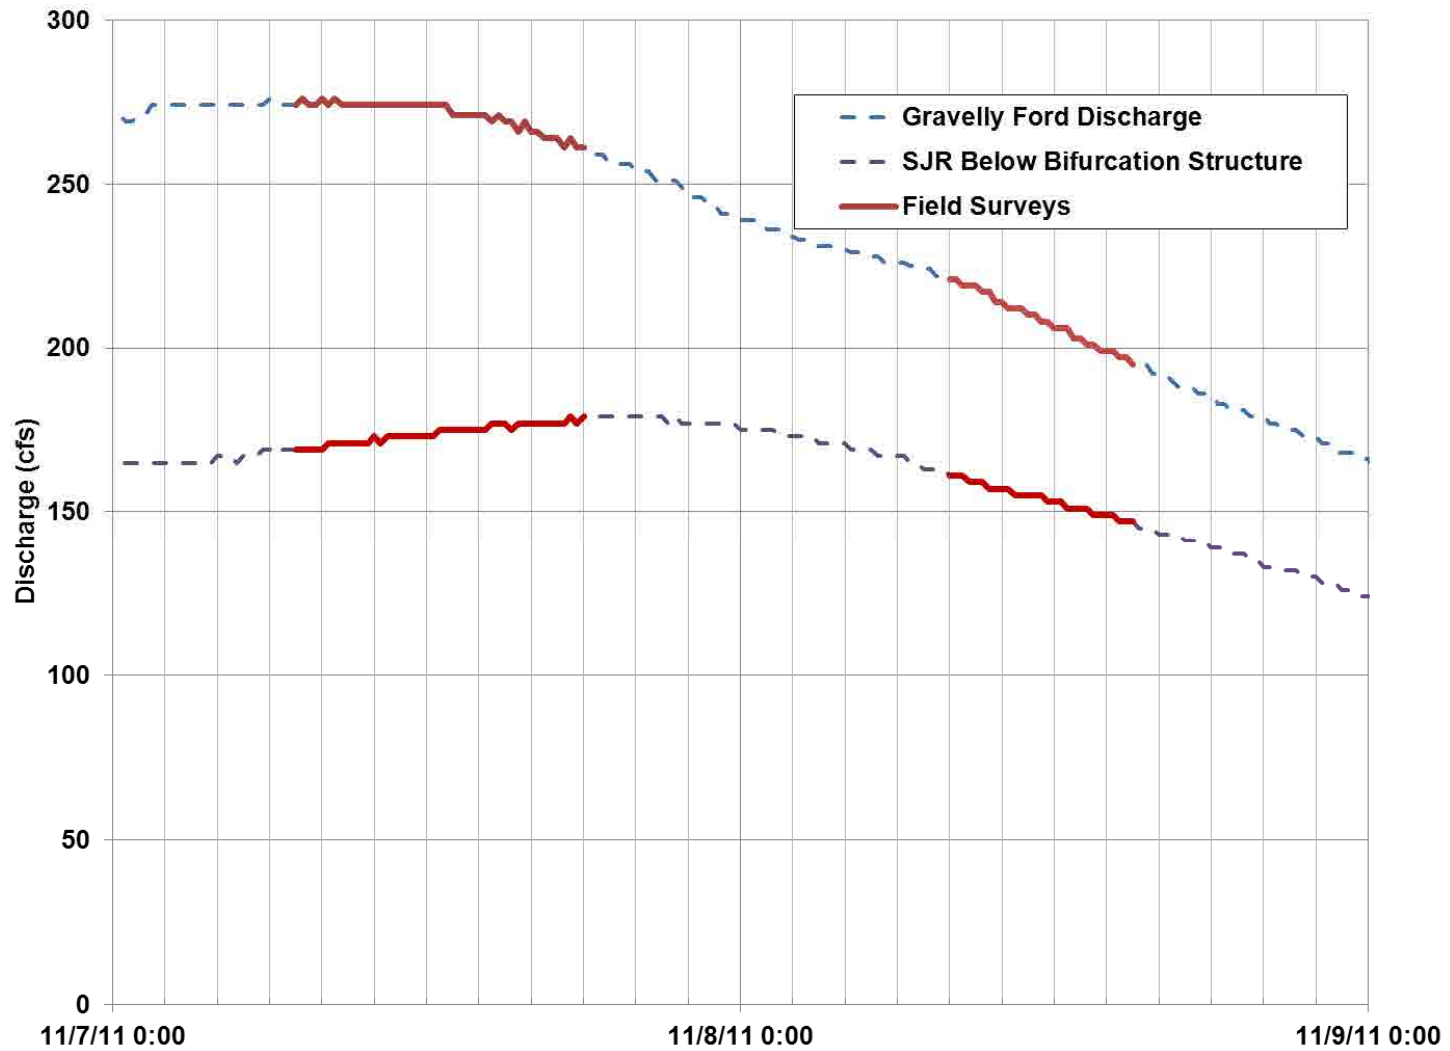
Figure 9. Discharge hydrograph during the November 2011 survey period at the Gravelly Ford (GRF) and below Bifurcation Structure (SJB) gages based on data from the CDEC website. **(Note that these discharges are provisional and subject to change upon review of the gage rating curves.)**

During the survey period on November 7, the discharge at the Gravelly Ford (GRF) gage, as reported on the California Data Exchange (CDEC) website, averaged about 270 cfs and declined slightly from about 275 cfs during the early part of the workday to 261 cfs at the end of the workday (**Figure 9**). The flows during this time-period at the below Bifurcation Structure (SJB) gage increased slightly from 169 to 177 cfs, and averaged 174 cfs. During the survey period on November 8, the discharge at the Gravelly Ford gage declined steadily from 214 cfs at the beginning of the workday to 195 cfs at the end of the workday, averaging about 205 cfs. At the below Bifurcation Structure gage, the flows on November 8 declined steadily from 161 to 147 cfs, and averaged about 154 cfs. This information was used to estimate the discharge associated with each of the water-surface elevation measurements by linearly interpolating between the reported flows at the two gages both along the reach and through time using time-stamp from the survey data logger. A total of 58 measurements were made on November 7 that covered essentially the entire survey reach. These were collected from up- to downstream through the day at discharges ranging from approximately 196 cfs at the upstream end of the reach to approximately 169 cfs at the downstream end (**Figure 10**).

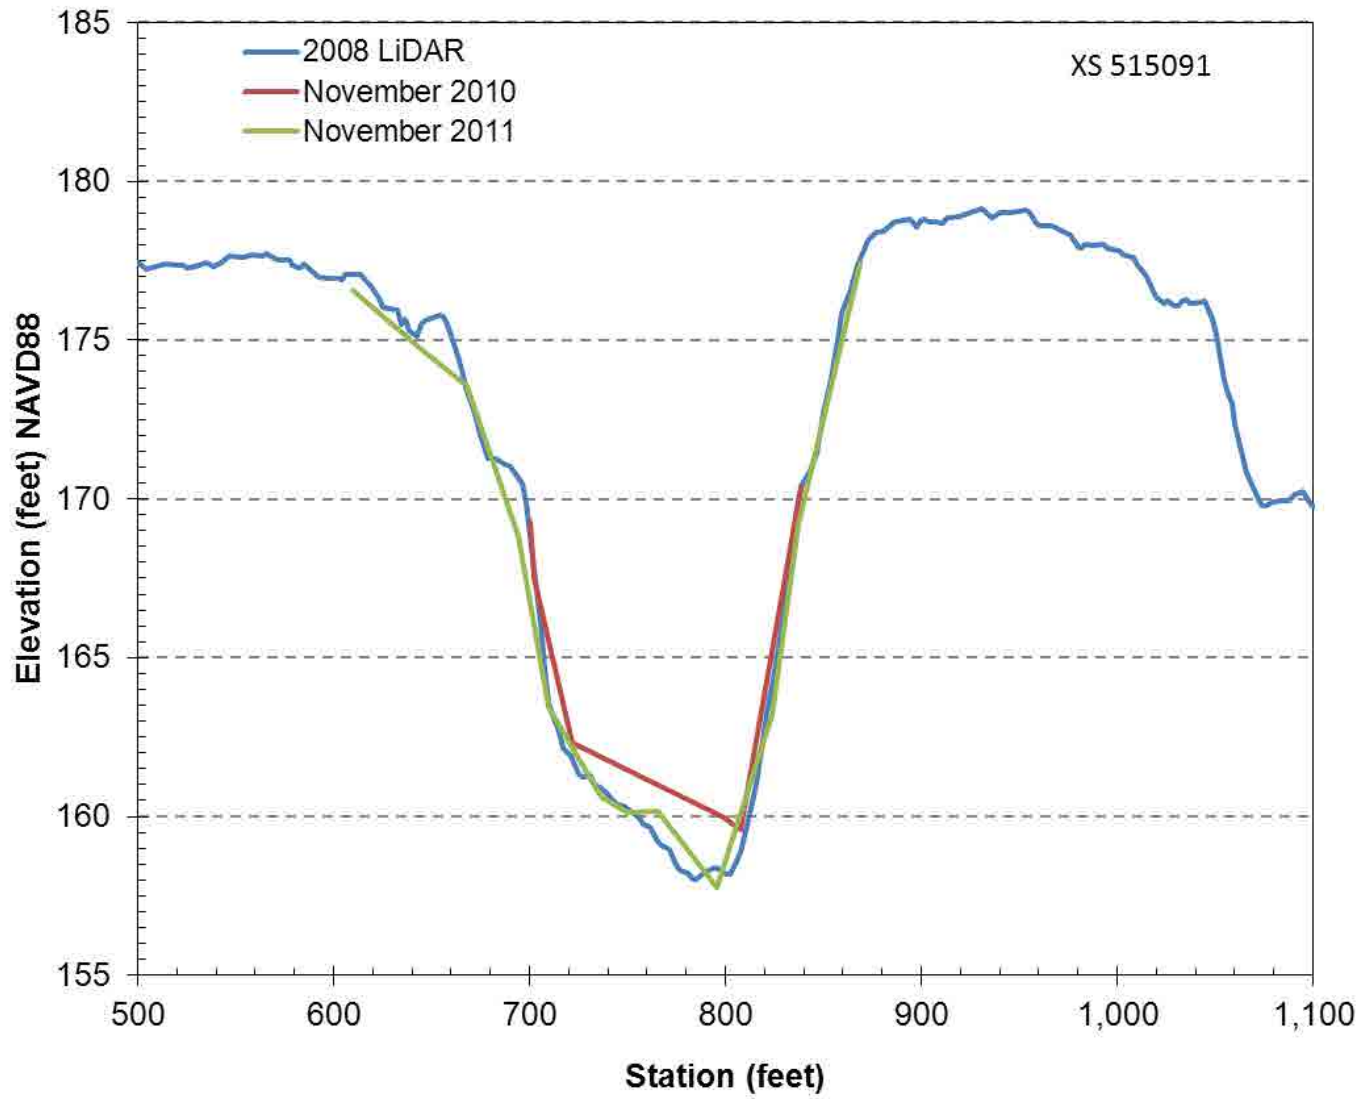
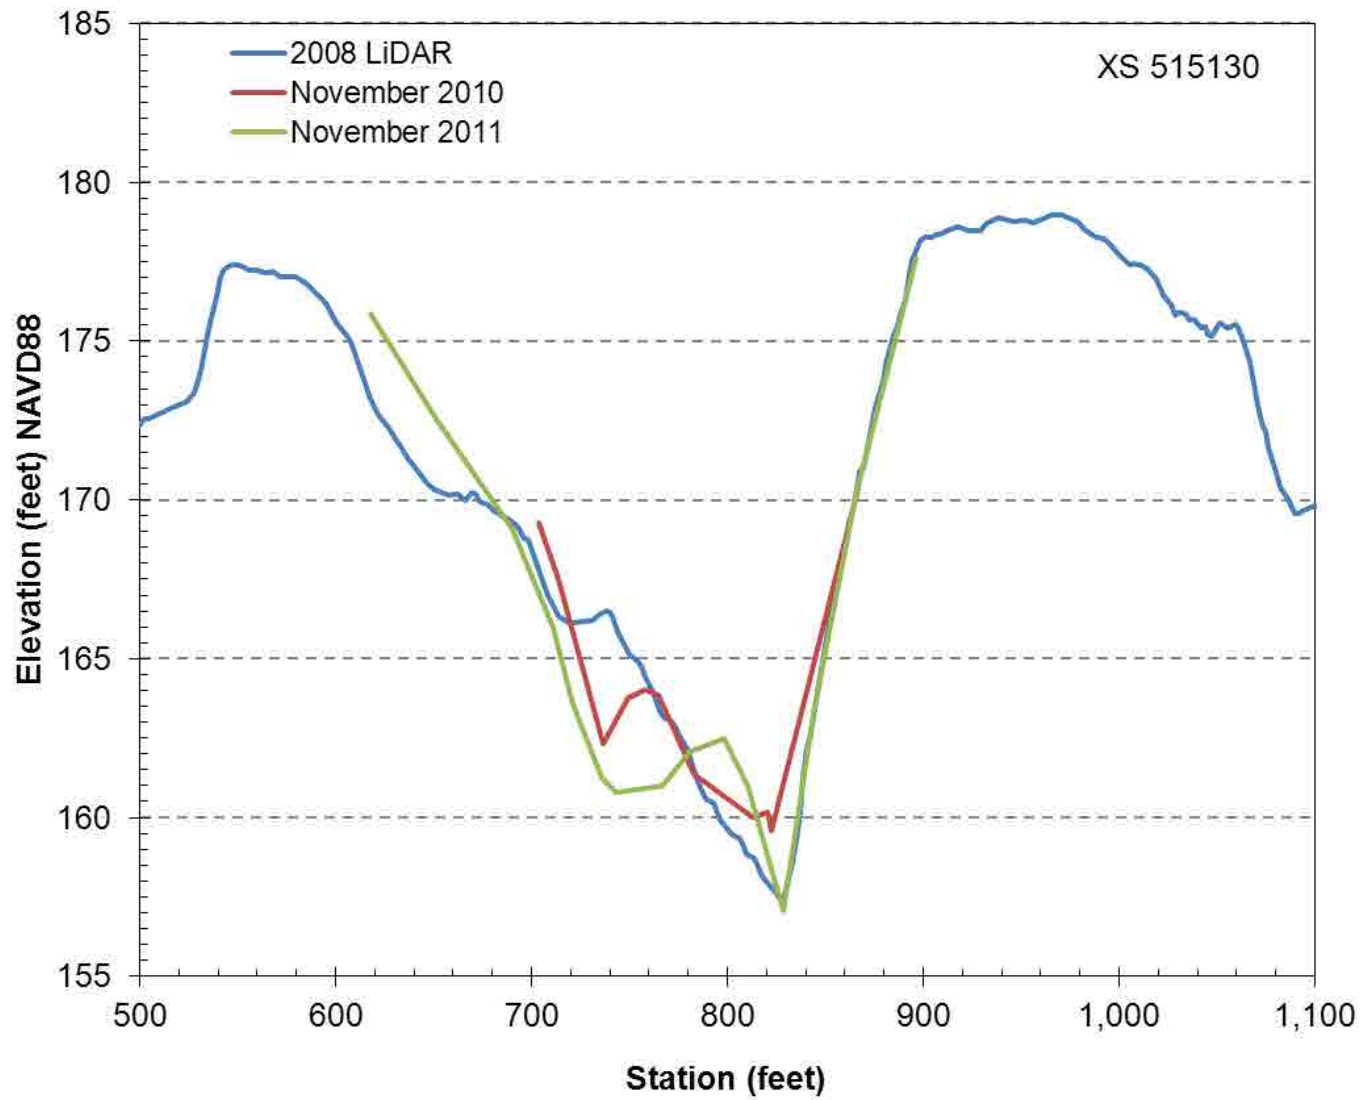
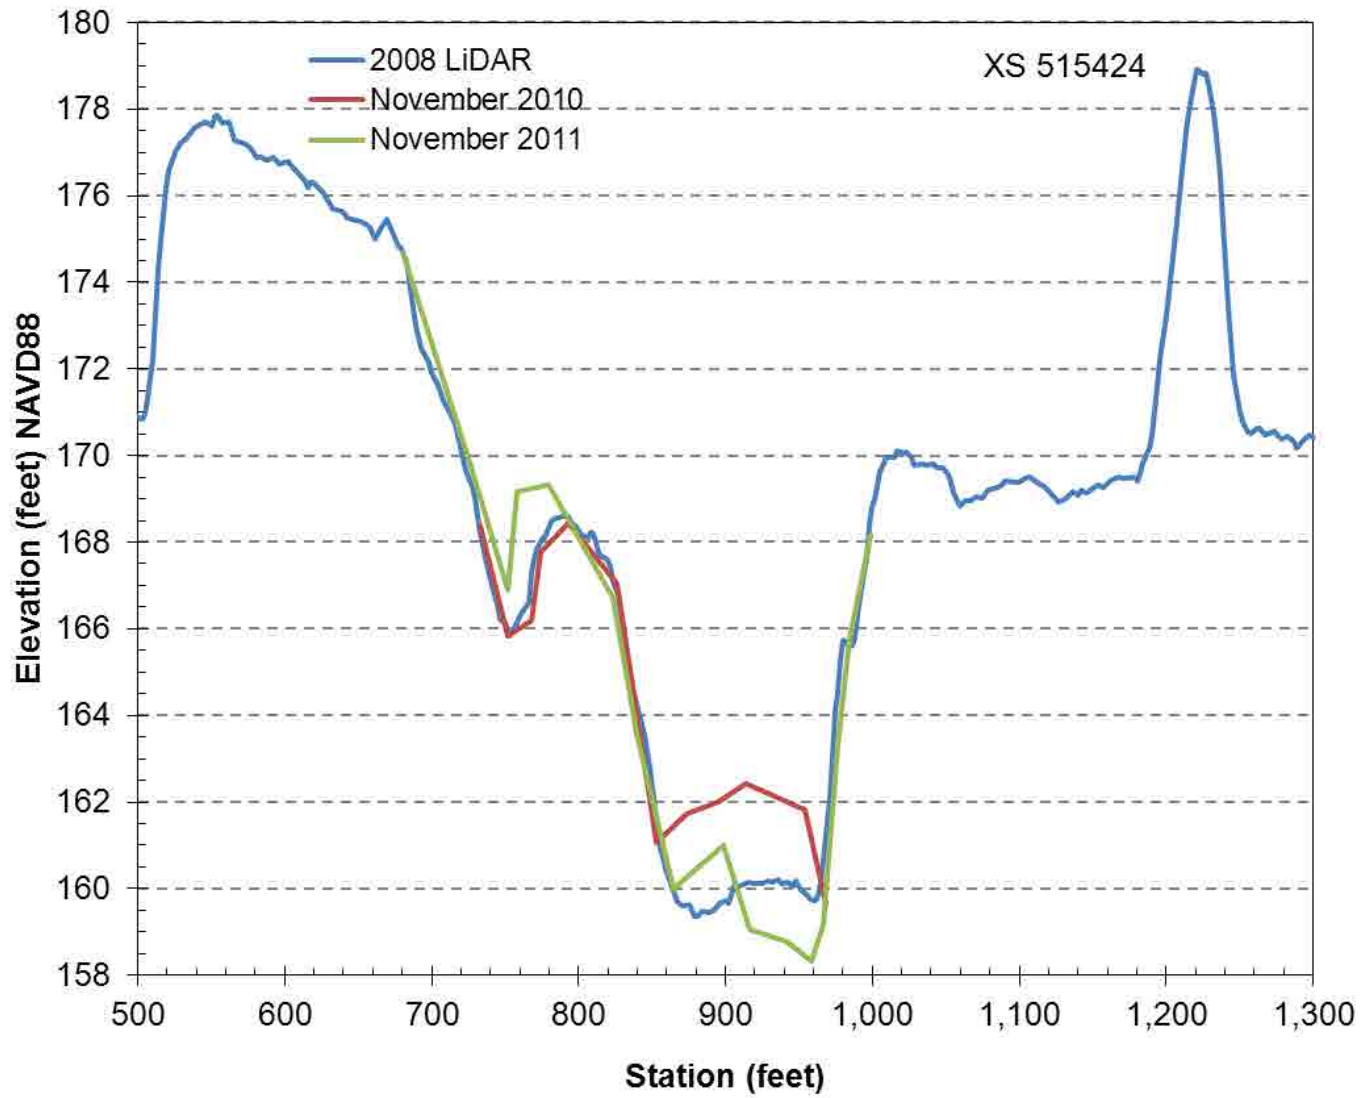
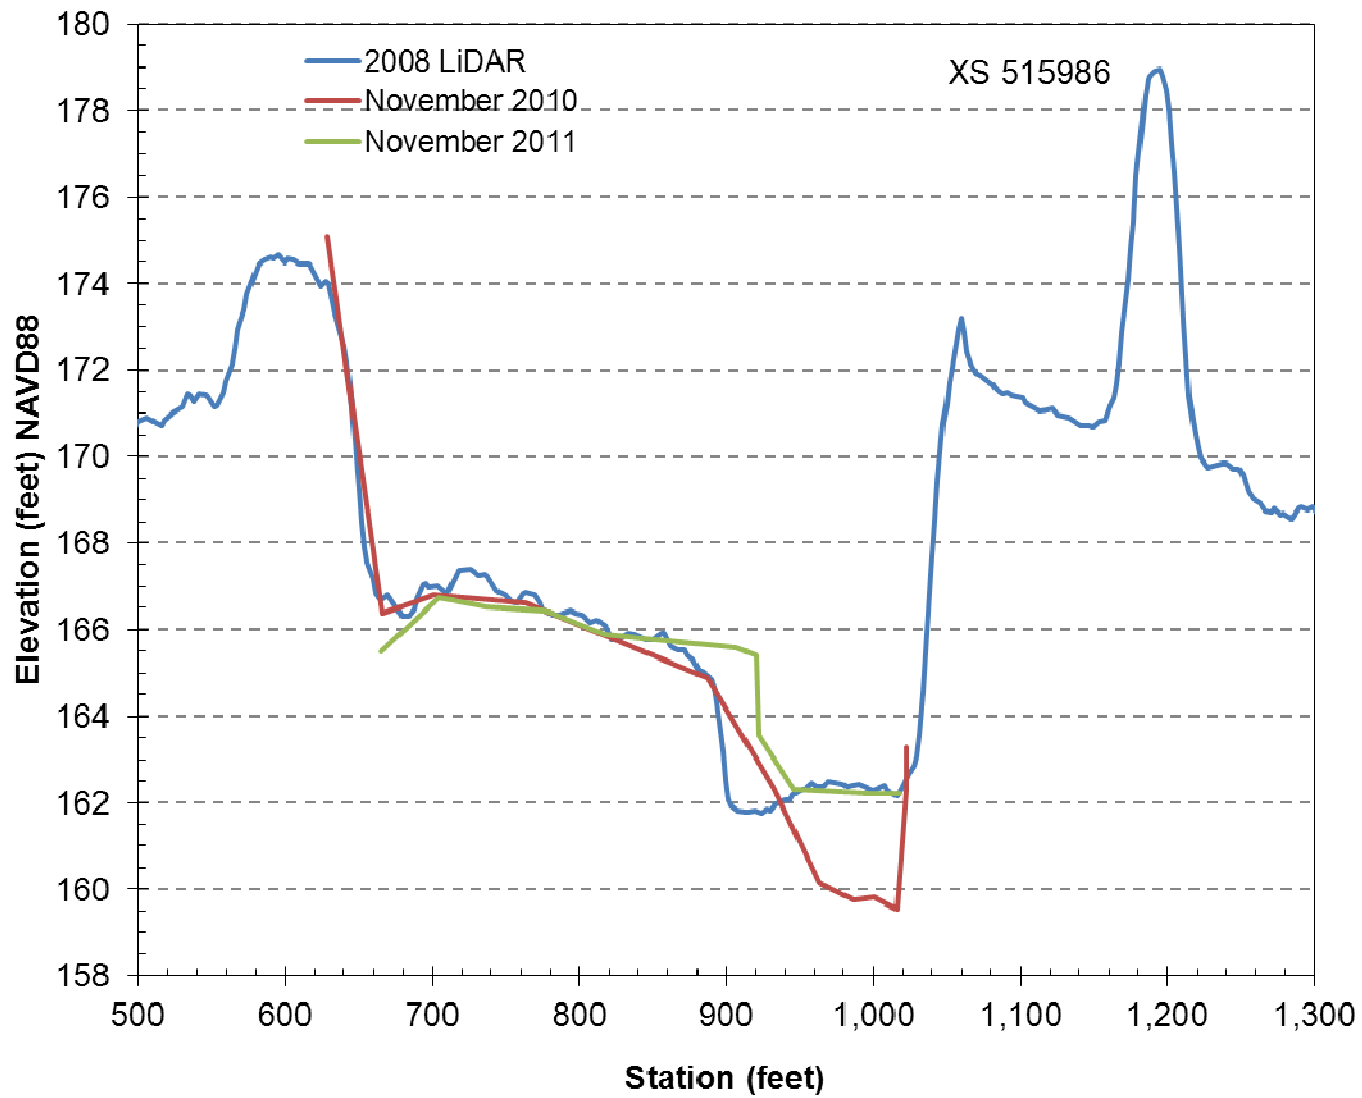
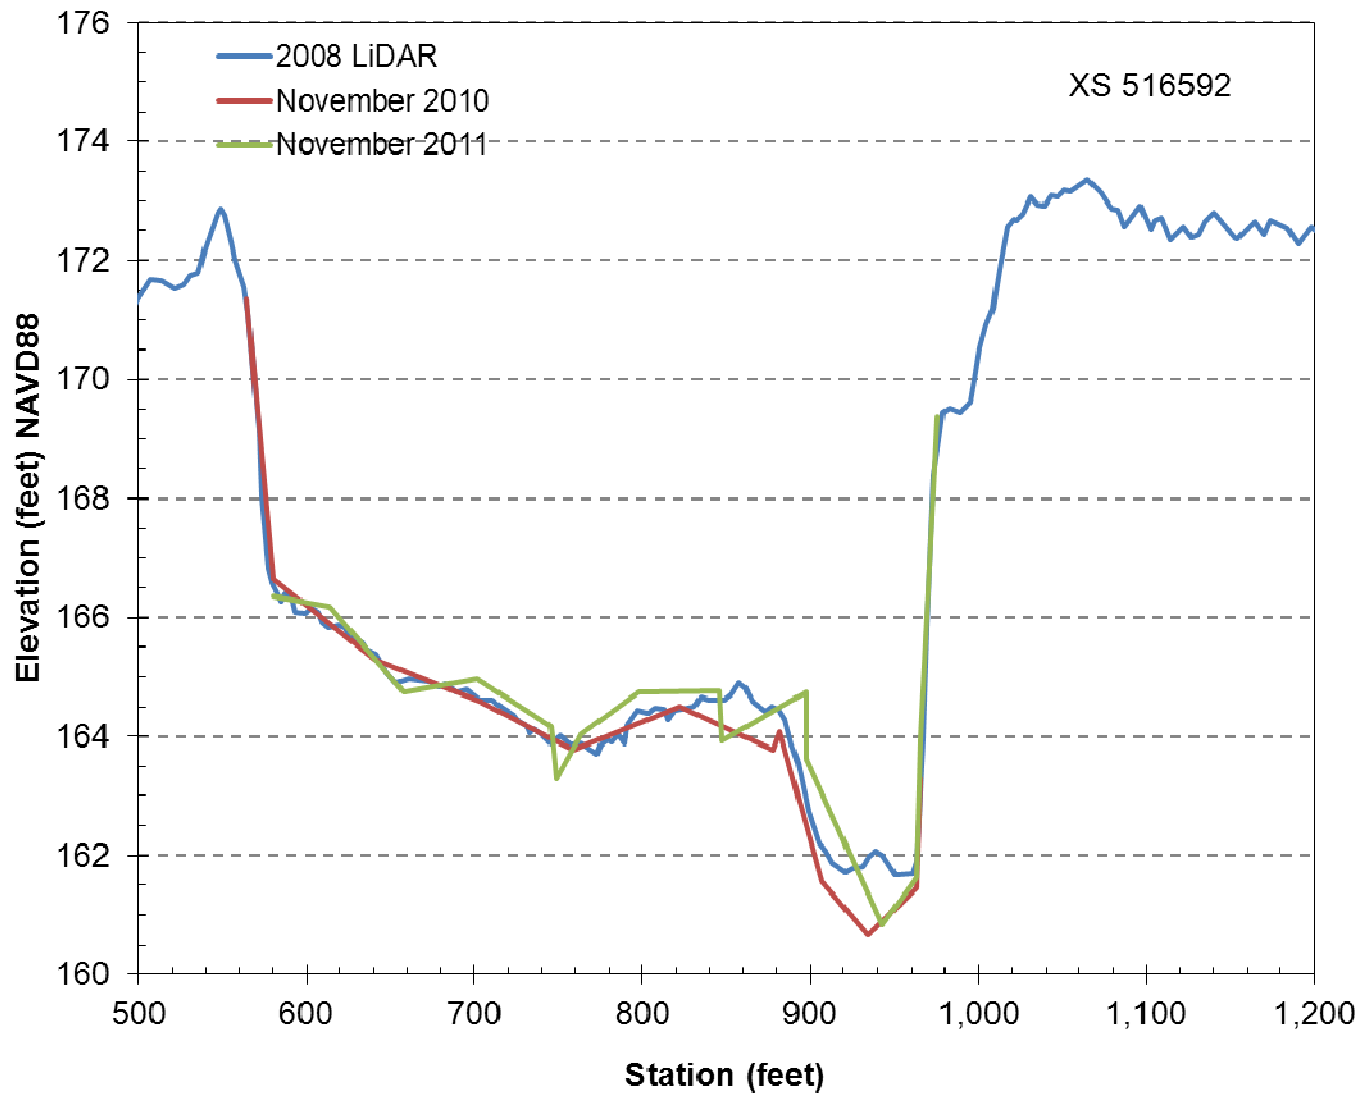
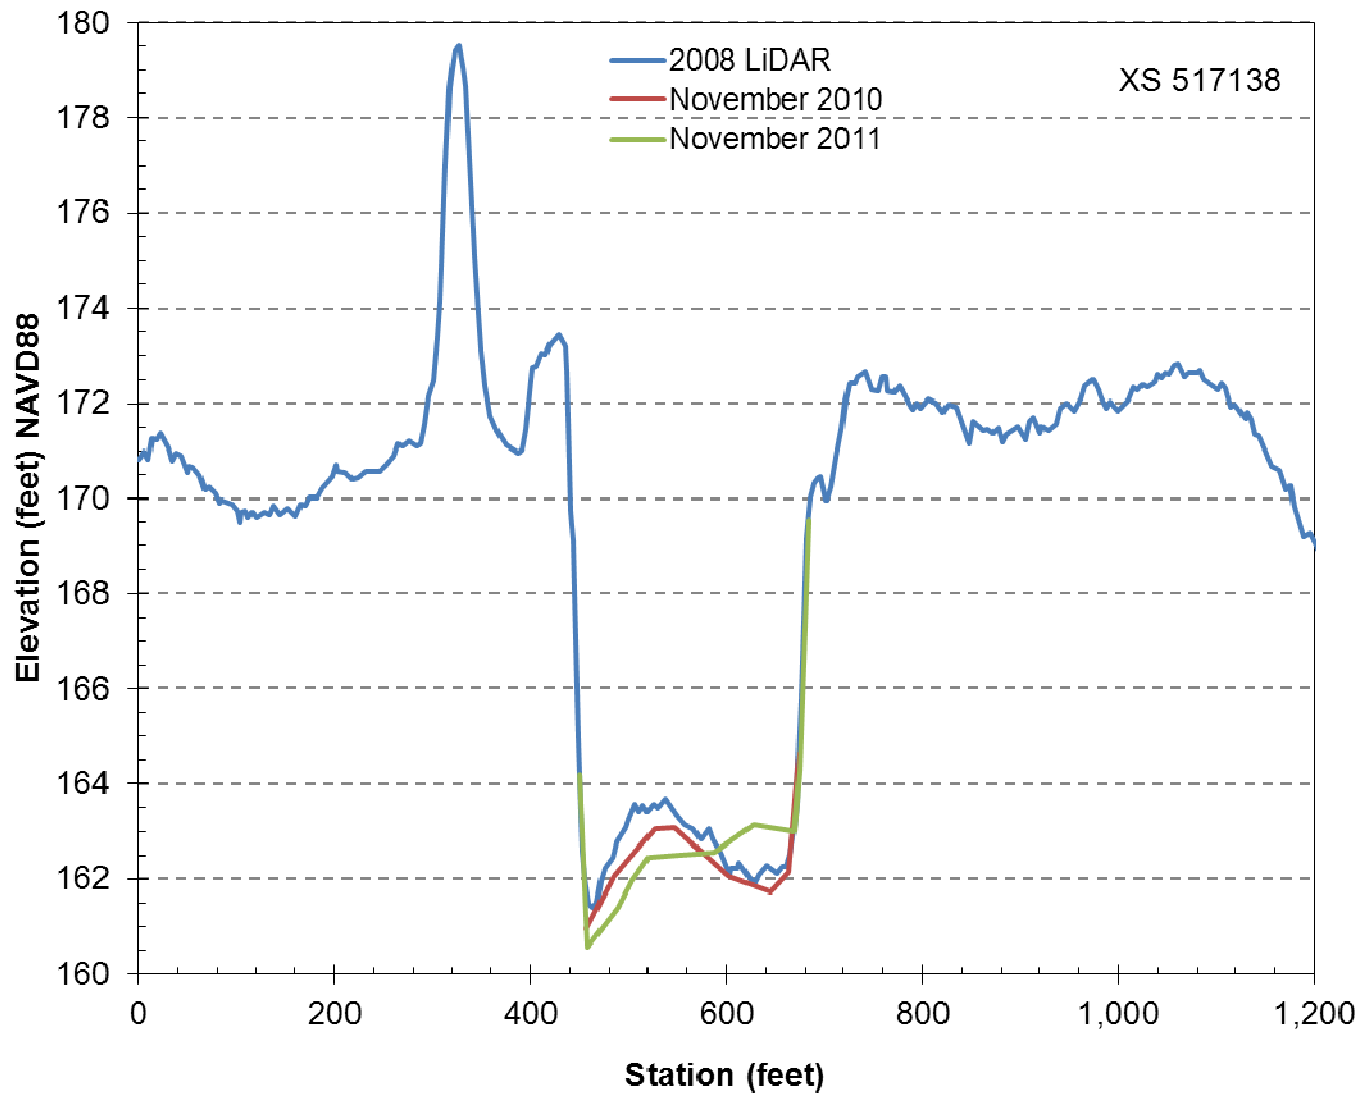
APPENDIX A
Reach 2A 2011 Survey Cross Section
Comparisons

Cross-section plots from the 2011 survey data were compared with cross sections cut from the 2008 LiDAR mapping and the November 2010 surveyed cross sections to evaluate changes in channel shape and aggradation/degradation trends (**Appendix A**). In general, the 2011 data show that the overall channel shape and width along the reach did not change significantly as a result of the 2011 high flows. Significant changes in the thalweg elevations and low-flow channel

did, however, occur at several locations¹. For example, the thalweg/low-flow channel downcut by a noticeable amount at Cross Sections (XS) 515,130, just upstream from the CBBS, at XS 518,453, XS 519,908, XS 522,881, and XS 525,918 in the middle of the reach, and most significantly at XS 528,030, near the upstream end of the reach, where the 2011 thalweg is over 5 feet lower than in either 2008 or 2011. In a few locations where significant changes in thalweg and low-flow channel elevation occurred between 2008 and 2010, the channel adjusted back to near the 2008 condition during the 2011 high flows. For example, the thalweg aggraded significantly at XS 515,424 between 2008 and 2010, but degraded back to essentially the 2008 condition in 2011. The opposite trend occurred at the next upstream XS 515,986. At XS 523,952, the thalweg and right side of the low flow channel appears to have degraded by about 1 foot between 2008 and 2010, but these areas backfilled to near their 2008 condition in 2011. A mid-channel bar that formed at XS 527,444 between 2008 and 2010 was eroded back to near the 2008 condition during the 2011 high flows.
