Task 2 Addendum
Technical Memorandum

Evaluation of Partial Fish Passage Barriers in the
Chowchilla and Eastside Bypass

**San Joaquin River Restoration Program
Fish Passage Evaluation**

Task 2 Addendum

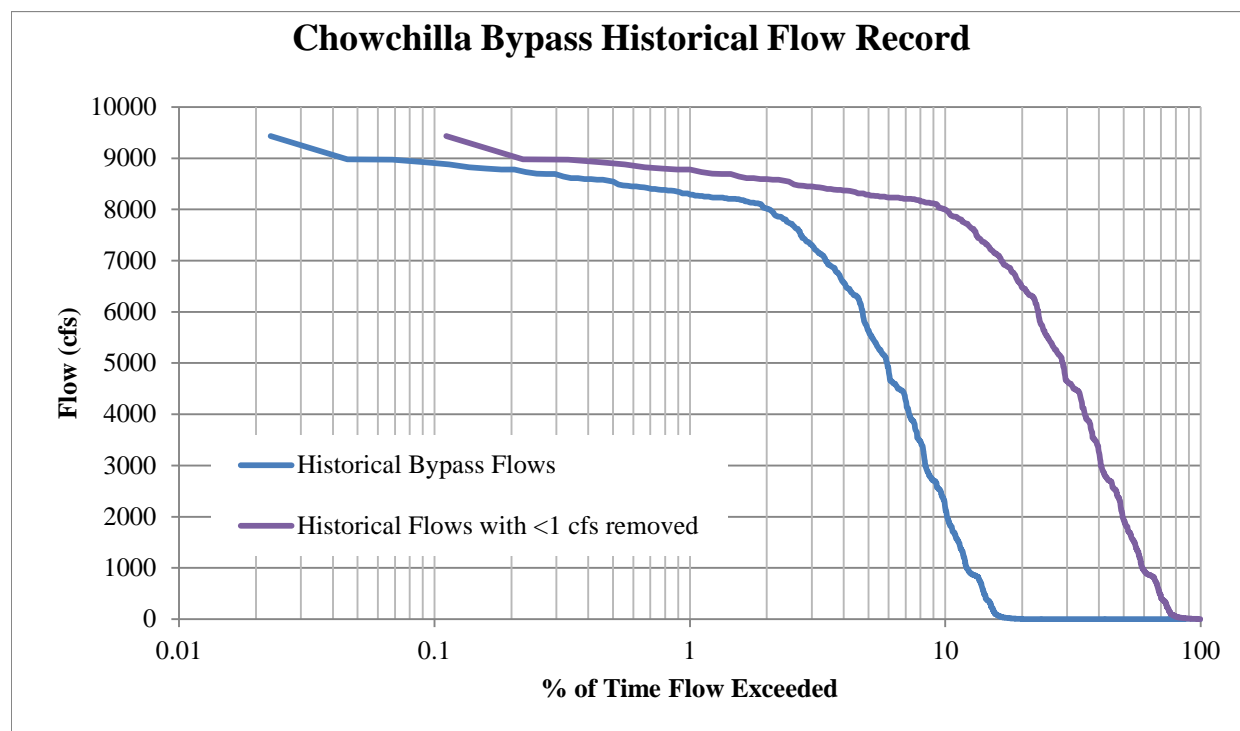
Figure 1. The Head of Chowchilla Bypass Flow Duration Curve

For the bypass, when fish are present, the estimated 1 percent exceedance flow is approximately 8,800 cfs and the 50 percent exceedance flow is near 1,900 cfs. Because historical gage data is not available for flows within the bypass downstream of the major tributaries, like the Fresno River, which may increase the exceedance flow for the downstream reaches of the bypass, the curves in Figure 1 only reflect the passage flows for the inflows at the head of the Chowchilla Bypass.

The guidance documents recommend a flow duration analysis to identify the range of passage flows for migrating fish. According to the guidelines, flow duration curves are developed to determine the upper and lower flow limits that a structure should allow for unimpeded fish passage. The upper fish passage flow limit for adult salmonids is defined as the 1 percent exceedance flow during an average year. For all adult salmonids, the lower fish passage flow equals the 50 percent exceedance flow (DFG, 2010).

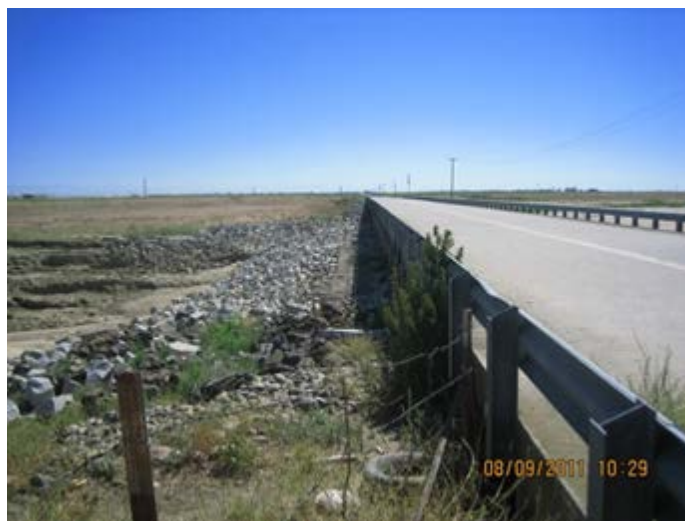
Avenue 21 Eastside Bypass downstream bridge crossing

A two-lane concrete bridge is located at the Avenue 21 crossing on the Upper Eastside Bypass. The bridge does not span the entire bypass channel and only extends the width of the low-flow channel. The bridge is slightly skewed to the channel with one- to three-foot diameter rough boulder riprap and cobble on the abutments and heavy riprap in the channel bottom under the bridge. Just downstream of the bridge, the channel is void of major vegetation. There is a significant drop (headcut) protected by riprap that extends about 50 feet with a two-foot-wide asphalt sill that is located about 15 feet downstream from the bridge that spans the low flow channel bottom. There is a drop from the sill to the riprap just downstream that varies three to five feet. Migrating fish would need to jump this sill during low flow events. The riprap just downstream of the asphalt sill gradually slopes down to the channel bottom. There is currently a ten-foot elevation difference from the sill to the natural channel bed at the edge of the riprap toe about 35 feet downstream of the sill.

Determining depth under the bridge is complex since the channel is lined with one- to three-foot diameter rough boulder riprap, which could create a hazard for adult migrating fish. The flow under the bridge meets the 1.2 feet depth criterion at 25 cfs, but the actual flow depth for fish passage may be reduced by the riprap since the height of the riprap is greater than 1.2 feet. The maximum depth over the sill, just before the drop, does not meet the 1.2 feet depth passage criterion until around 250 cfs. If a two-foot-depth over the riprap is used for the passage depth criterion under the bridge, then the minimum passage flow would be around 500 cfs. Even though there is depth for

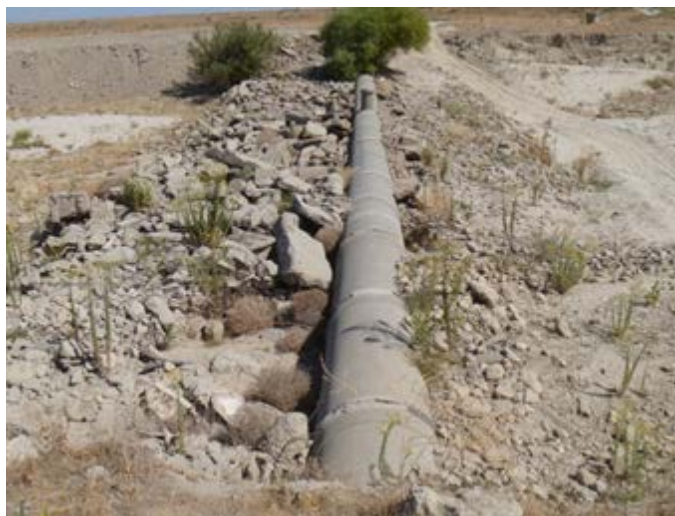
Pipeline in the Eastside Bypass looking east

The pipeline crossing is located on the Upper Eastside Bypass just upstream of the confluence with Ash Slough (north of Avenue 18-1/2). It is assumed that the pipe is used to deliver irrigation (ditch water) for agricultural use based on the presence of gated structures to the east and west of the bypass levees, which is located in line with the pipe that feeds the irrigation canals. The circular concrete pipe is exposed with riprap at the base, and extends the width of the low flow channel. The riprap is estimated to extend 35 feet beyond the downstream pipeline crossing. The pipe is raised on fill and riprap that is about seven feet higher

than the average channel bed elevation. The fill serves as a vehicular and equipment crossing. The top of the pipe is about three feet above the fill and riprap. The channel is incised in this section of the bypass with depths estimated between 10 and 20 feet. This structure is evaluated as a low-flow crossing.

Depth over the cross section just downstream of the pipe does not meet the flow depth criterion until flows are around 100 cfs, but flows greater than 100 cfs may be needed to safely pass the large riprap. If a depth of two-feet-over the riprap is used to meet the flow depth criterion then the minimum flow needed for passage would be 300 cfs. However, sufficient pool depth to meet the jumping criterion is not met until flows are over 1,300 cfs. Depth over the pipe meets the flow depth criterion for flows above 2,150 cfs, so it is possible for an adult salmon in good and in poor condition to jump the pipe for flows between 1,300 – 2,150 cfs.

The velocity criterion for the entire low-flow crossing length, 45 feet, is used to determine the unimpeded passage flow until the pipe and fill for the crossing is fully submerged with sufficient depth at 2,150 cfs. The velocity criterion for a structure with a length of 45 feet is around 8 fps for a fish in good condition (Table 2). The velocity criterion is not exceeded over the fill but is exceeded over the pipe for flows between 3,000 – 5,000 cfs. Since passage flows exceed the velocity criterion only at the pipe when the structure is fully submerged, but not upstream and downstream of the pipe, this analysis will assume that an adult Chinook salmon could burst past the pipe because velocities over the pipe do not exceed the burst speed criterion of 10.8 cfs. If the velocity through the entire length of structure for a fish in poor condition is applied then the

In conclusion, this structure meets passage criteria from 1,300 – 8,500 cfs assuming optimum response. However, when considering minimum response, a fish in poor condition does not meet the passage criteria for any flows.

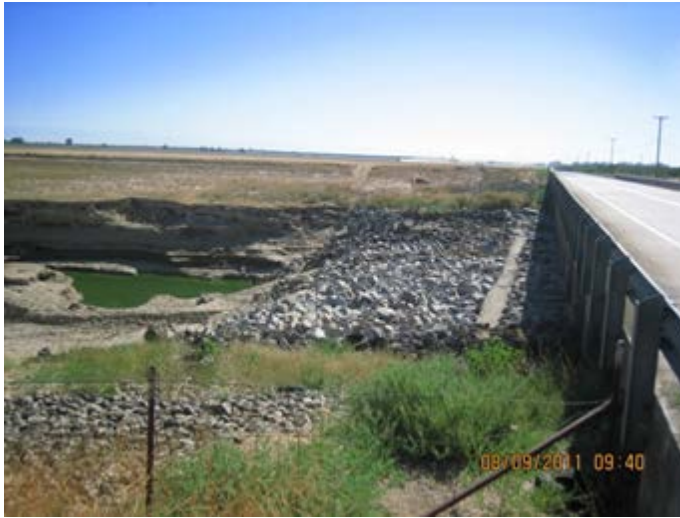
Avenue 18-1/2 Eastside Bypass downstream bridge crossing

The Avenue 18-1/2 crossing is a two-lane concrete bridge located on the Upper Eastside Bypass and is upstream of Avenue 21. This bridge, like the Avenue 21 Bridge, only spans the low flow channel with abutments that extend to the levees. The bridge is slightly skewed to the channel with cobble on the abutments and one- to three-foot-diameter rough boulder riprap in the channel bottom under the bridge. The riprap in the channel under the bridge averages about two feet in depth and extends about 50 feet upstream. The channel upstream is mostly silty sand, void of major vegetation, and shallow. The channel

Like the Avenue 21 crossing, determining depth under the bridge is complex since there is large, rough riprap with heights greater than two feet that could create a hazard for adult migrating fish. The minimum passage depth of 1.2 feet under the bridge meets the criterion at 25 cfs, but the actual passage depth may be reduced by the height and large voids in the riprap. The minimum flow depth over the sill does not meet the 1.2 foot criterion for passage until around 300 cfs. If a depth of two-feet-over the riprap is used for the minimum depth flow criterion, then the minimum passage depth could be around 700 cfs.

In conclusion, the Avenue 18-1/2 Bridge meets passage criteria for flows between 300 – 2,500 cfs assuming optimum response. However, when considering minimum response, if a depth of two feet is needed over the riprap, then the minimum flow depth could be 700 cfs. Because of the uncertainty about whether fish can burst past the sill at flows above 1,000 cfs passage flows could be between 700 cfs – 1,000 cfs for a fish in poor condition.

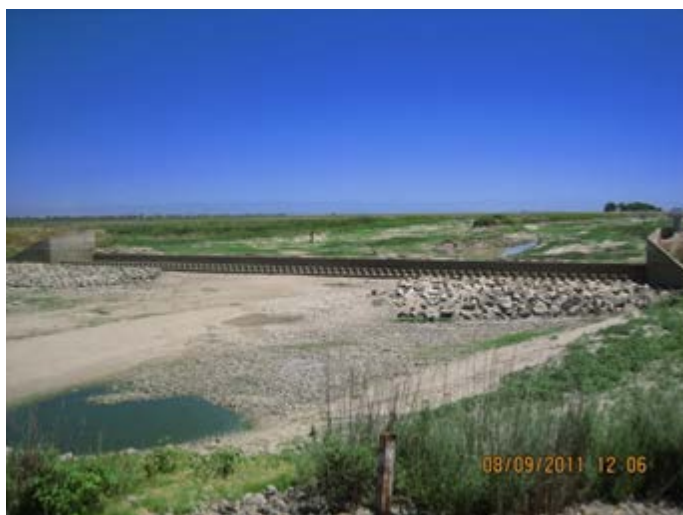
Drop 1 looking upstream within the Eastside Bypass

Drop 1 is a concrete weir structure within the Upper Eastside Bypass that is downstream of the Fresno River confluence with the bypass and Road 9. The weir extends the width of the low-flow channel. It has a height of around 5 feet, and the total length of the structure from the inlet to outlet is 24 feet. The structure has a concrete apron with concrete baffles and a short sill, which is approximately one foot in height, and is located downstream of the weir. The structure has large concrete wingwalls and an earthen levee that extends to connect the bypass levees with the structure. The structure diverts all of the flows into and over the weir, so the weir cannot be bypassed. The channel downstream the weir is void of major vegetation with riprap scour protection near the structure's wingwalls and downstream of the structure. Road 9 (Hemlock) Bridge is about 200 feet downstream of the weir. About 2,000 feet upstream the weir there is a second drop structure, Drop 2.

The flow depth through the drop structure is greater than the minimum flow depth criterion of 1.2 feet due to backwatering behind the downstream sill; therefore, passage is not limited for flow depth at any flows. Flow depth over the weir and the downstream sill may limit passage but these structural features can be jumped by adult Chinook salmon at some flows. Once flows are around 3,000 cfs, the flow depth criterion of 1.2 feet is met at the weir, so it is assumed that the migrating fish could swim over the weir.

When flows are just over 800 cfs, the pool depth meets the criterion for jumping at the weir for a fish in good condition. An adult Chinook salmon in good condition should be able to jump the total height of the hydraulic drop from the fall of the jump pool to the water surface upstream of the weir. For flows below 1,600 cfs, the jump height at the weir meets the jump criterion for a fish in poor condition.

Because the maximum swimming distance to clear the width of the structure is 25 feet, the velocity criterion of 6 fps for a fish in poor condition is applied to the structure for the entire length (Table 2). The velocity criterion is exceeded at flows over 1,600 cfs at the weir. However, velocities at the weir are less than 10.8 fps, so a fish in good condition may be able to swim through the structure, since the burst speed is not exceeded. Baffles at this structure are 1.5 feet deep by 1.5 feet wide and 2.7 feet in height with spacing between each baffle of 1.3 feet. The

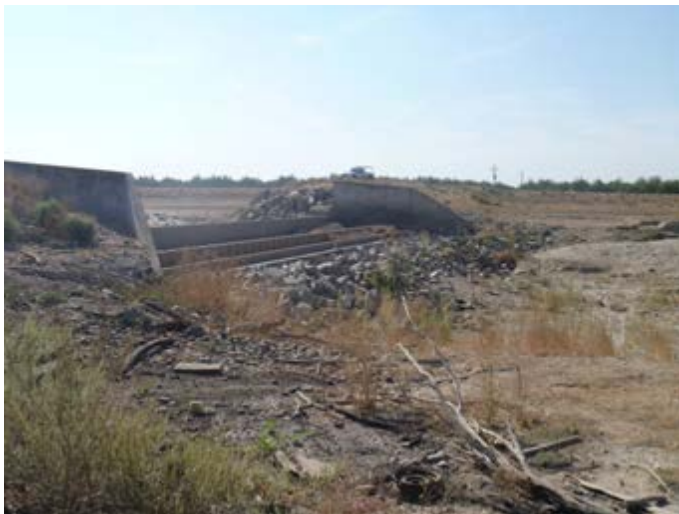
Drop 2 looking upstream within the Eastside Bypass

Like Drop 1, flow depth through the structure is not limiting passage due to the backwater caused by the downstream sill. The depth of flow over the weir does not meet the depth criterion of 1.2 feet until flows are above 4,500 cfs. Throughout the flow range there is a hydraulic drop greater than one foot that could impede fish passage. At 4,500 cfs when an adult can swim over the weir, there is still a hydraulic drop that exceeds one foot from upstream the weir to downstream at the jump pool, so swimming over the weir may not be possible at any passage flows.

jump over the weir to pass. The jump pool depth does not meet the jump criterion for flows under 4,500 cfs. A fish in poor condition meets the velocity criterion of 6 fps (Table 2) for a swimming distance of 25 feet. The velocity criterion of 6 fps is applied to the structure for the entire length, but it is exceeded at flows over 1,000 cfs at the weir. Velocities at the weir exceed the burst speed criterion of 10.8 fps at flows around 5,000 cfs. Like Drop 1, Drop 2 has baffle blocks that do not have velocities that exceed the burst speed criterion of 10.8 fps. The baffles are overtopped at flows above 600 cfs.

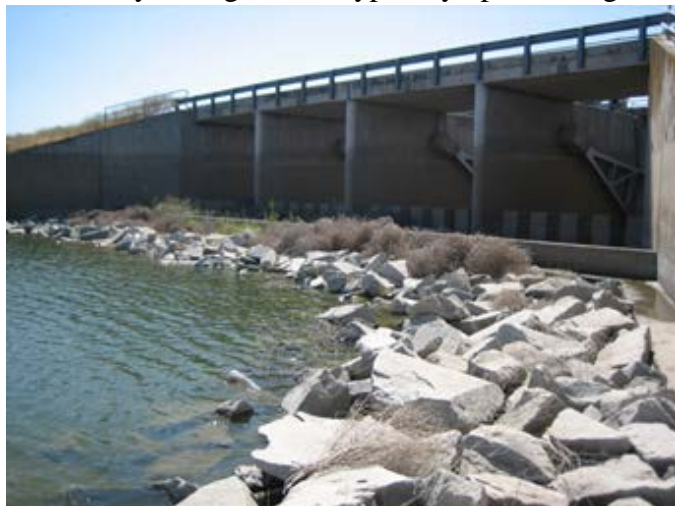
Chowchilla Bypass Control Structure outlet looking upstream

The Chowchilla Bypass Control Structure is part of the Chowchilla Bifurcation Structure located at the head of the Chowchilla Bypass at the San Joaquin River. The control structure is gated with four large radial gates that are controlled manually. The gates are typically open during flood flows, and generally remain closed during Restoration Flows or water deliveries. The structure is similar to the control structures on the San Joaquin River and Eastside Bypass. There are four large concrete bays with baffle blocks located at each outlet, and a short sill at the end of the concrete apron that flow is directed into. Riprap protects the channel from erosion just downstream of the sill, at grade, for about 30 feet. This structure is a complete fish passage barrier when gates are closed and potentially during partial gate closure, due to the potentially high velocities that pass beneath the gates. For this evaluation, the gates are assumed to be fully opened.

Depth within the structure meets the minimum flow depth criterion at all flows due to the 2.5-foot tall sill at the end of the apron. The flow depth over the sill meets the 1.2-foot flow depth criterion when flows exceed 700 cfs, so for flows below 700 cfs fish would need to jump the sill.

The jump criterion is not met until flows are over 275 cfs because of the lack of sufficient pool depth needed for the jump. Jumping at the sill meets the criterion for flows between 275 – 700 cfs, even for a fish in poor condition.

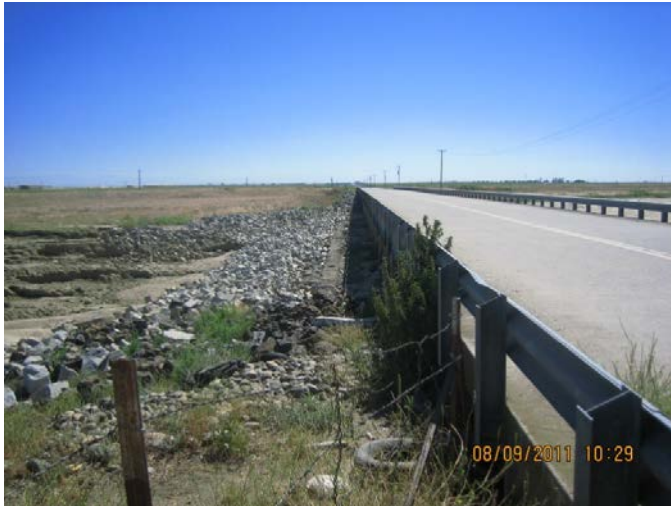
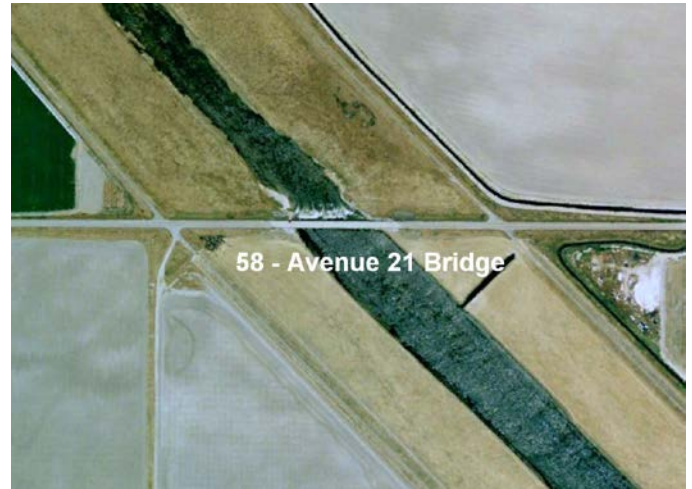
Barrier Type¹: Bridge

Rank¹: **Red**

- Model - Flows through Avenue 21 were simulated using the HEC-RAS Chowchilla Bypass and Upper Eastside Bypass model developed by DWR's South Central Region Office (SCRO) modeling team.
- Geometry - The structure was based on the as-built design drawing. The geometry was adjusted for subsidence and reflects 2011 conditions.
- Boundary Condition - The reach-wide model has a downstream rating curve developed using Tetra Tech's latest Middle Eastside Bypass model with vertically varied n-values.
- Calibration - The model was calibrated using the water surface elevation data collected by DWR on April 7, 2011; the flow was measured to be 7,470 cfs using an ADCP device. The model water surface elevations were compared to the 2011 measured water surface elevations and were within +/- 1'.

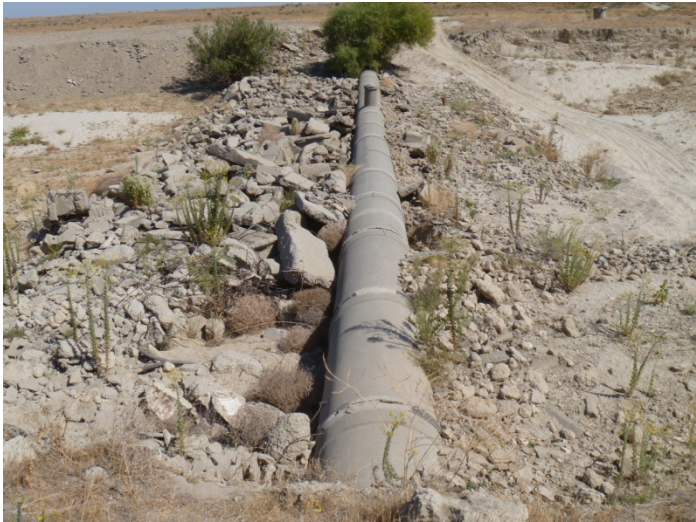
BEARINGS		
Site Name³: EB Pipeline Crossing	I.D. Number¹: 60	Reach: Eastside Bypass
River Mile:	Barrier Type¹: Pipe	Rank¹: Red

- Model - Flows through the pipeline crossing were simulated using the HEC-RAS Chowchilla Bypass and Upper Eastside Bypass model developed by DWR-SCRO modeling team.
- Geometry - The structure was based on survey information collected by DWR via P&P. The geometry was adjusted for subsidence and reflects 2011 conditions.
- Boundary Condition - The reach-wide model has a downstream rating curve developed using Tetra Tech's latest Middle Eastside Bypass model with vertically varied n-values.
- Calibration - The model was calibrated using the water surface elevation data collected by DWR on April 6, 2011; the flow was measured to be 7,160 cfs using an ADCP device. The model water surface elevations were compared to the 2011 measured water surface elevations and were within +/- 1'.

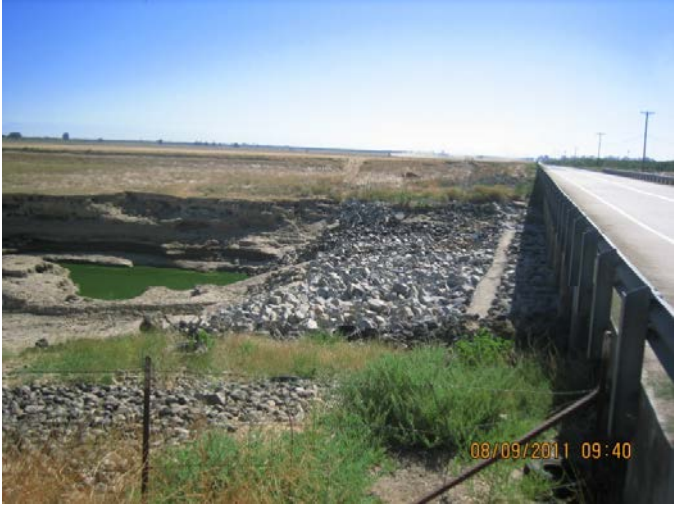
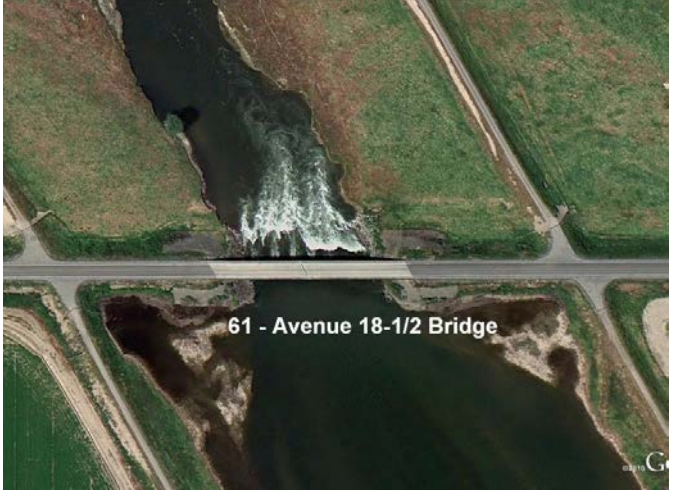
BEARINGS		
Site Name⁴: Avenue 18-1/2	I.D. Number¹: 61	Reach: Eastside Bypass
River Mile:	Barrier Type¹: Bridge	Rank¹: Red

- Model - Flows through Avenue 18-1/2 were simulated using the HEC-RAS Chowchilla Bypass and Upper Eastside Bypass model developed by DWR-SCRO modeling team.
- Geometry - The structure was based on the as-built design drawing. The geometry was adjusted for subsidence and reflects 2011 conditions.
- Boundary Condition - The reach-wide model has a downstream rating curve developed using Tetra Tech's latest Middle Eastside Bypass model with vertically varied n-values.
- Calibration - The model was calibrated using the water surface elevation data collected by DWR on April 6, 2011; the flow was measured to be 7,160 cfs using an ADCP device. The model water surface elevations were compared to the 2011 measured water surface elevations and were within +/- 1'.

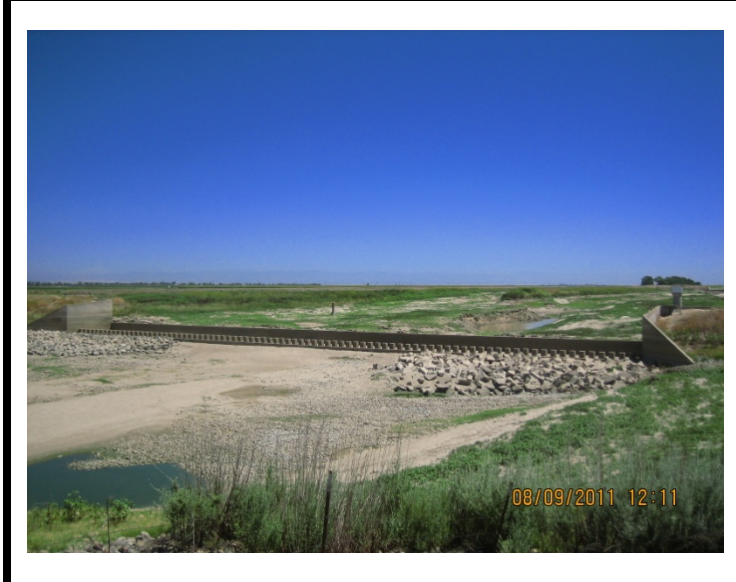
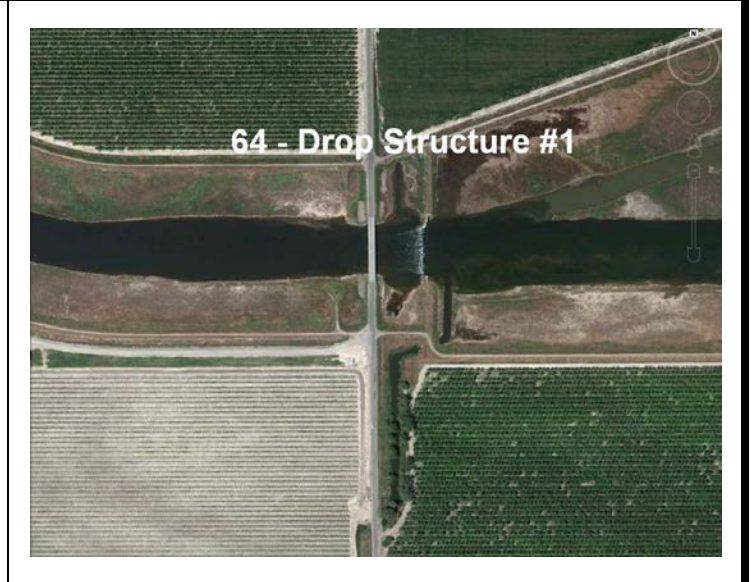
Site Name⁵: EB Drop Structure 1 **I.D. Number¹:** 64 **Reach:** Eastside Bypass

River Mile: **Barrier Type¹:** Weir **Rank¹:** **Red**

- Model - Flows through Drop Structure 1 (The Downstream Drop Structure) were simulated using the HEC-RAS Chowchilla Bypass and Upper Eastside Bypass model developed by DWR-SCRO modeling team.
- Geometry - The structure is based on survey data and the as-built design drawing. The geometry was adjusted for subsidence and reflects 2011 conditions.
- Boundary Condition - The reach-wide model has a downstream rating curve developed using Tetra Tech's latest Middle Eastside Bypass model with vertically varied n-values.
- Calibration - The model was calibrated using the water surface elevation data collected by DWR on April 6, 2011; the flow was measured to be 7,160 cfs using an ADCP device. The model water surface elevations were compared to the 2011 measured water surface elevations and were within +/- 1'.

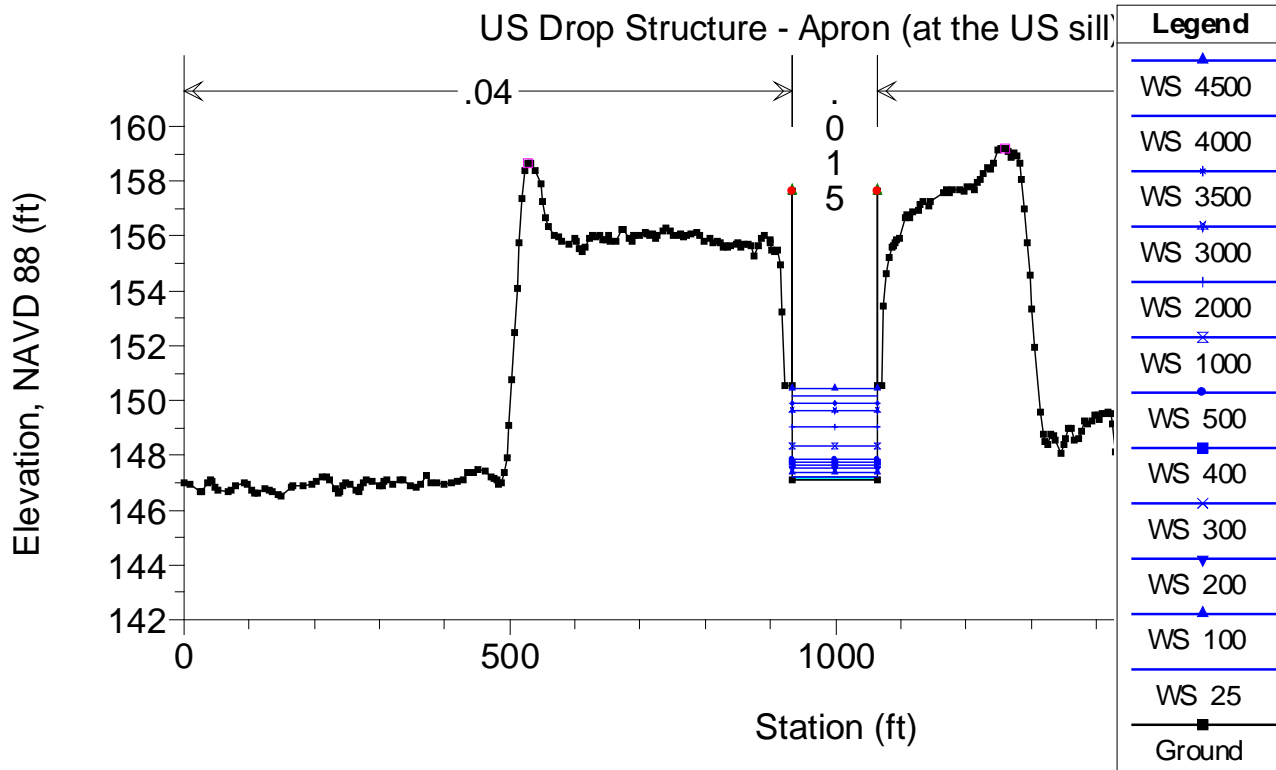
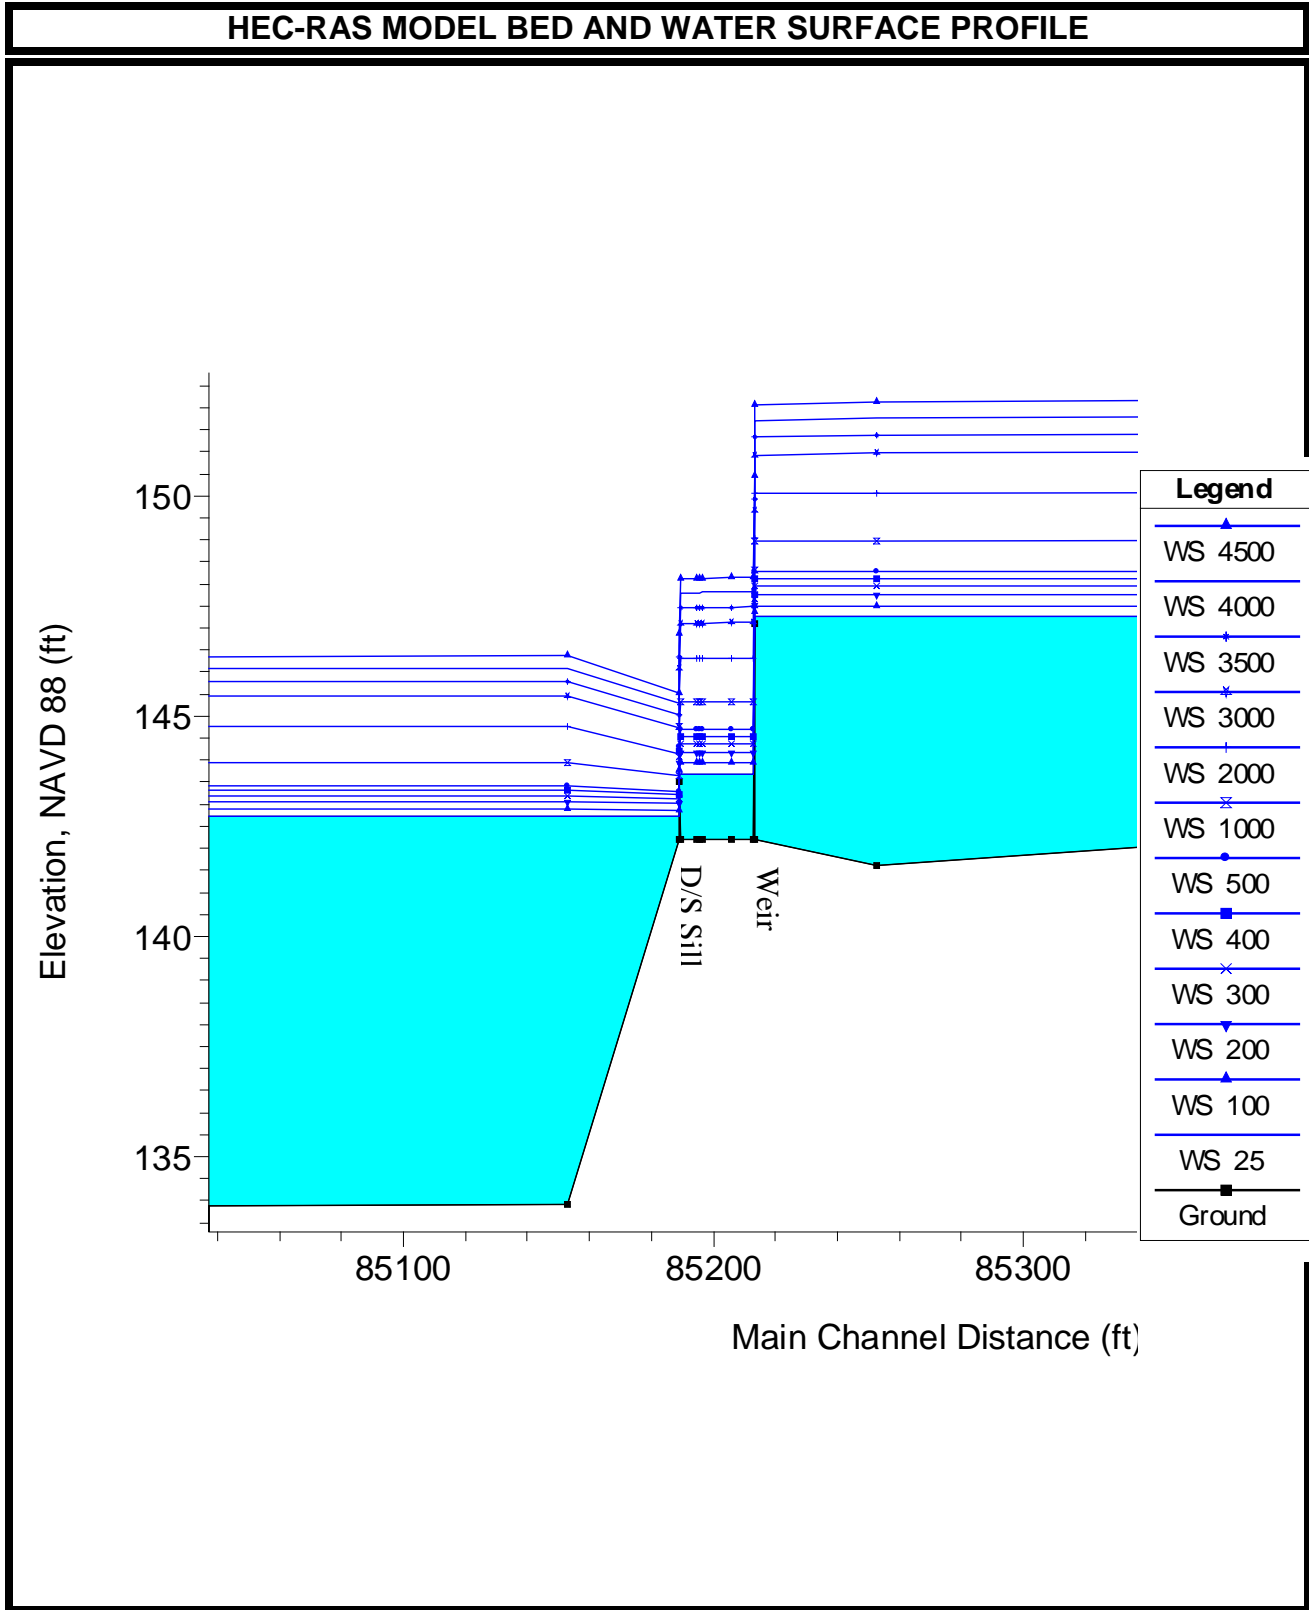
HEC-RAS MODEL STRUCTURE CROSS SECTION

- Geometry - The structure was based on the as-built design drawing and was surveyed by DWR via P&P. The geometry was adjusted for subsidence and reflects 2011 conditions.

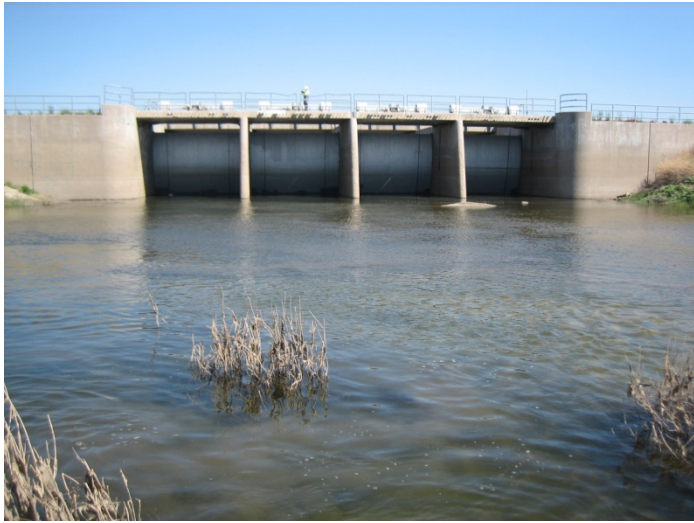
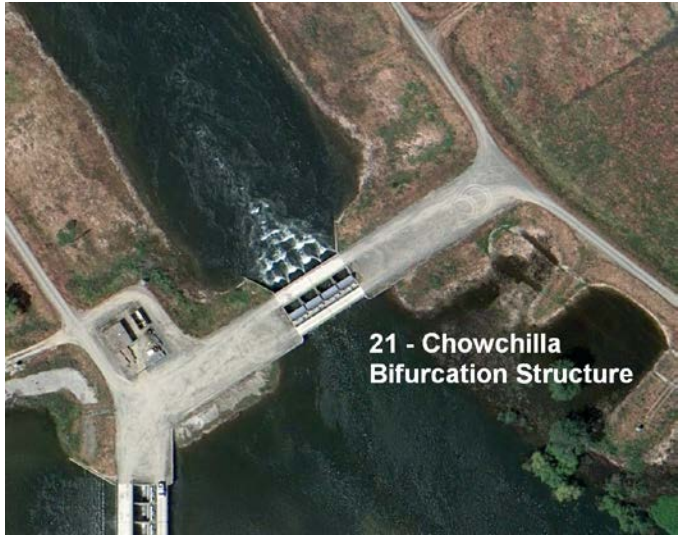
BEARINGS		
Site Name⁷: Chowchilla Bypass Control	I.D. Number¹: 21	Reach: 2B
River Mile:	Barrier Type¹: Control Structure	Rank¹: Red

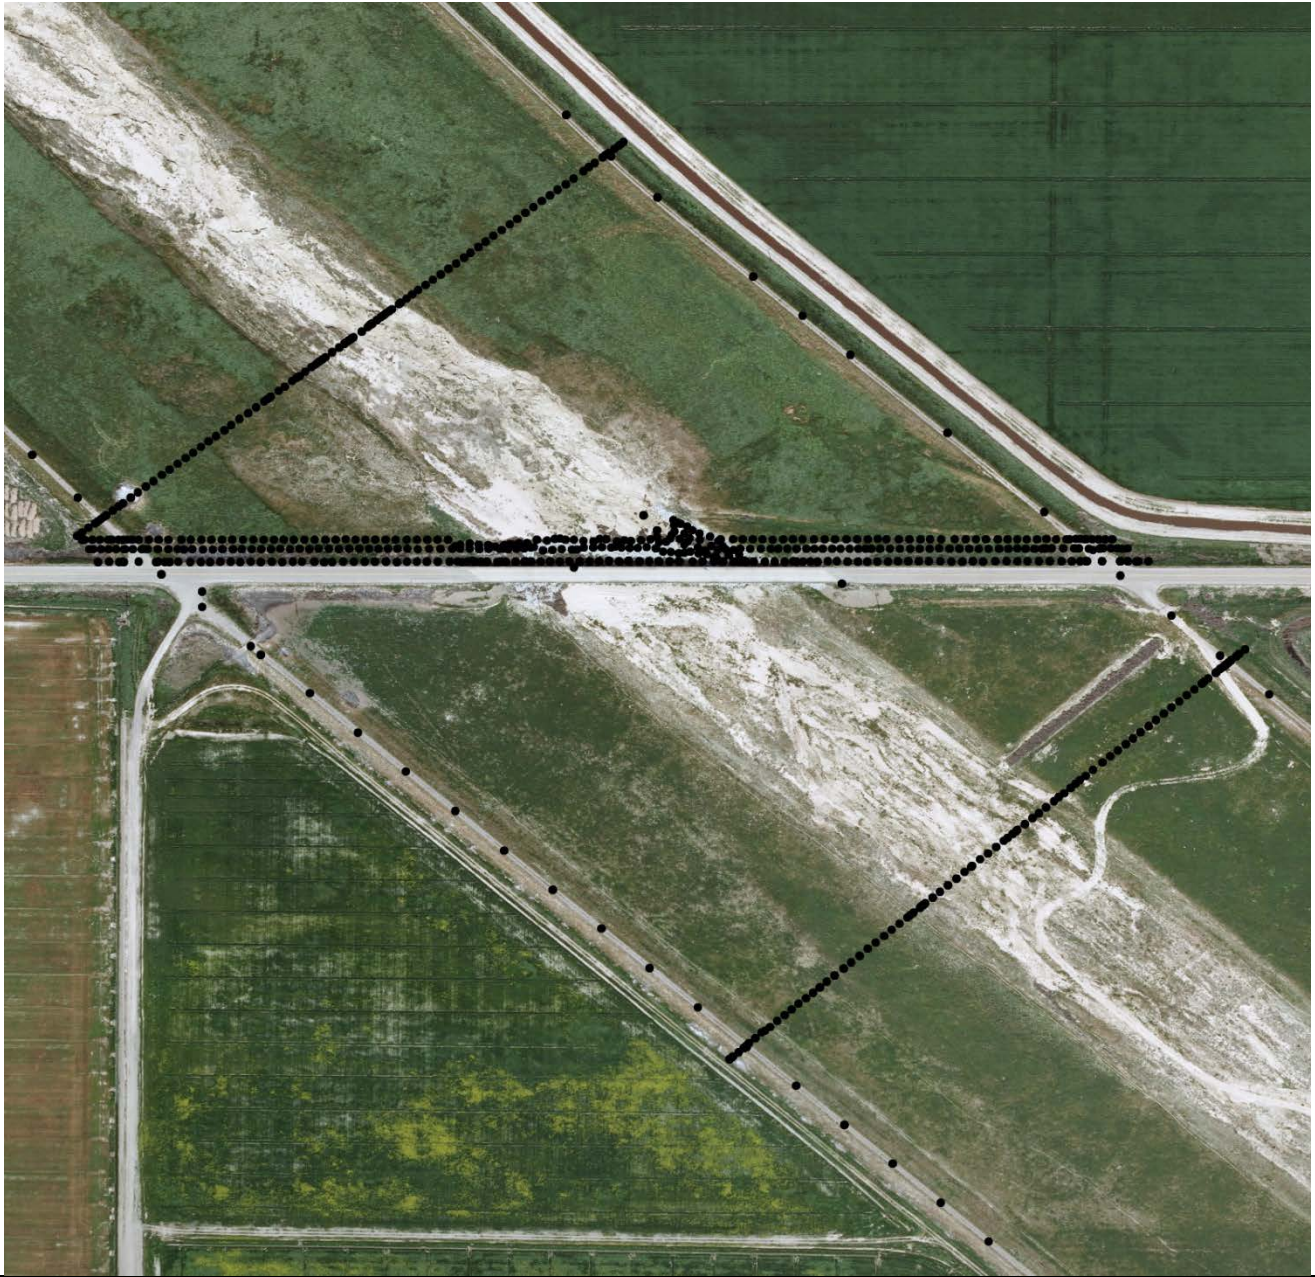
Topographic data was collected on October 2, 2012 by using GPS. Elevations were set based on surveyed control near the structure. Elevation data was focused on the structure to supplement elevations to build the structure into the model.

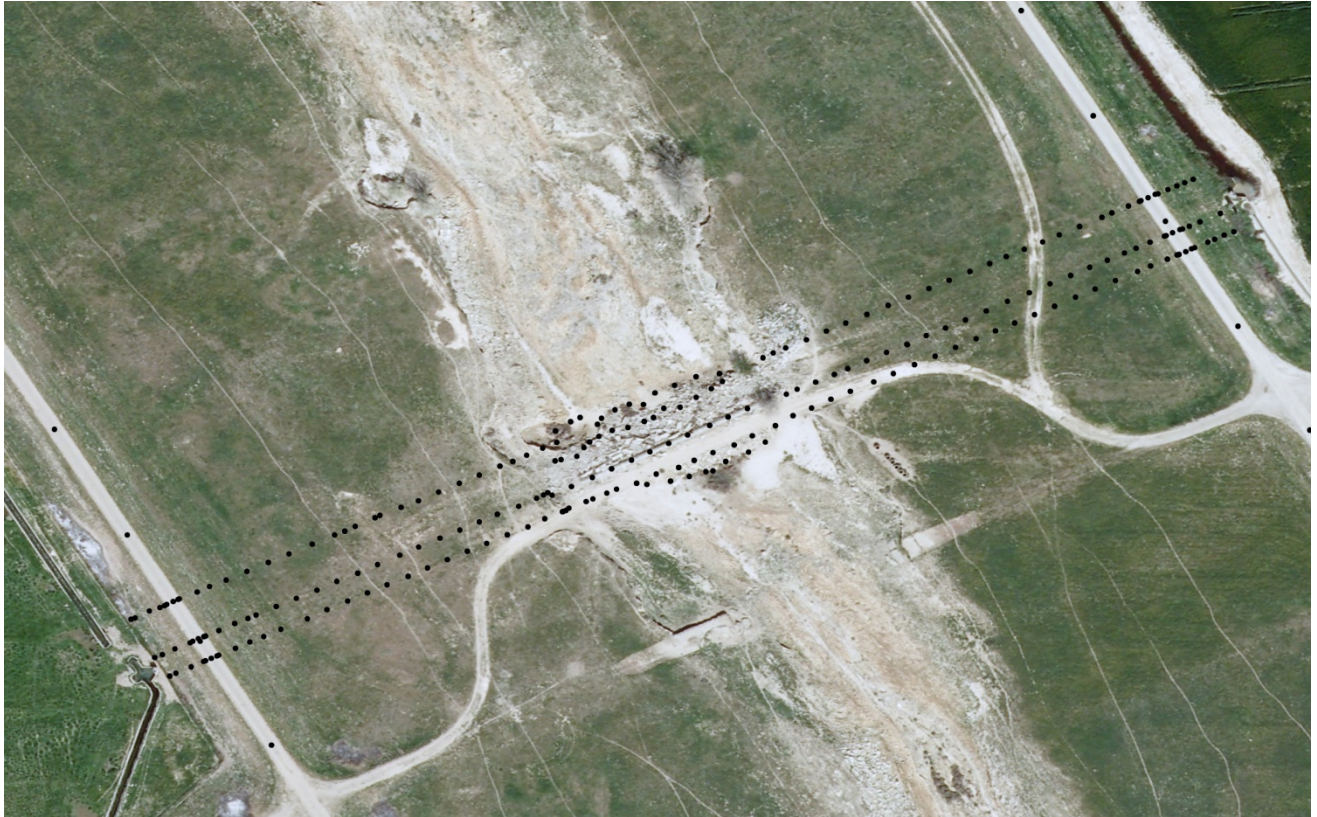
Topographic data was collected on October 2, 2012 by using GPS. Elevations were set based on surveyed control near the structure. Elevation data was focused on the structure to supplement elevations to build the structure into the model.

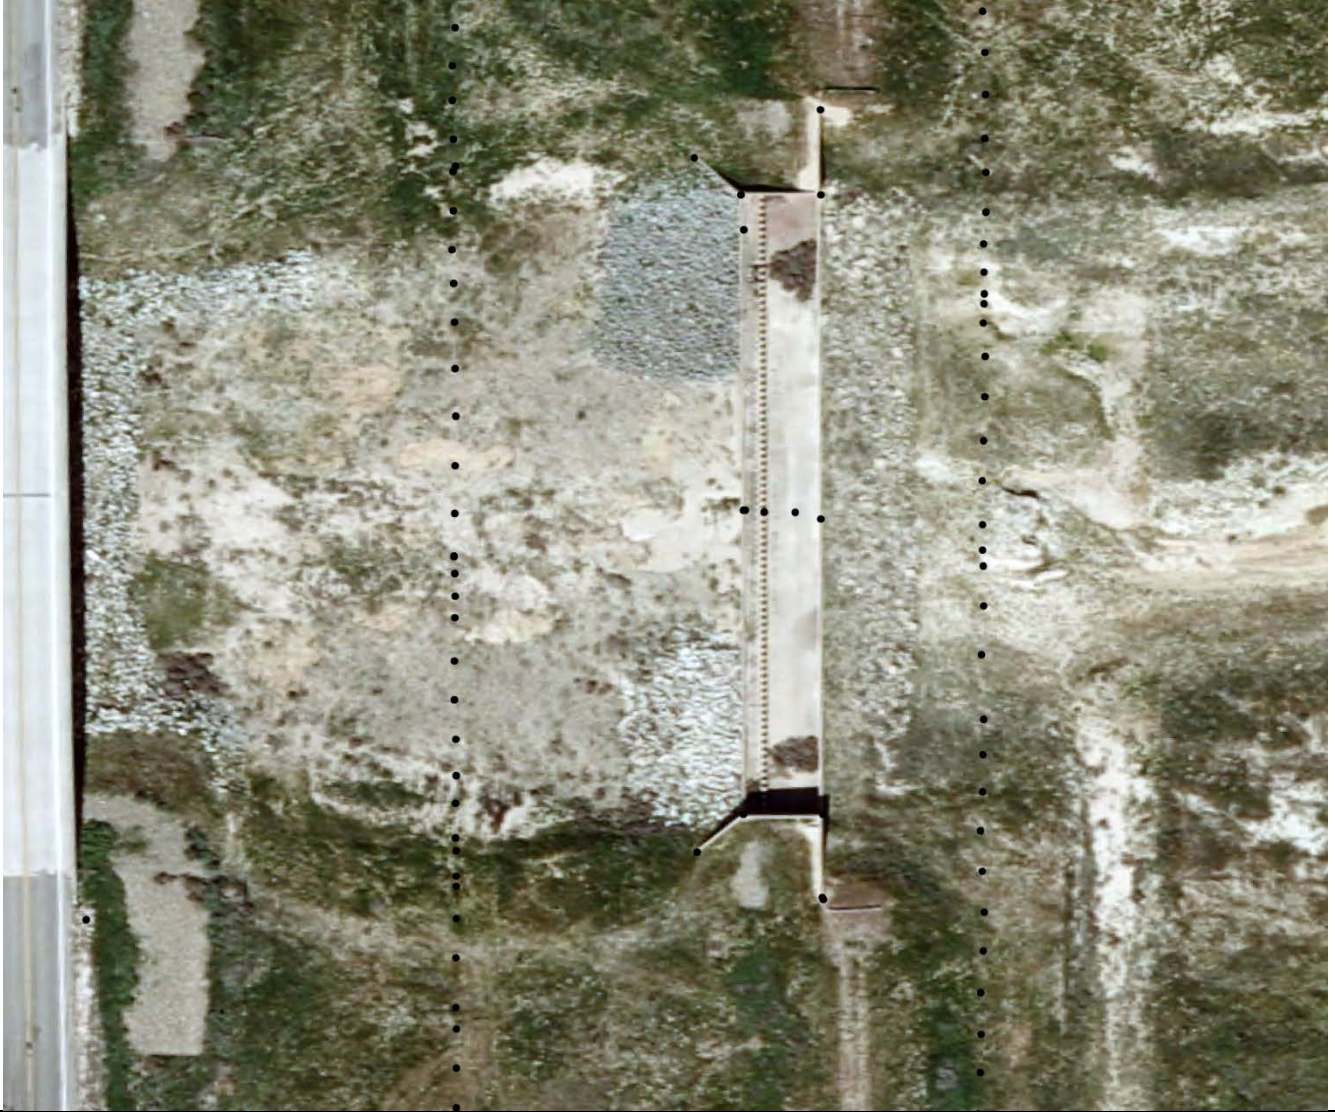
Topographic data was collected on September 28, 2012 by using GPS. Elevations were set based on surveyed control near the structure. Elevation data was focused on the structure to supplement elevations to build the structure into the model.

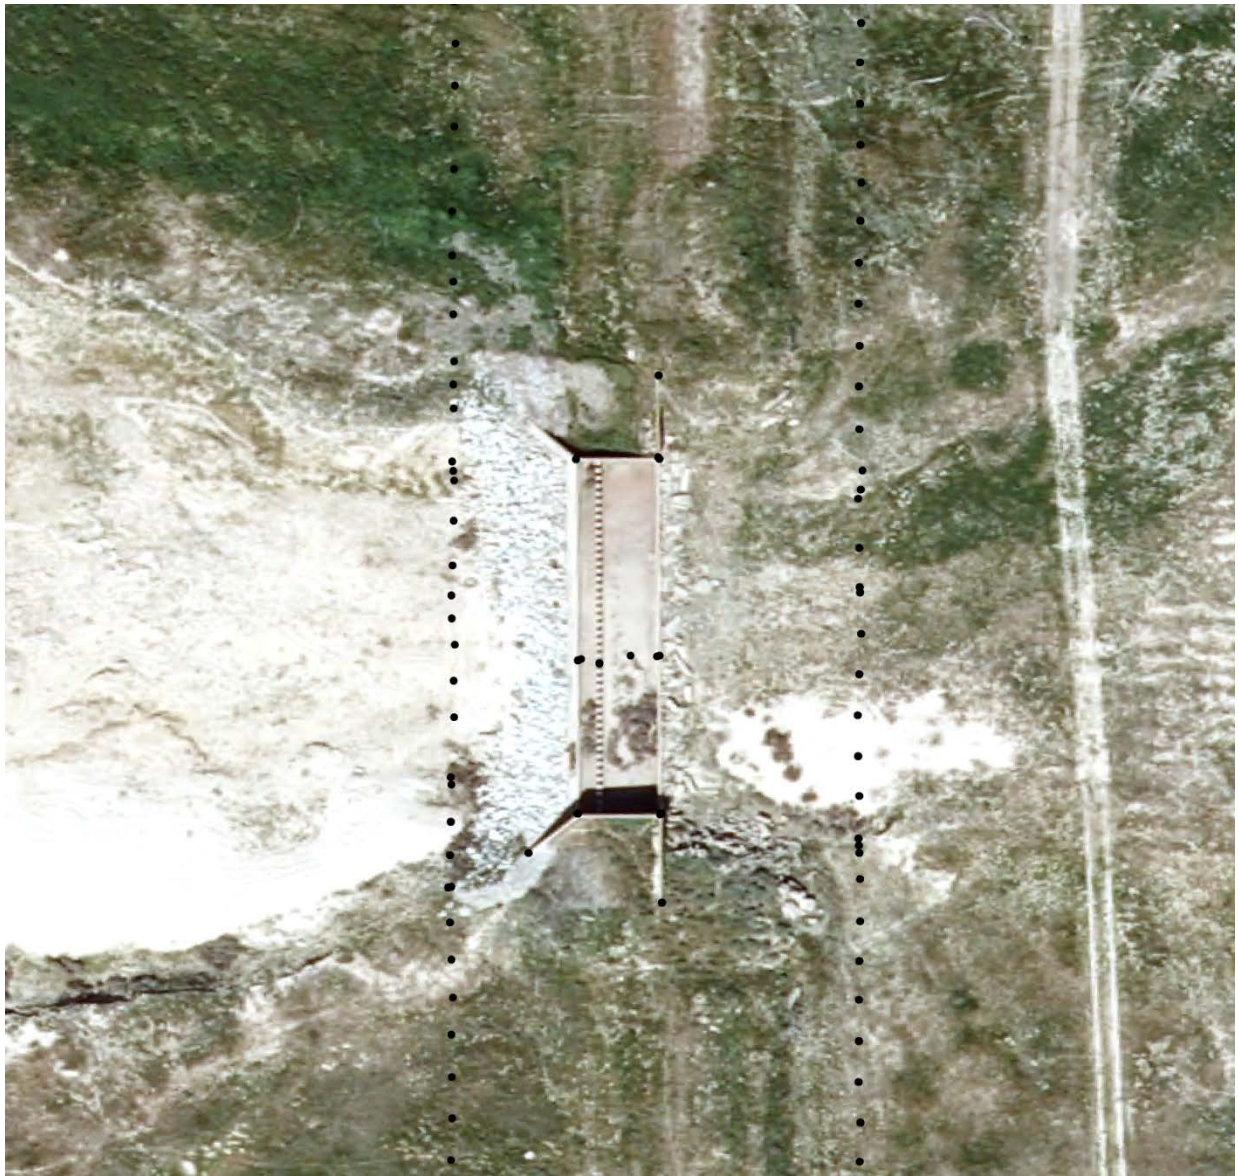
Topographic data was collected on September 28, 2012 by using GPS. Elevations were set based on surveyed control near the structure. Elevation data was focused on the structure to supplement elevations to build the structure into the model.
