6.0 Water Surface Profile

7.0 Discharge Measurements

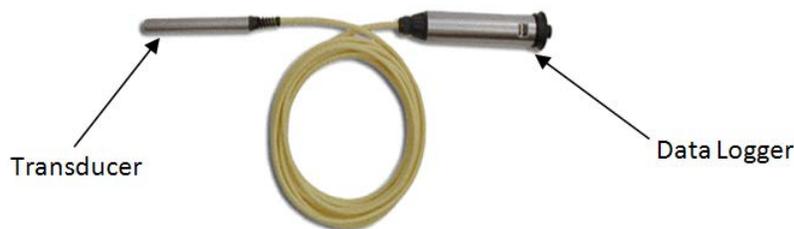
**Figure A-13-1.
Water Level Recorder**

As shown in Figure A-13-1, this particular type of WLR, Global Water-WL16U, is an integrated unit consisting of a submersible pressure transducer (pressure sensor) connected to the data logger with a standard 25-foot cable (longer cable lengths are available). Refer to the 2009 ATR (SJRRP, 2010) for more detailed information about installation methods.

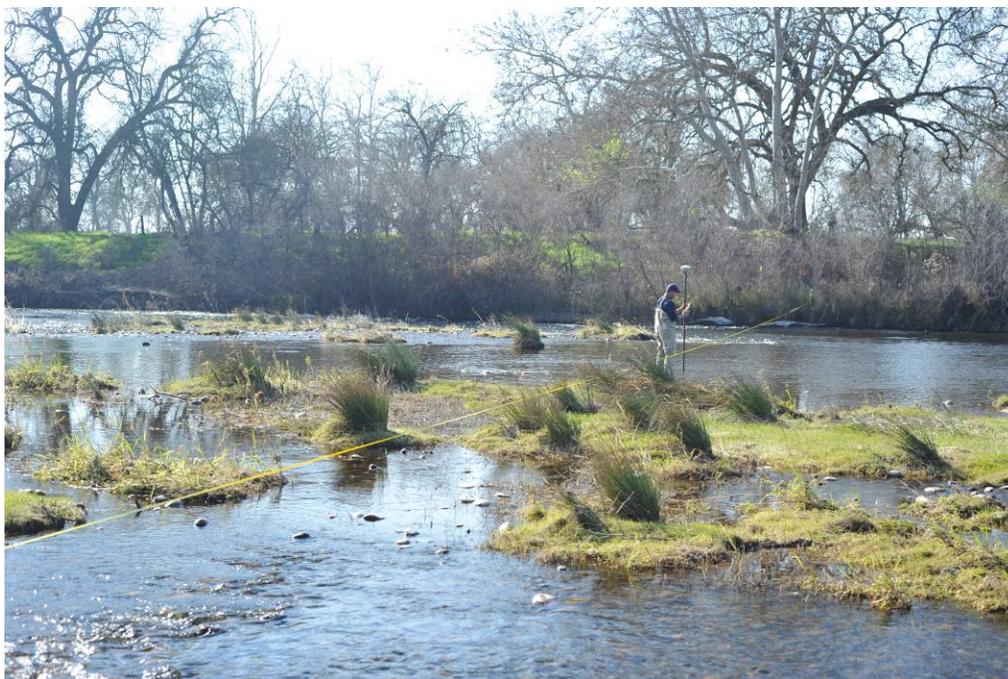
Note: The yellow tape is stretched between monument stakes on both banks and the rover rod is held plumb while placed tangential to the tape at each survey point.

Figure A-17-1.
RTK GPS Rover Used While Repeat Surveying XS1 at RC38

Repeated cross-sectional surveys were performed to monitor change in bed elevation and location of the banks. Each monitoring event followed a high-flow event such as the January 5, 2011, 7,080 cfs peak flow; and the July 7, 2011, 8,600 cfs peak flow. Topography along monumented, channel-spanning cross sections was surveyed using an RTK GPS and methodology described under “Channel Bathymetric Surveys: Topographic Surveys” (Figure A-17-1).
