California Department of Water Resources  
South Central Region Office  
River Restoration and Environmental Compliance Branch

# Fall 2009 Interim Flows Monitoring Data Report For the San Joaquin River Restoration Program

**March 26, 2010**

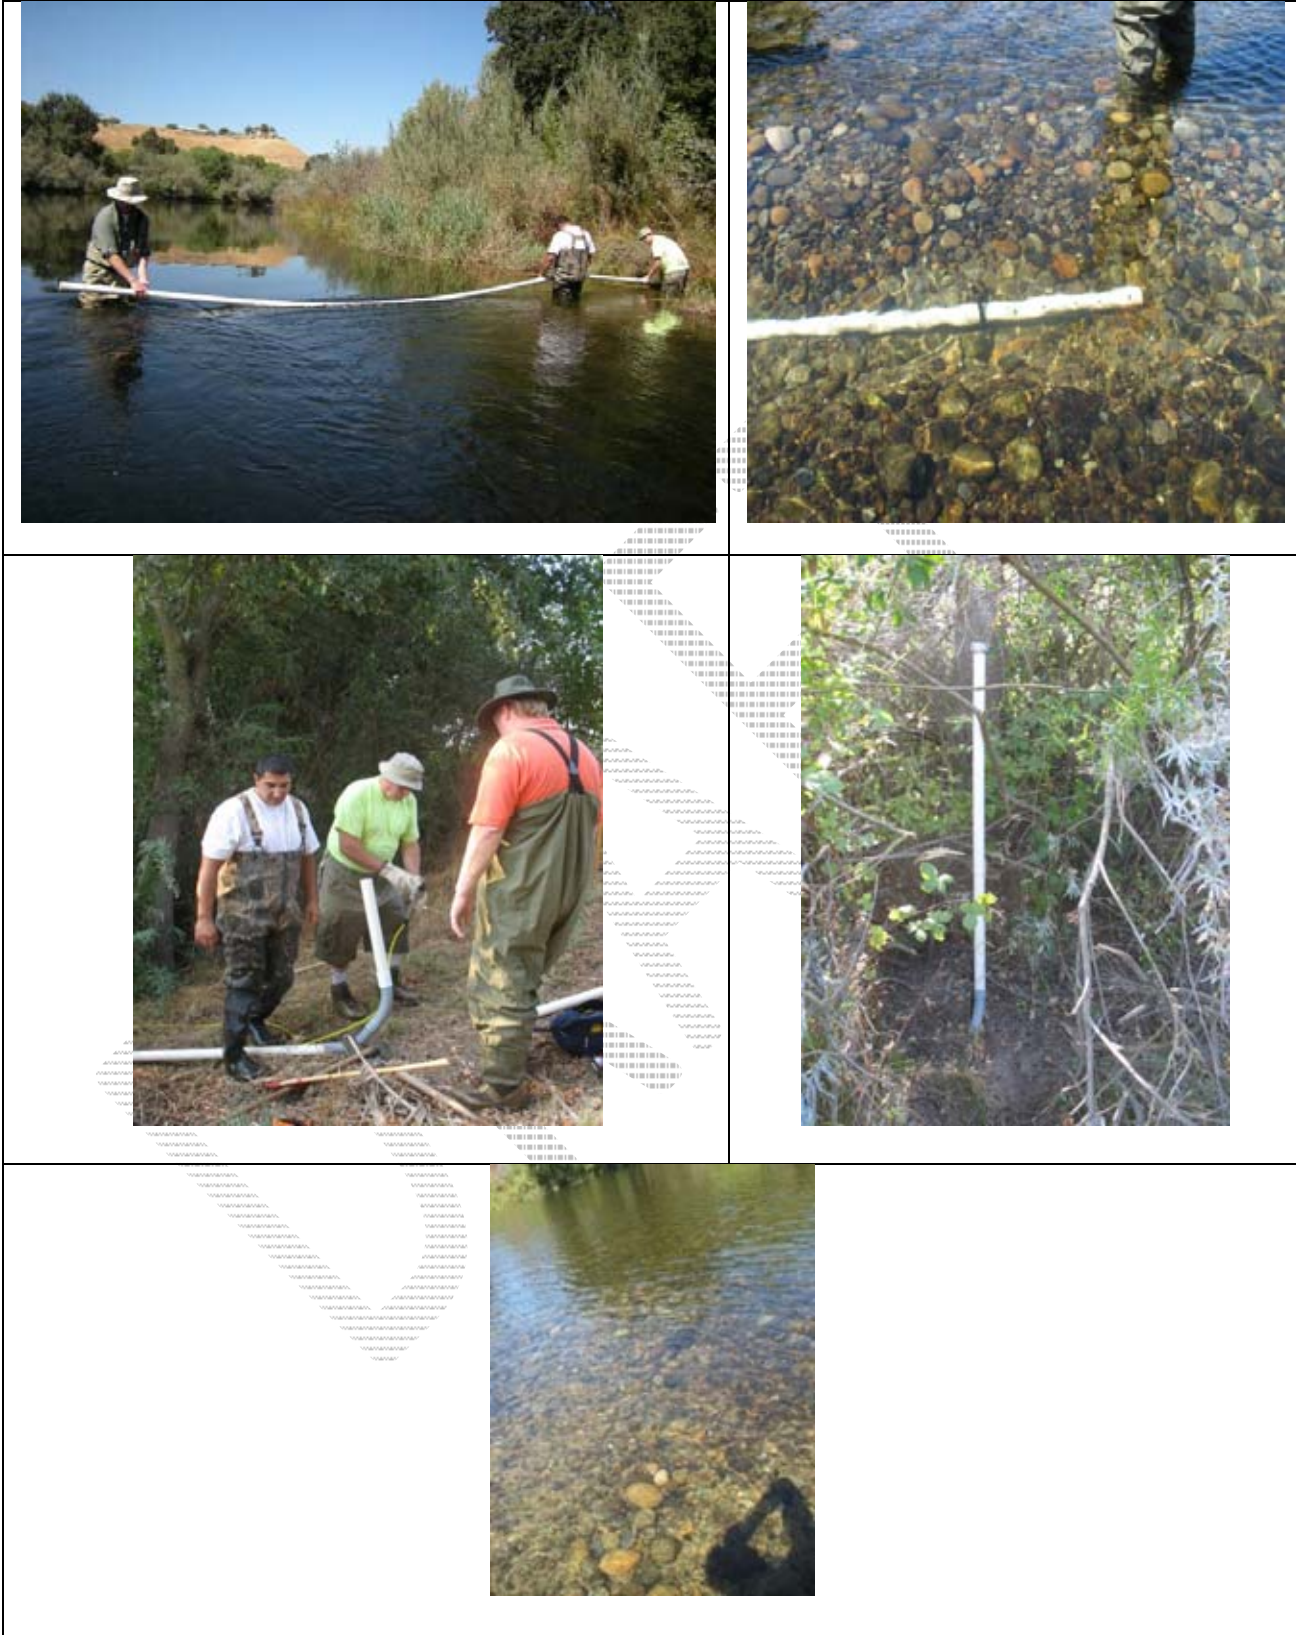
Figure 3 – WLR installation

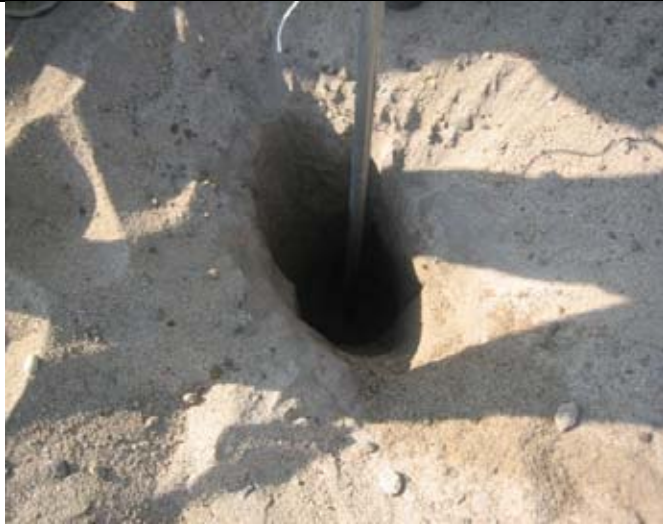
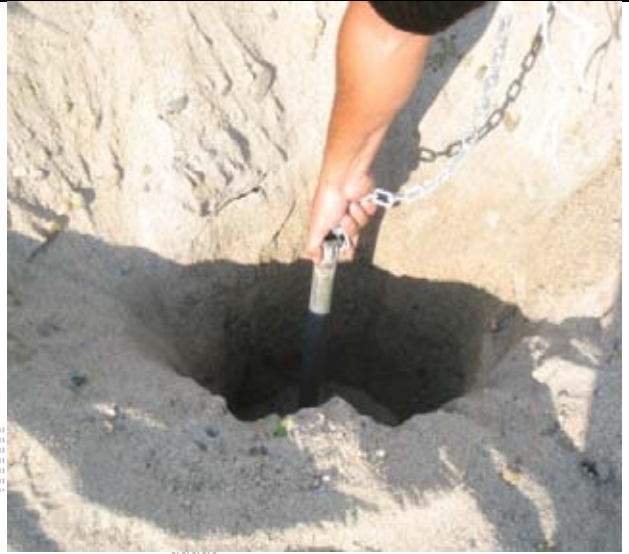
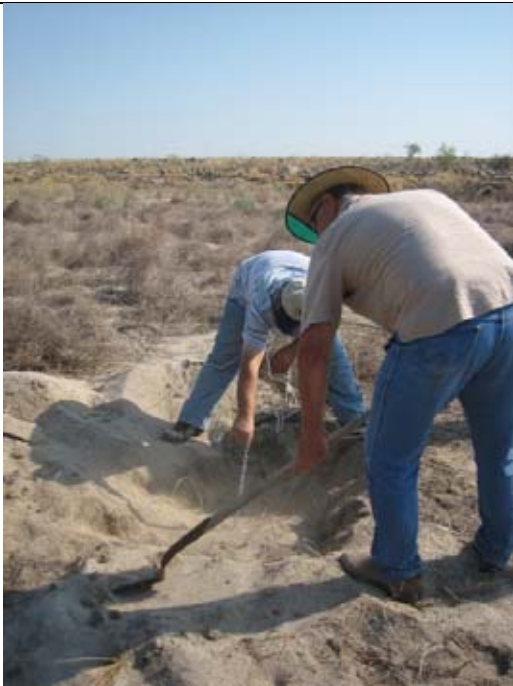
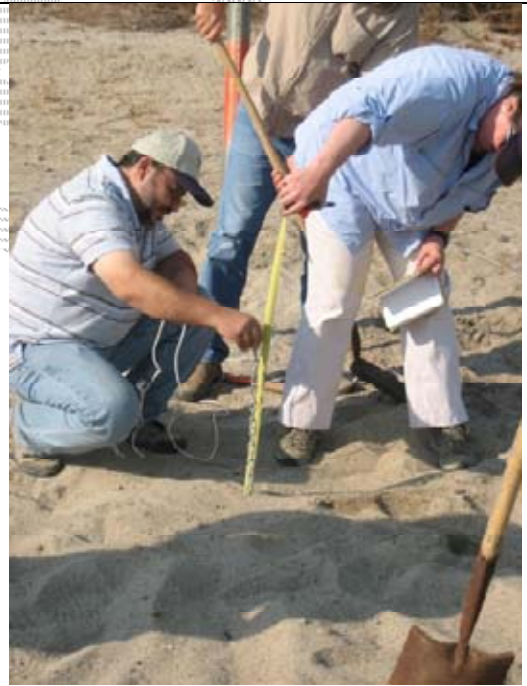
Photo 1. Pounding in pipe

Photo 2. Removing pipe

Photo 3. Sand shoveled back in place

Photo 4. Measuring excess chain above ground

Figure 8 – Photos showing chain installation process

An approximately 2.0-ft deep hole was dug before the pipe was driven into the ground. Then the pipe with the chain inside was pounded into the ground with a post driver. The pipe was then pulled out, leaving the chain buried in the ground. The sand that was removed from the hole was then shoveled back into place to bring the surface back as close to original conditions as possible. The length of the excess chain above ground was then measured to determine the length of the chain below the surface. A set of pictures showing the process of installing one of the chains is shown in Figure 8.

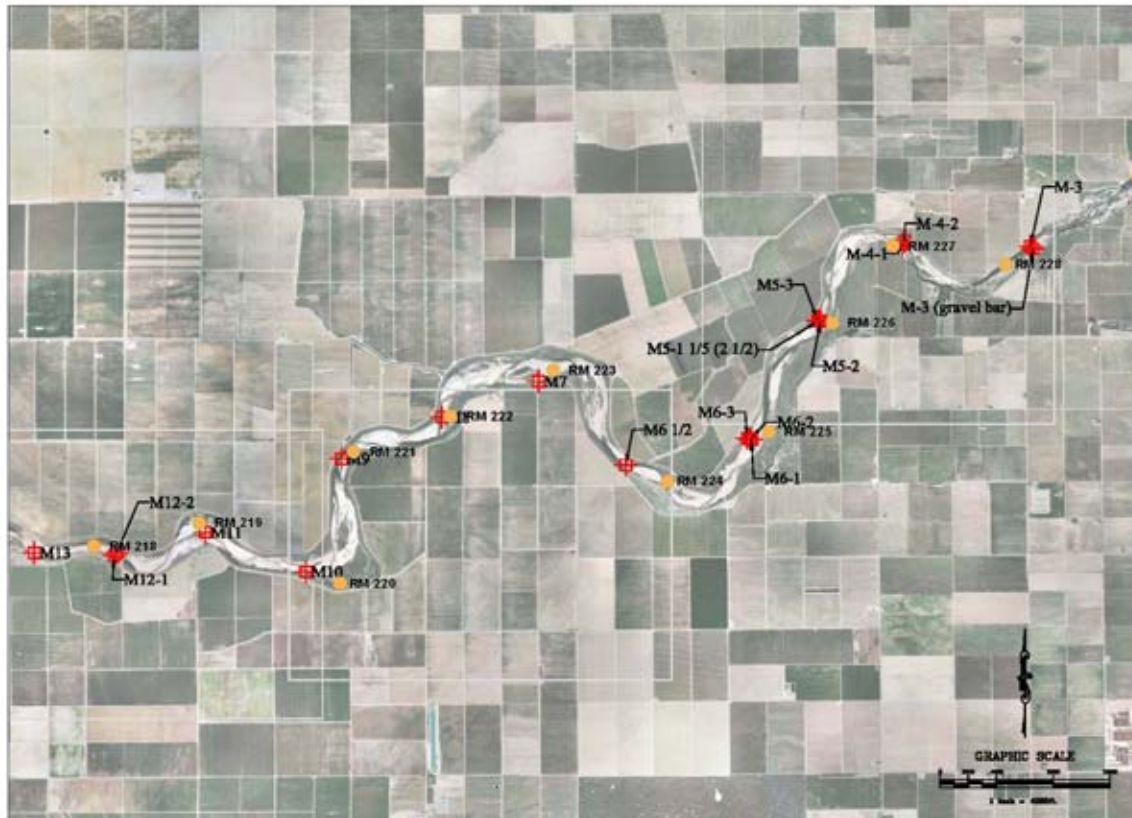
Grab Sample Location Map - Reach 2A

Figure 9 – Location Map

The riverbed samples were located between from River Mile 217.5 and River Mile 228.2. Monitoring sections are designated M3, M4, M5, M6, M6½, M7, M8, M9, M10, M11, M12, and M13. Figure 9 below displays the locations where each sample was taken. Samples that had significant sediment size variation within one section were designated M#-# (ex. M5-2).

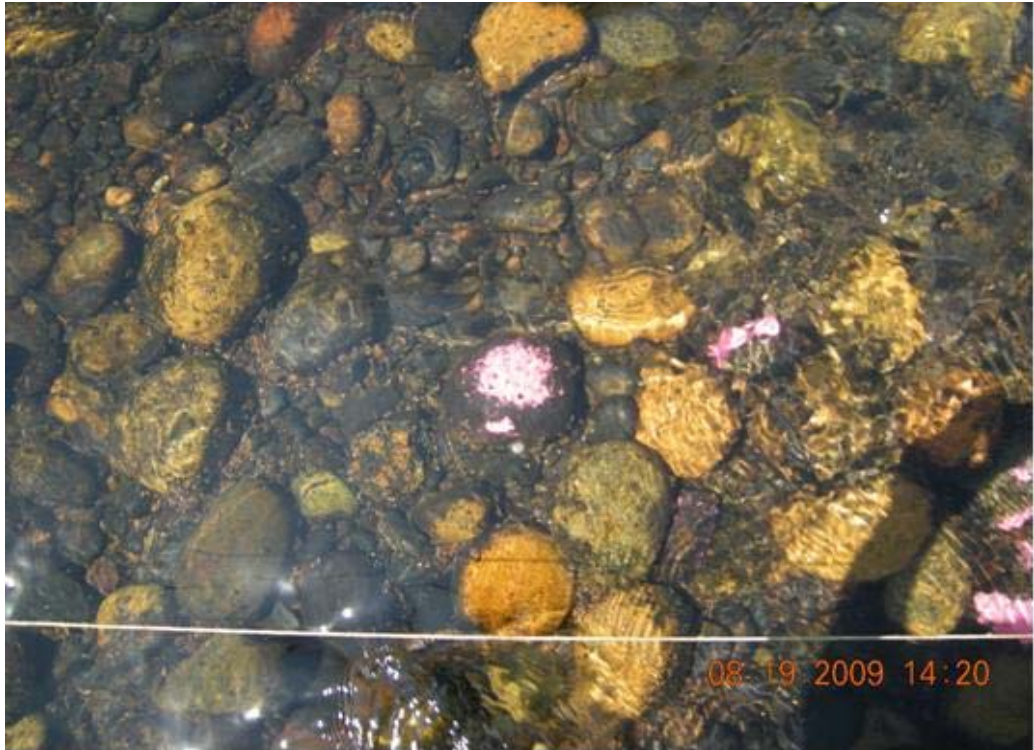
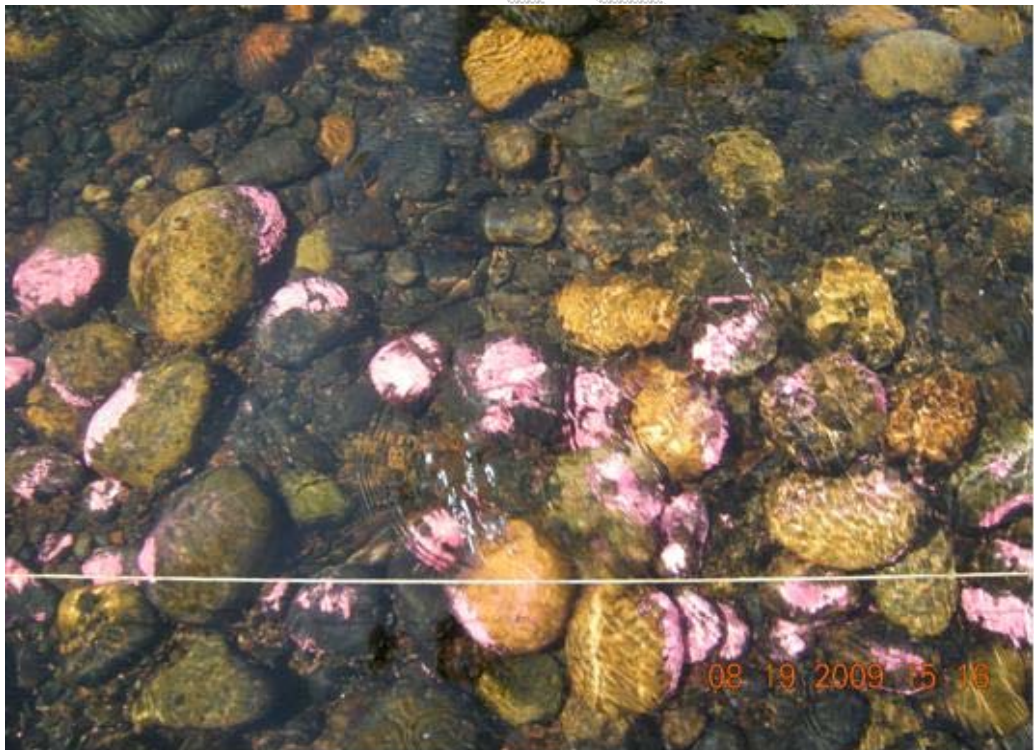
Figure 11 – An example of the bed’s condition before and after tracer painting (XS-3, approx bin 30-31)

To install the tracers, all particles with a visible portion larger than 32 mm within approximately 2 feet upstream of a cross-section tagline were marked with a Kevlar® based epoxy coating (paint). The tagline was stretched tight between either the monuments or a monument and a temporary midchannel stake. Tracers were installed within the channel where the following conditions existed: absence of soil, predominance of gravel to cobble sized particles, and absence of dense vegetation. Due to difficulty painting underwater, particles were evaluated as to whether manipulation would disturb the surrounding bed particles. If so, the particle was measured, scrubbed, painted in-situ, and if it was felt the particle retained enough paint to be recognized in the future, its information was recorded. Otherwise, each particle was carefully plucked from the bed, while carefully noting the particle's position and orientation, measured with a gravel-o-meter to the 1/2-phi size class and recorded, scrubbed of periphyton and silt, painted, and returned to the bed in its noted original position and orientation (Figure 14). Particles painted in this manner were typically able to accept a generous coat of paint on less than half the particles' surface area. Submerged in-situ painted particles, on the other hand, typically accepted much less paint and it was often questionable whether it would retain any at all with time. A different color of the paint was used for each cross-section to allow the source of mobilized particles to be identified during the data collection phase. At all times, field personnel worked downstream of the tagline and were directed not to walk over or near the planned or installed tracer cross-section areas.

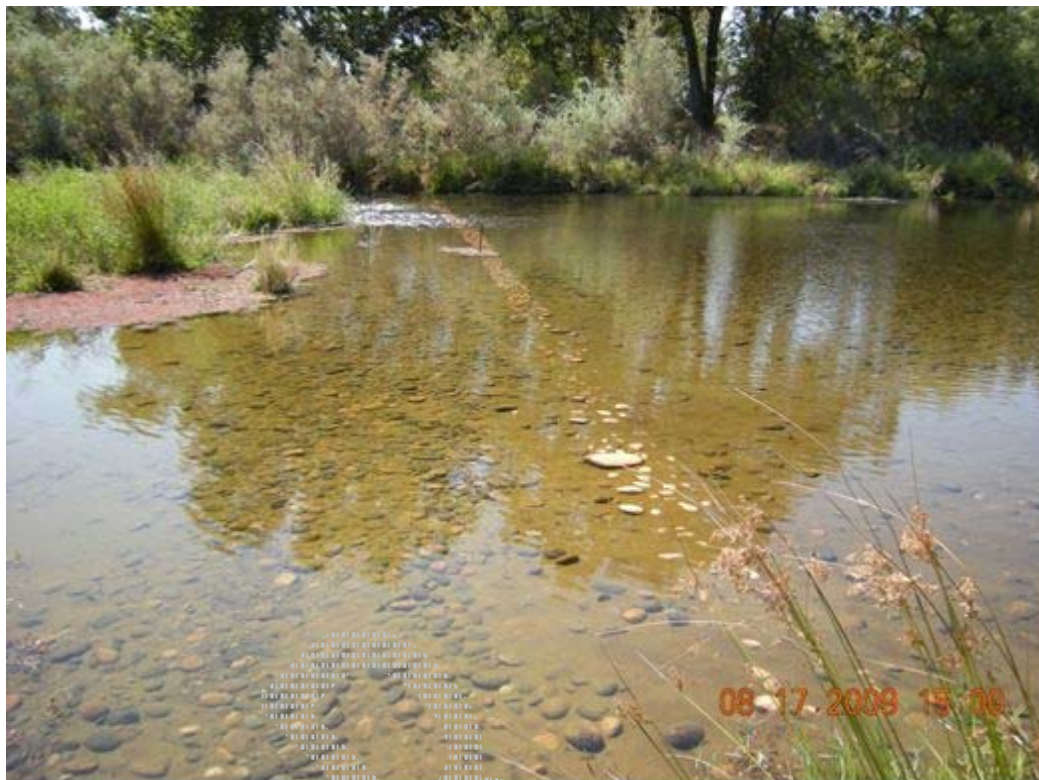
**Figure 12 - An example of a completed tracer cross-section (XS-1, bins 33 to 54); viewed looking towards the right bank. In the foreground, most of the tracers are covered by a layer of silt that settled after installing these tracers. Closer to the far bank is seen the more active channel.**

The tagline is divided into 2 foot units. Each 2 foot unit was considered a bin in which all particles painted within it was tallied according to its respective size class (see Appendix V-II). The total number of marked particles along each cross-section and within each 2 foot wide bin was recorded for later comparison with the post-experiment condition. See Figure 15 for an example of a completed tracer cross-section.

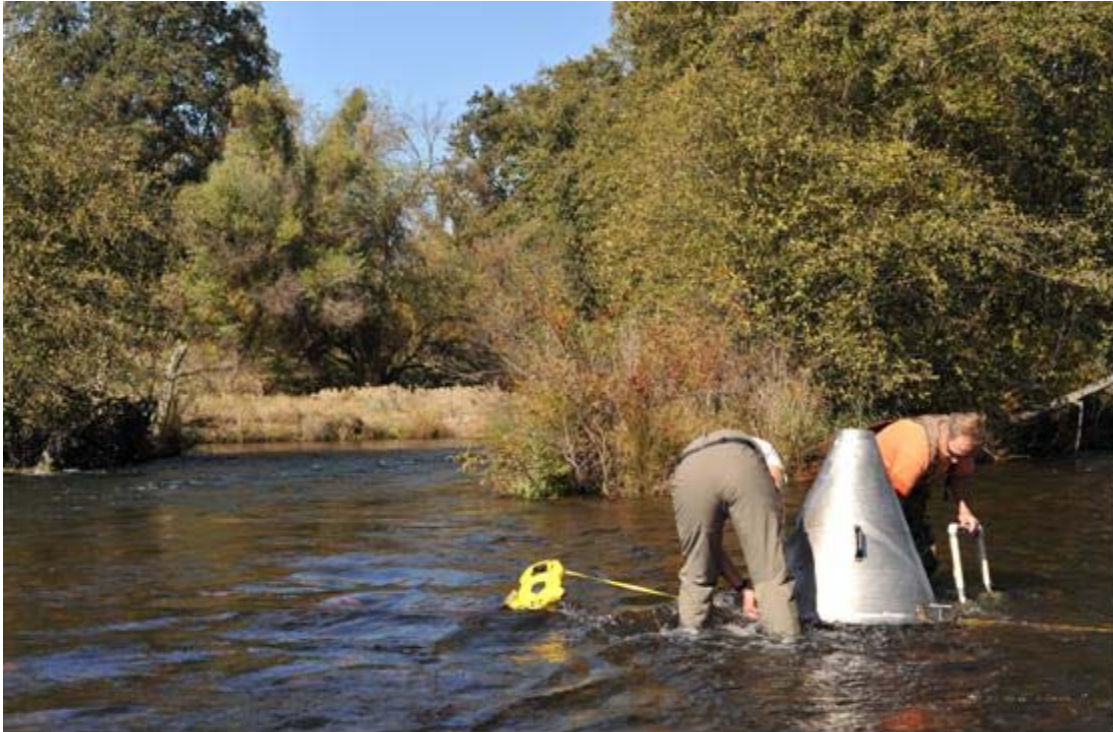
**Figure 13 - Photoscope in use during photo-survey of cross-section 3; viewed looking upstream.**

As much as possible the bed along each cross-section was photographed using a high resolution digital SLR camera (Nikon D700), with a 35 millimeter (mm) lens and circular polarizing filter capable of distinguishing between the sand-sized and larger particles. This procedure was aided with the use of an in-house designed and constructed device we have named the photoscope (Figure 16). The photoscope is essentially a stainless-steel cone with a sheet of plexi-glass (the photoscope's lens) sealed onto the larger diameter end of the cone. The smaller diameter end of the cone is approximately 6 inches in diameter and allows one of the operators to insert the camera lens for collection of photos of the river bed particles as the other end is positioned beneath the water's surface. The photoscope allows the water's surface to be smoothed, light reduced, and glare minimized such that the bed particle details can be captured to as high a degree as possible. Included in each photo was a measuring tape (tied taut between the tracer cross-section monuments) so as to be able to determine the position relative to the stakes from the photo. Also, a scale was placed on the bed for the purpose of measuring particle sizes from the photos (Figure 17). Limitations to photographing the bed were related to depth of flow and velocity. If the depth was too shallow, the lens could not be fully submerged and significant reflections could not be overcome. If the flow was too swift, holding the photoscope in place without disturbing the bed became problematic.

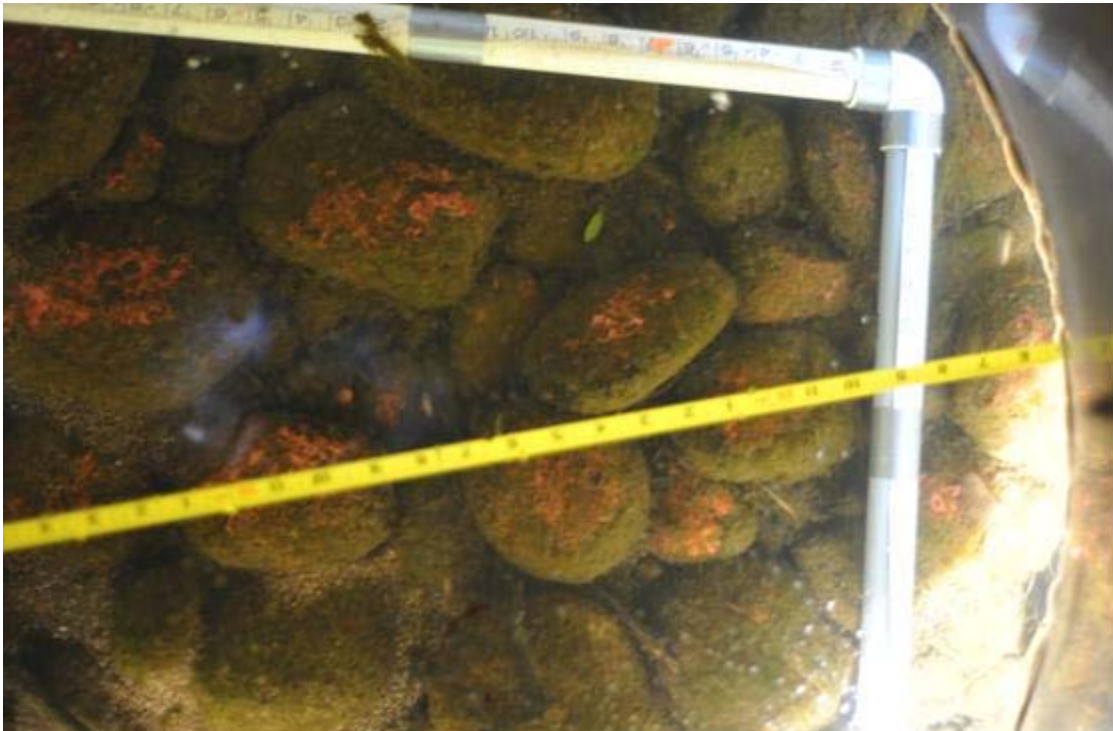
**Figure 14 - An example of a photo of the bed shot through the photoscope. The yellow tape indicates the position along the cross-section. The white frame serves as a scale to measure gravel diameters.**
