Appendix D

Surface Water Quality

2011 Draft Annual Technical Report

SAN JOAQUIN RIVER
RESTORATION PROGRAM

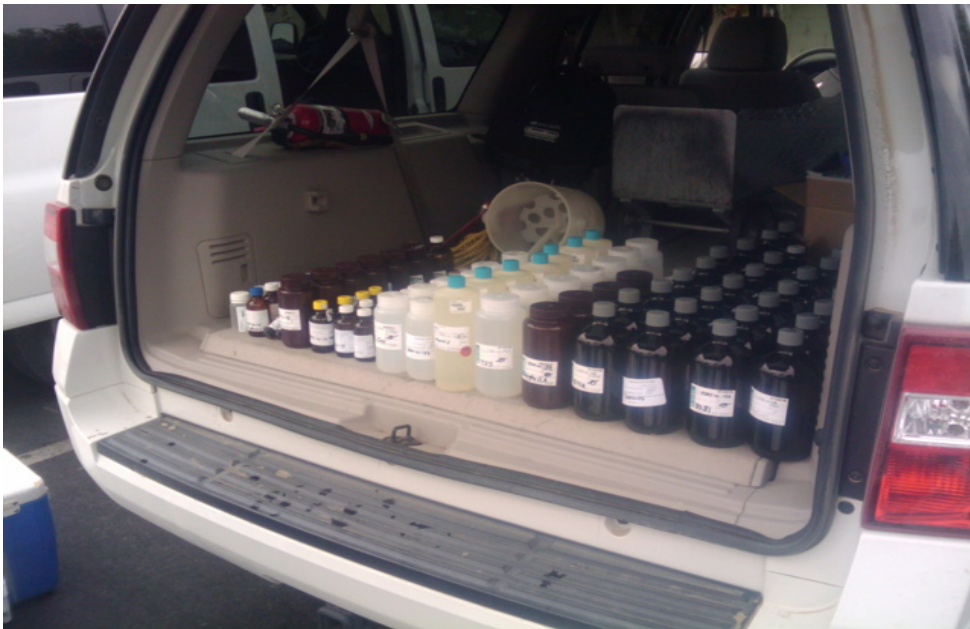
October 2010 SJRRP water samples from seven sites, including pesticides
