Reach 4A

Temperature Monitoring Sites

SAN JOAQUIN RIVER
RESTORATION PROGRAM

Preliminary Data

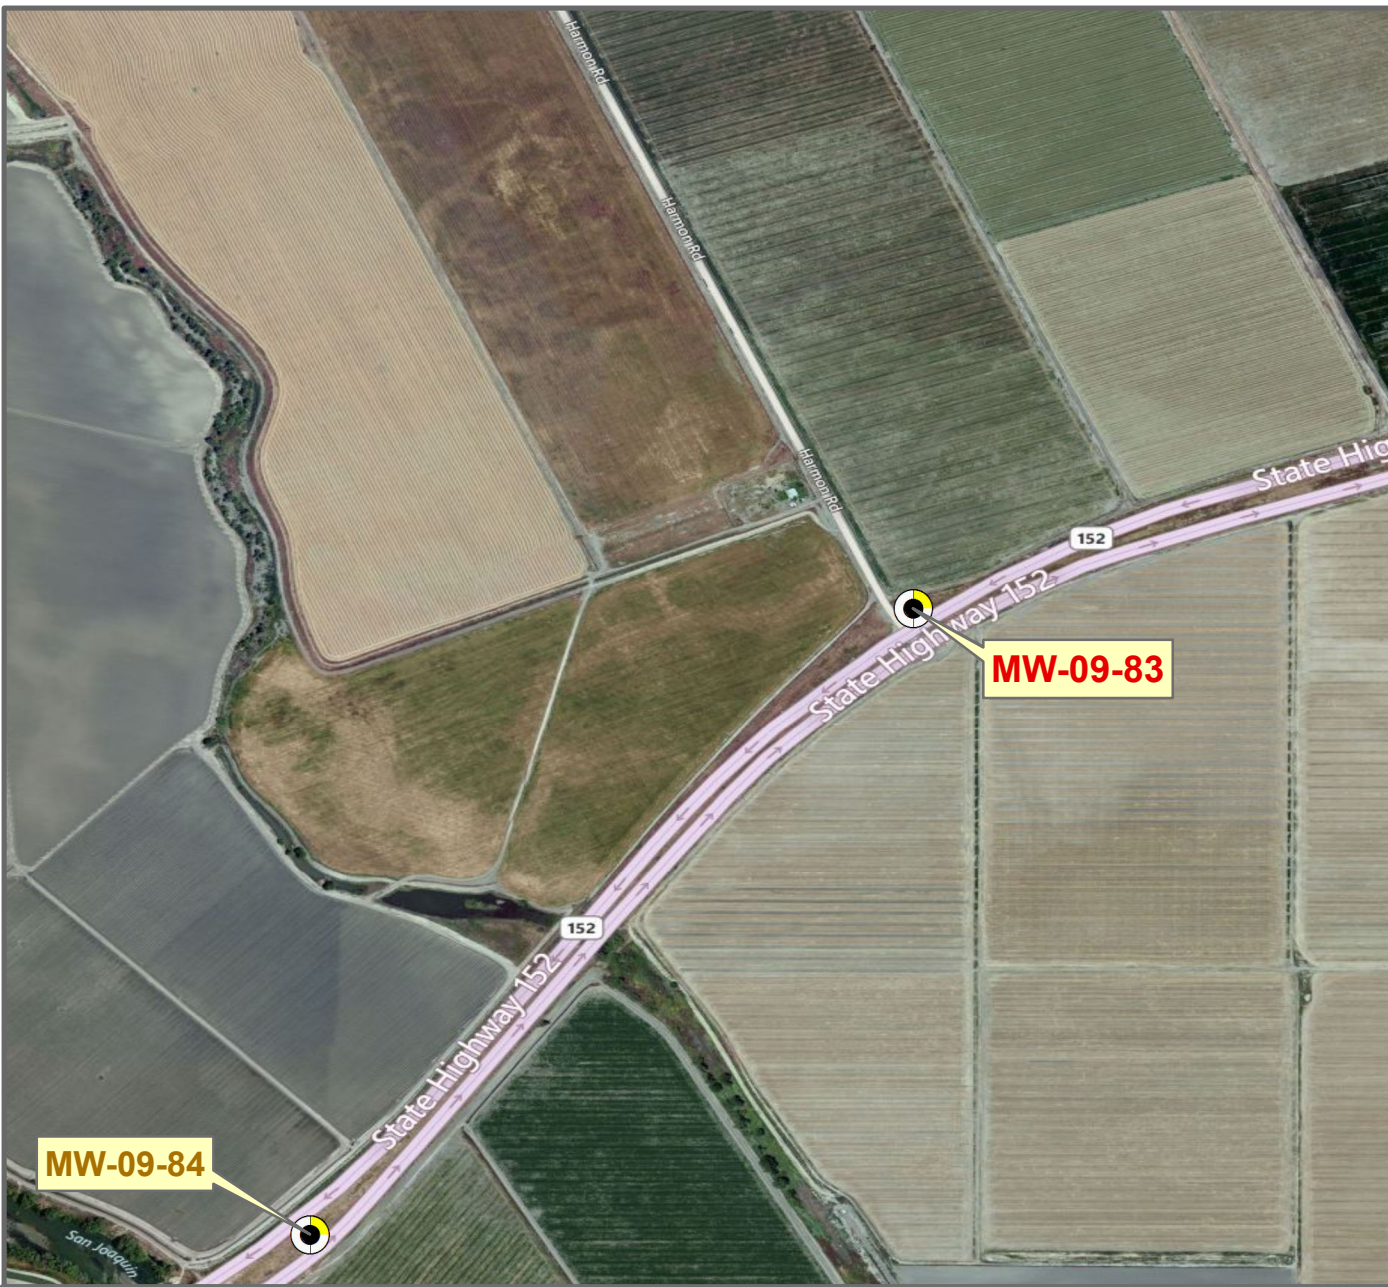
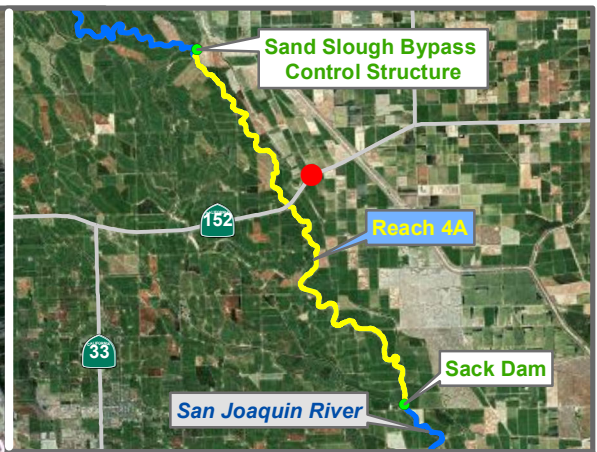
Monitoring Location MW-09-83

Reach = 4A
 River Mile = 173.9
 Merced County
 Right Bank

X = -120.5391 Y = 37.0663 Status = Existing
 (Horizontal Datum is NAD83)
 Distance From River (ft)= 4977
 Reference Elevation (ft NAVD88) = 114.84
 Site = Hwy. 152

Agency = USBR
 Measurements:
 Type = Datalogger
 Interval = Hourly
 Timeseries unavailable

Description:
 2 inch PVC casing FM

Ground Surface Elevation (ft) = 114.80
 Monitoring Depth (ft) = 51.5 - 61.5 ft below gs

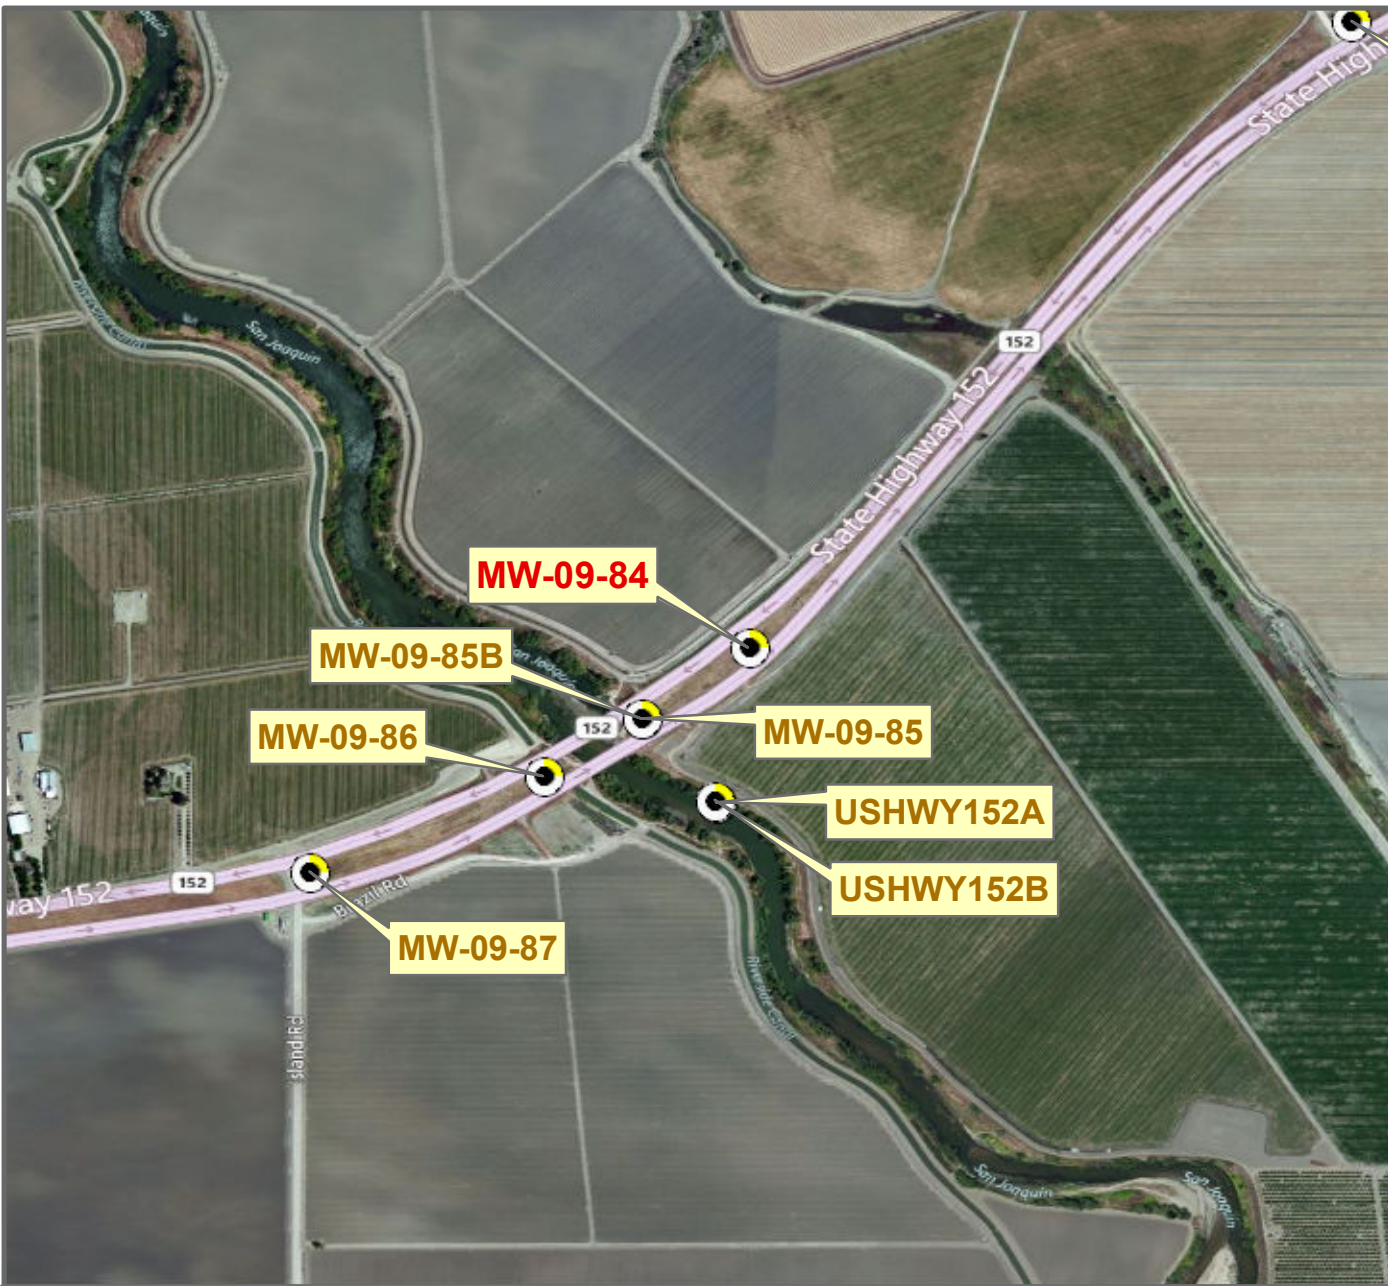
Monitoring Location MW-09-84

Reach = 4A
 River Mile = 173.9
 Merced County
 Right Bank

X = -120.5477 Y = 37.0574 Status = Existing
 (Horizontal Datum is NAD83)
 Distance From River Centerline (ft)=
 Reference Elevation (ft NAVD88) = 115.70
 Site = Hwy. 152

Agency = USBR
 Measurements:
 Type = Datalogger
 Interval = Hourly
 Timeseries unavailable

Description:
 2 inch PVC casing FM

Ground Surface Elevation (ft) = 115.80
 Monitoring Depth (ft) = 32.0 - 52.0 ft below gs

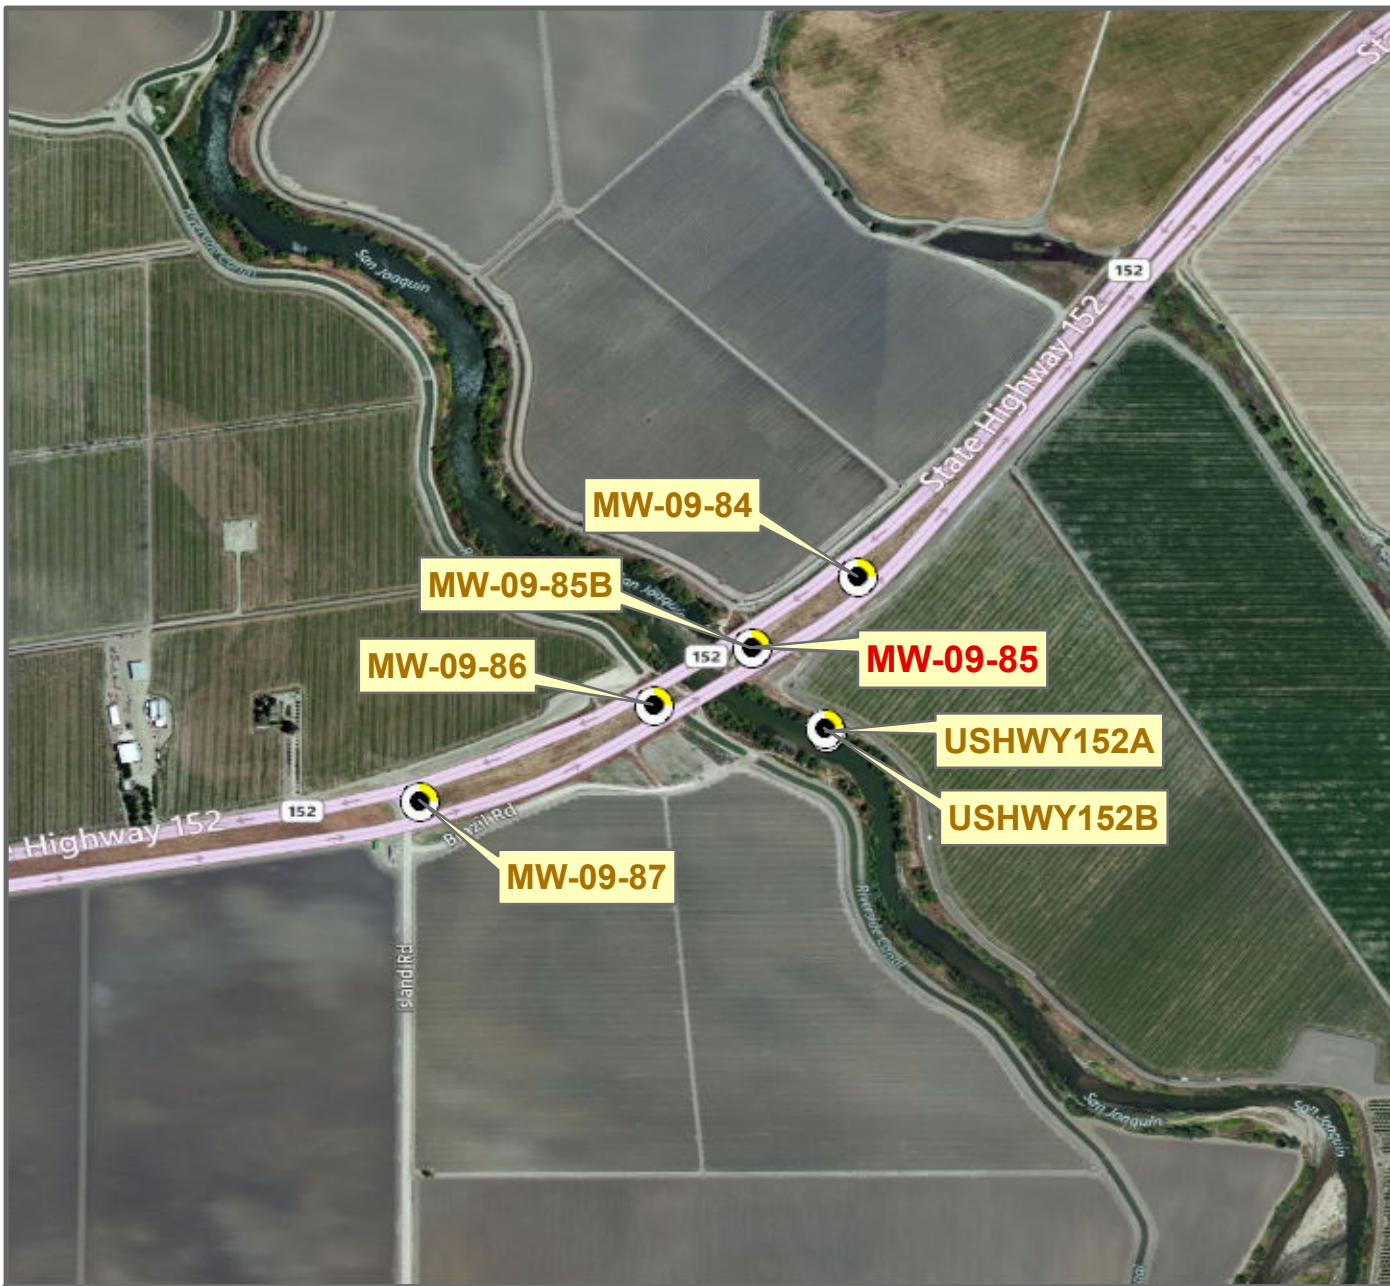
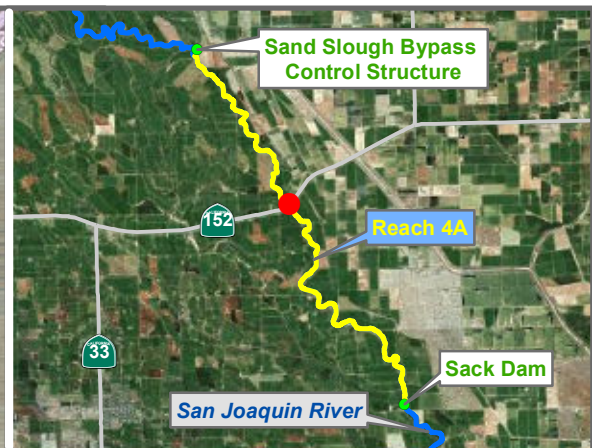
Monitoring Location MW-09-85

Reach = 4A
 River Mile = 173.9
 Merced County
 Right Bank

X = -120.5492 Y = 37.0564 Status = Existing
 (Horizontal Datum is NAD83)
 Distance From River Centerline (ft) = 285
 Reference Elevation (ft NAVD88) = 120.70
 Site = Hwy. 152

Agency = USBR
 Measurements:
 Type = Datalogger
 Interval = Hourly
 Timeseries unavailable

Description:
 2 inch PVC casing FM

Ground Surface Elevation (ft) = 120.80
 Monitoring Depth (ft) = 52.0 - 82.0 ft below gs

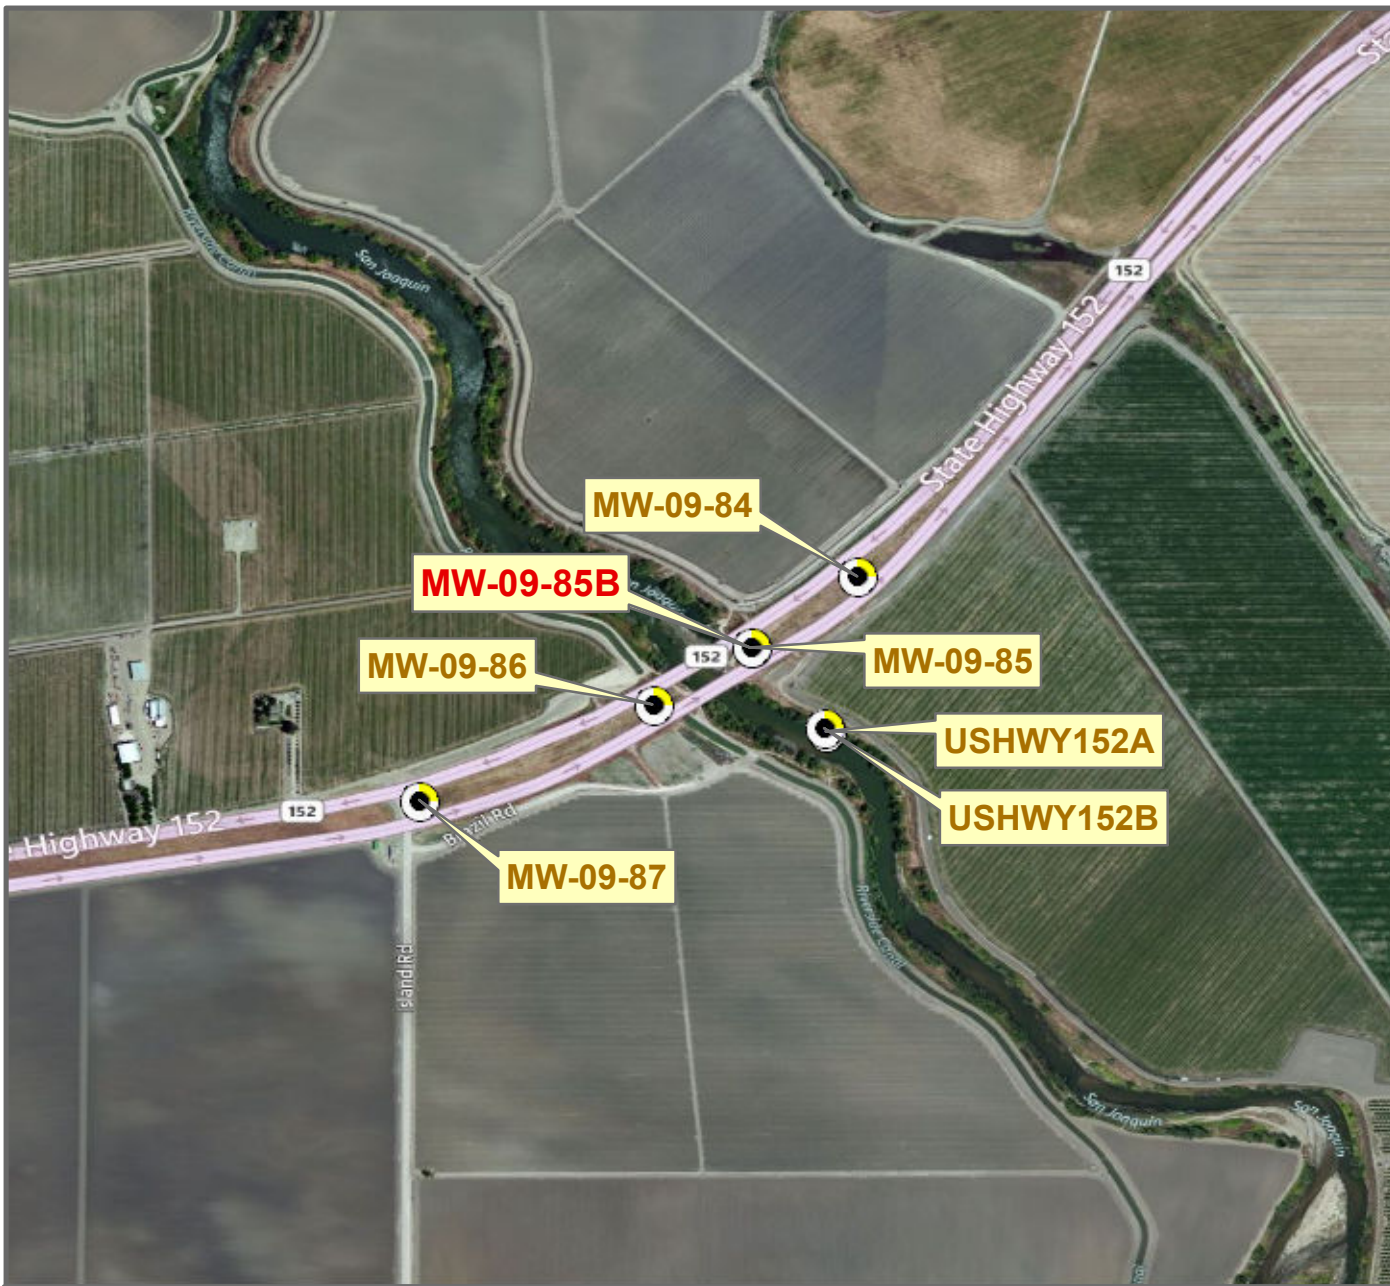
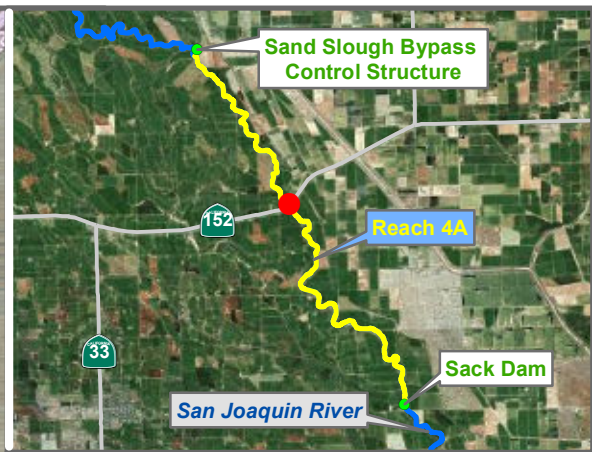
Monitoring Location MW-09-85B

Reach = 4A
 River Mile = 173.9
 Merced County
 Right Bank

X = -120.5492 Y = 37.0564 Status = Existing
 (Horizontal Datum is NAD83)
 Distance From River Centerline (ft) = 285
 Reference Elevation (ft NAVD88) = 120.50
 Site = Hwy. 152

Agency = USBR
 Measurements:
 Type = Datalogger
 Interval = Hourly
 Timeseries unavailable

Description:
 2 inch PVC casing FM

Ground Surface Elevation (ft) = 120.60
 Monitoring Depth (ft) = 9.5 - 29.5 ft below gs

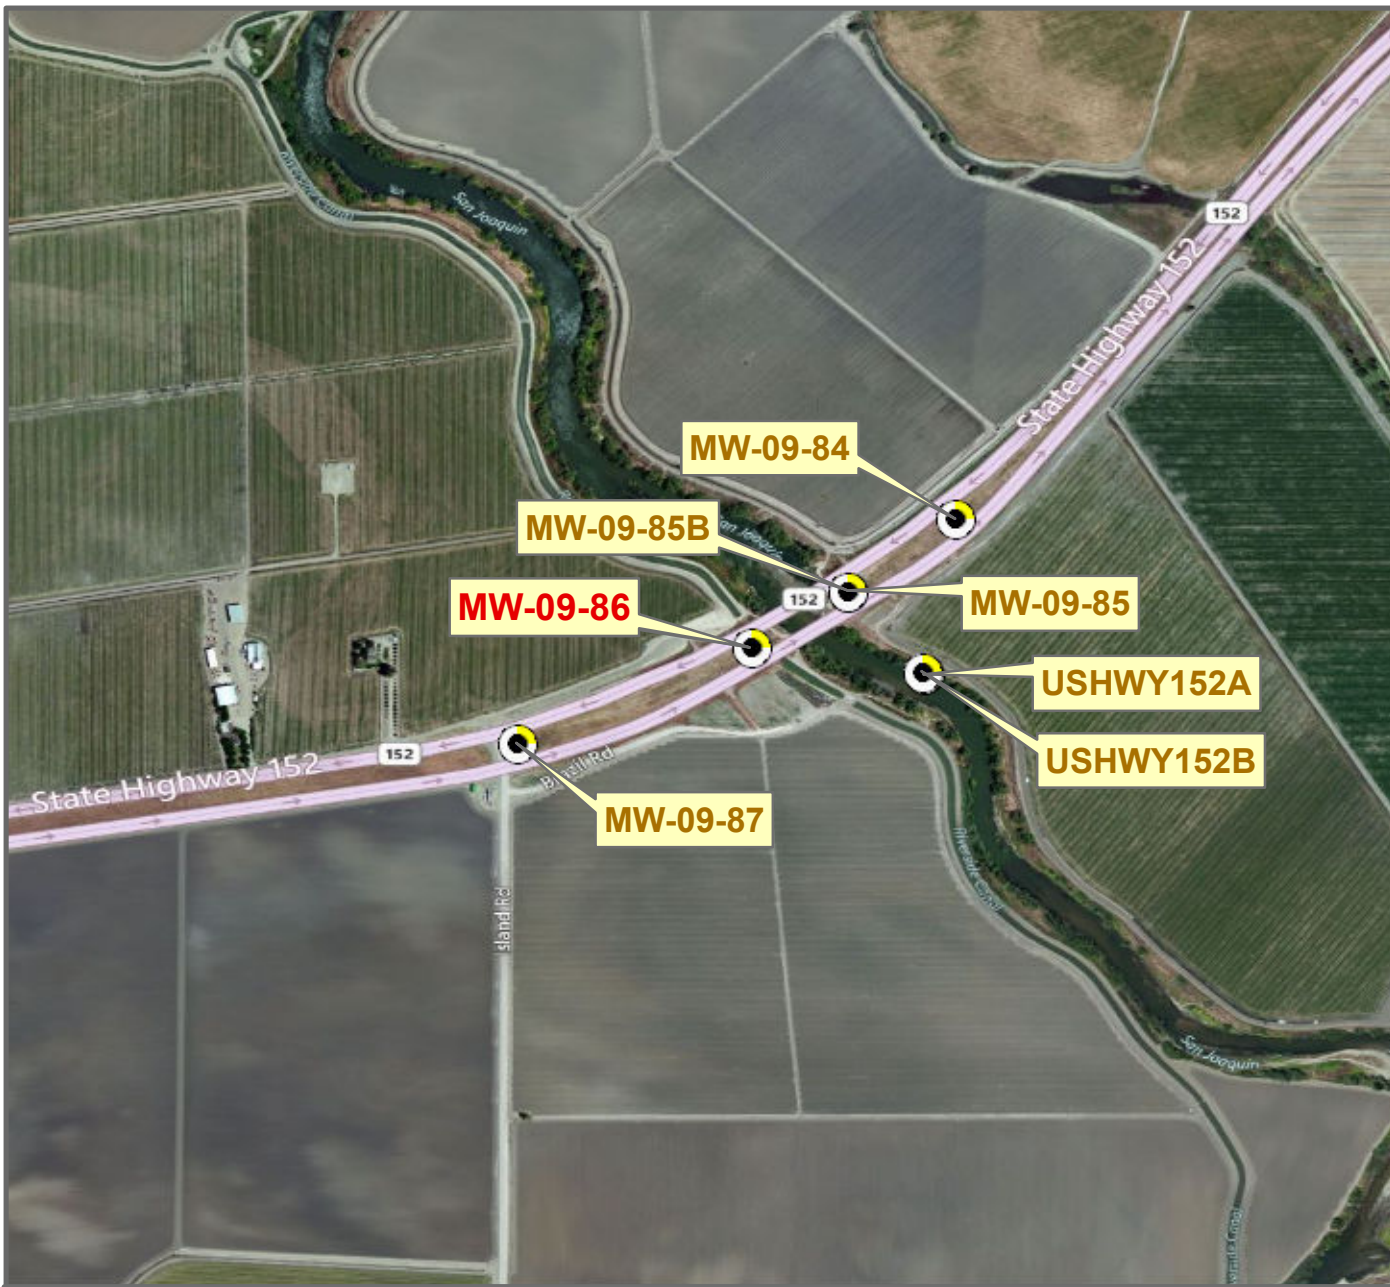
Monitoring Location MW-09-86

Reach = 4A
 River Mile = 173.9
 Merced County
 Left Bank

X = -120.5506 Y = 37.0556 Status = Existing
 (Horizontal Datum is NAD83)
 Distance From River Centerline (ft) = 287
 Reference Elevation (ft NAVD88) = 120.90
 Site = Hwy. 152

Agency = USBR
 Measurements:
 Type = Datalogger
 Interval = Hourly
 Timeseries unavailable

Description:
 2 inch PVC casing FM

Ground Surface Elevation (ft) = 121.00
 Monitoring Depth (ft) = 52.0 - 72.0 ft below gs

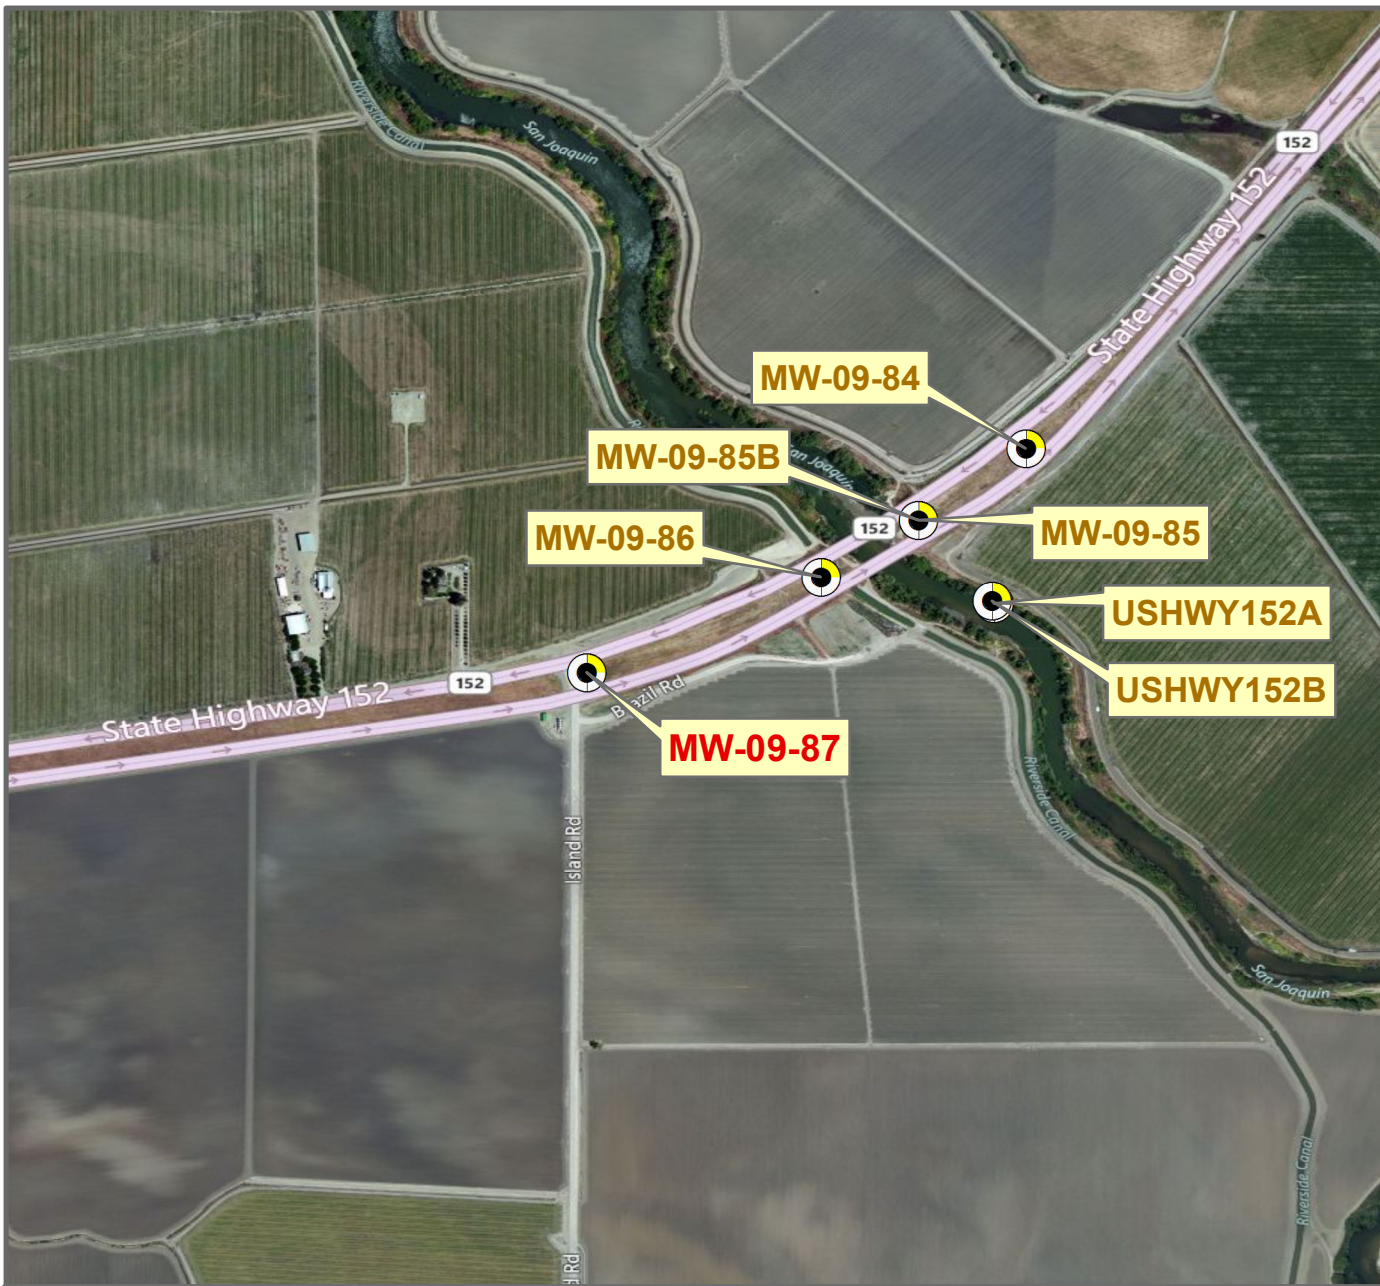
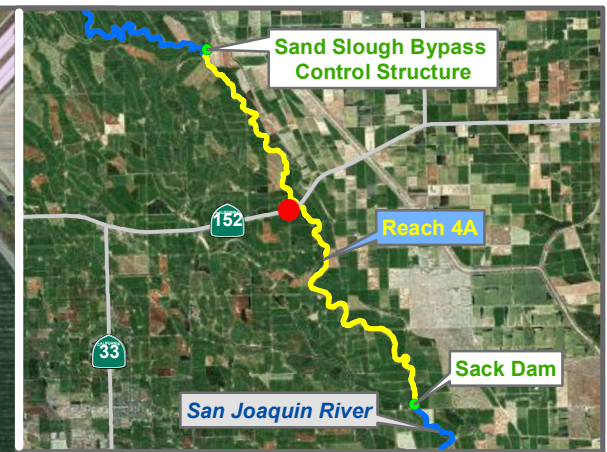
Monitoring Location MW-09-87

Reach = 4A
 River Mile = 173.9
 Merced County
 Left Bank

X = -120.5540 Y = 37.0542 Status = Existing
 (Horizontal Datum is NAD83)
 Distance From River Centerline (ft)=
 Reference Elevation (ft NAVD88) = 114.90
 Site = Hwy. 152

Agency = USBR
 Measurements:
 Type = Datalogger
 Interval = Hourly
 Timeseries unavailable

Description:
 2 inch PVC casing FM

Ground Surface Elevation (ft) = 115.03
 Monitoring Depth (ft) = 37.0 - 47.0 ft below gs

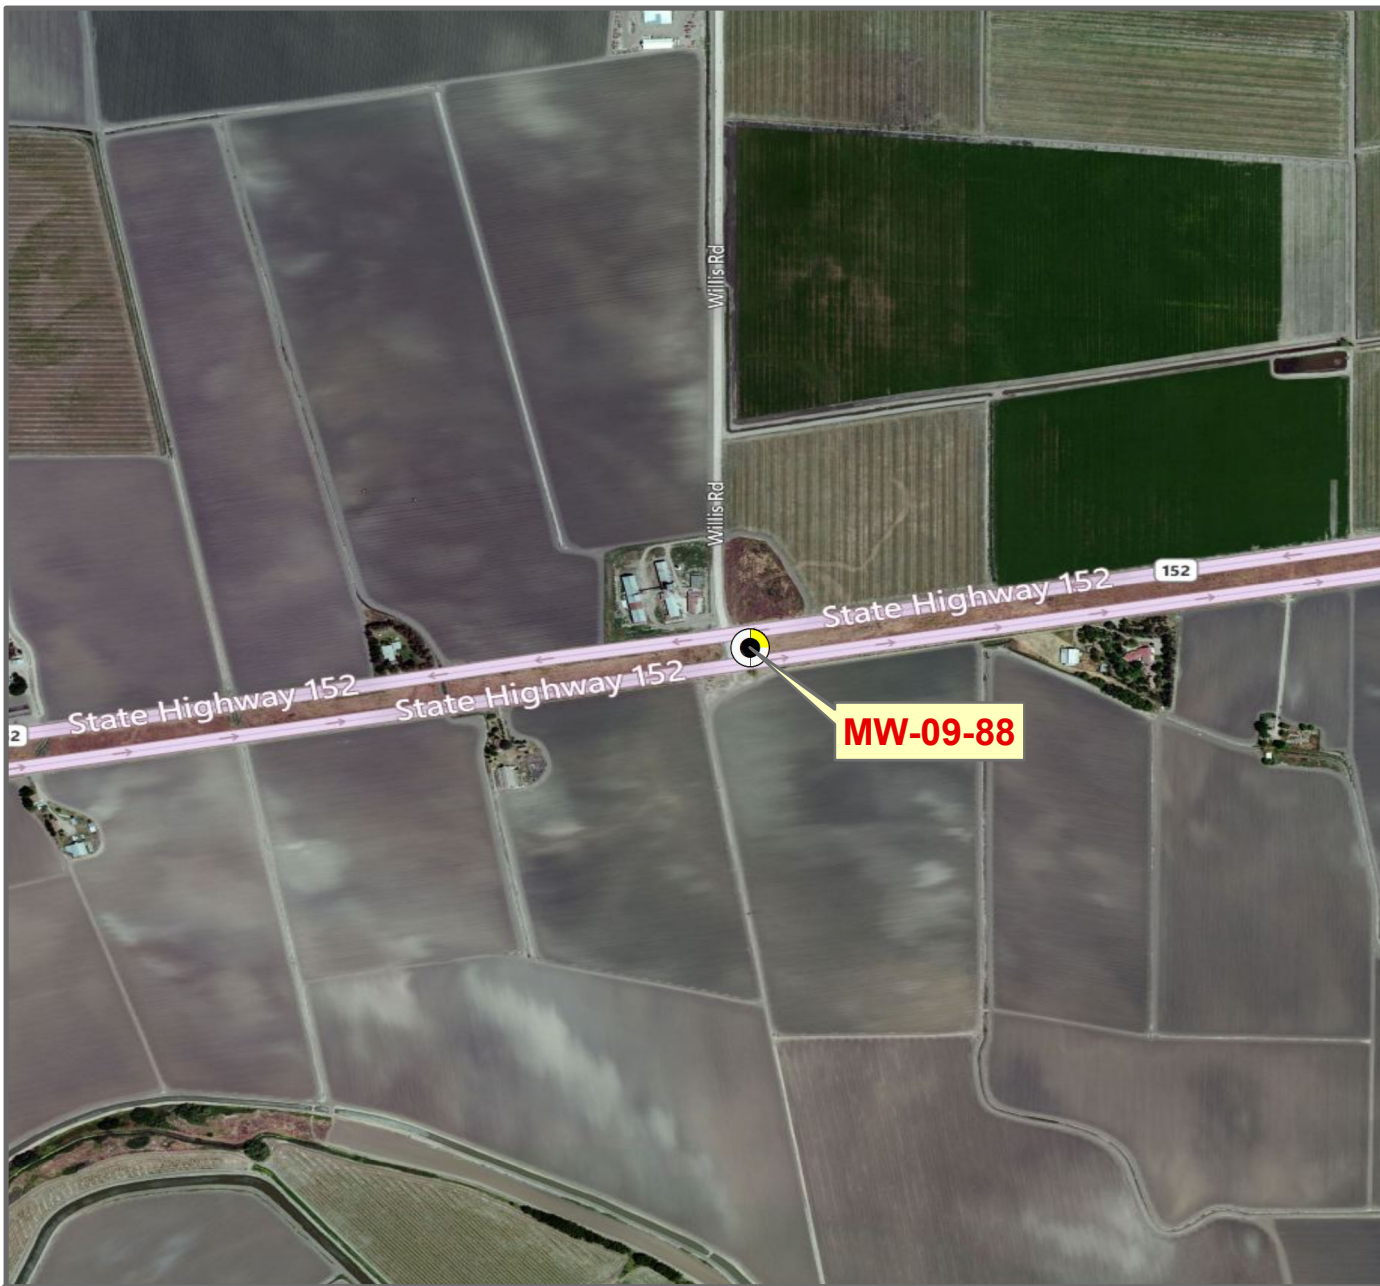
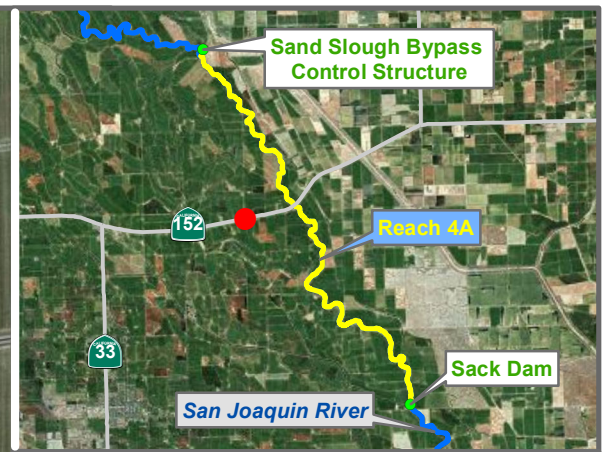
Monitoring Location MW-09-88

Reach = 4A
 River Mile = 173.9
 Status = Existing
 (Horizontal Datum is NAD83)
 Distance From River (ft) = 6557
 Reference Elevation (ft NAVD88) = 111.80
 Site = Hwy. 152

Merced County
 Left Bank

Agency = USBR
 Measurements:
 Type = Datalogger
 Interval = Hourly
 Timeseries unavailable

Description:
 2 inch PVC casing FM

Ground Surface Elevation (ft) = 112.00
 Monitoring Depth (ft) = 25.0 - 45.0 ft below gs

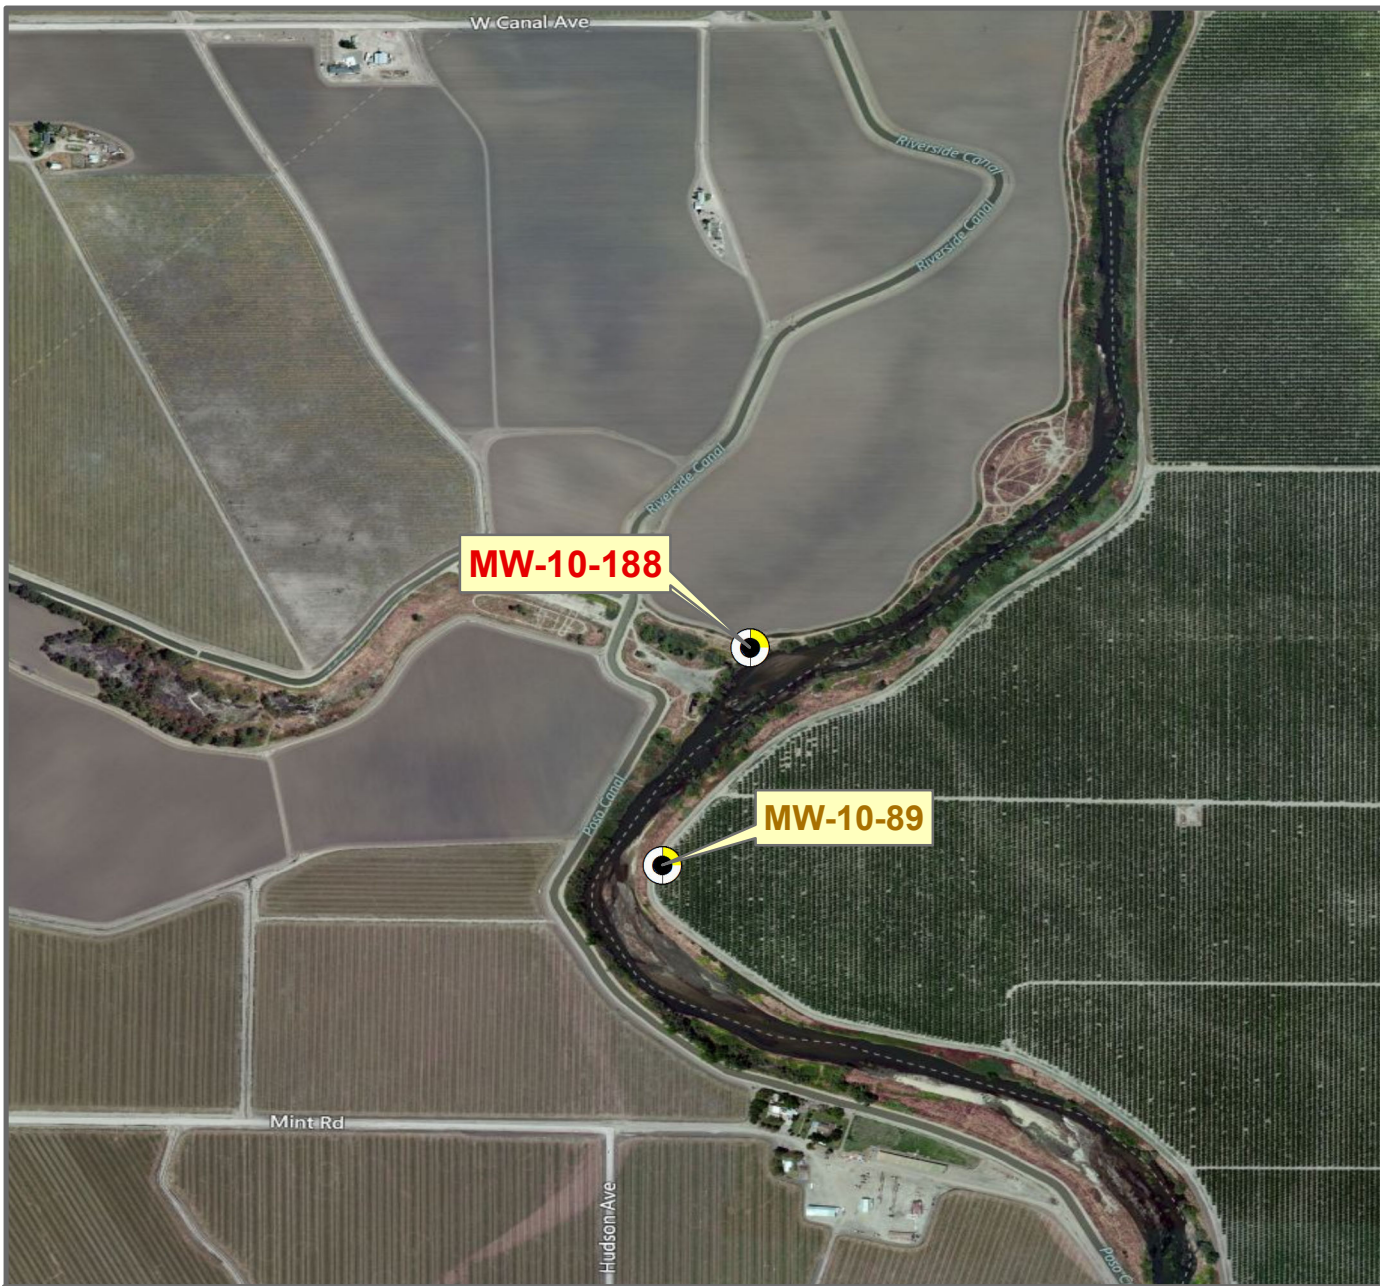
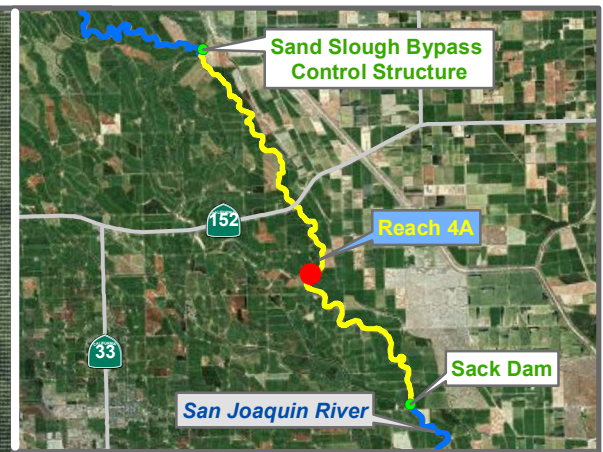
Monitoring Location MW-10-188

Reach = 4A
 River Mile = 176.2
 X = -120.5432 Y = 37.0310 Status = Existing
 (Horizontal Datum is NAD83)
 Distance From River (ft) = 255
 Reference Elevation (ft NAVD88) = 120.00
 Site = TBD

Agency = USBR
 Measurements:
 Type = Datalogger
 Interval = Hourly
 Timeseries unavailable

Description:
 2 inch PVC casing AG

Ground Surface Elevation (ft) = 116.90
 Monitoring Depth (ft) = 8.6-13.6 ft below gs

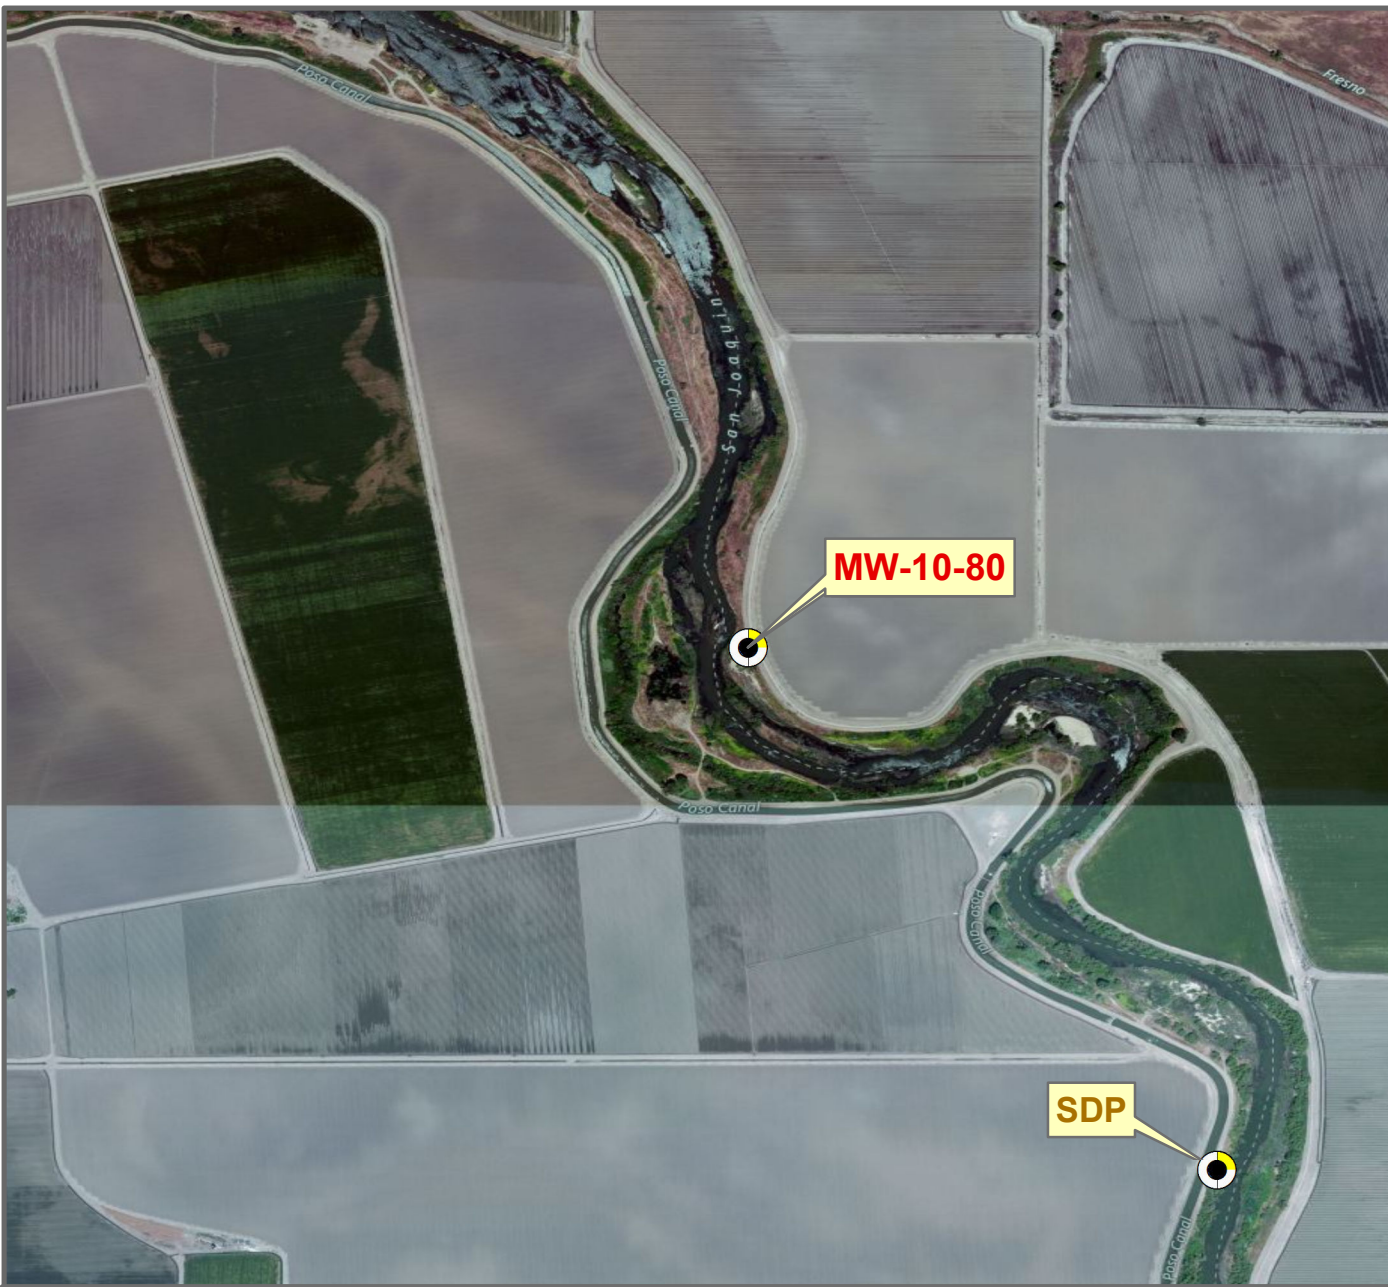
Monitoring Location MW-10-80

Reach = 4A
 River Mile = 179.9
 Madera County
 Right Bank

X = -120.5082 Y = 37.0015 Status = Existing
 (Horizontal Datum is NAD83)
 Distance From River (ft) = 125
 Reference Elevation (ft NAVD88) = 127.50
 Site = TBD

Agency = USBR
 Measurements:
 Type = Datalogger
 Interval = Hourly
 Timeseries unavailable

Description:
 2 inch PVC casing AG

Ground Surface Elevation (ft) = 124.90
 Monitoring Depth (ft) = 10-25 ft below gs

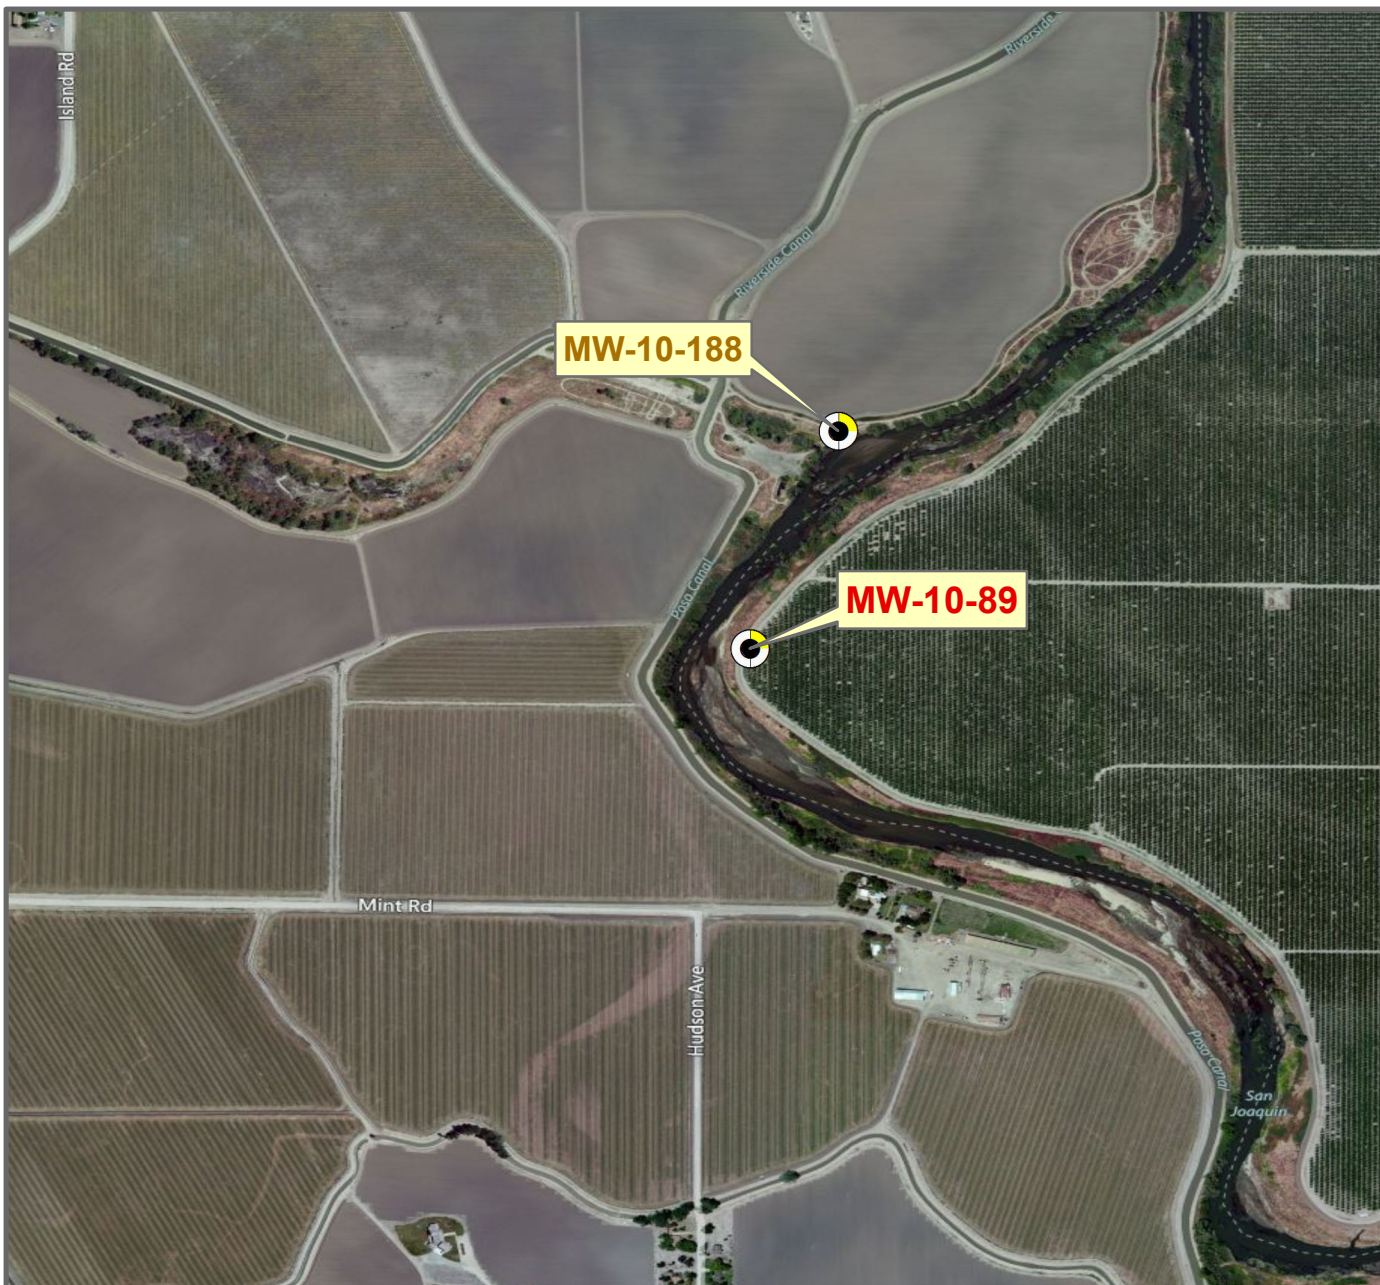
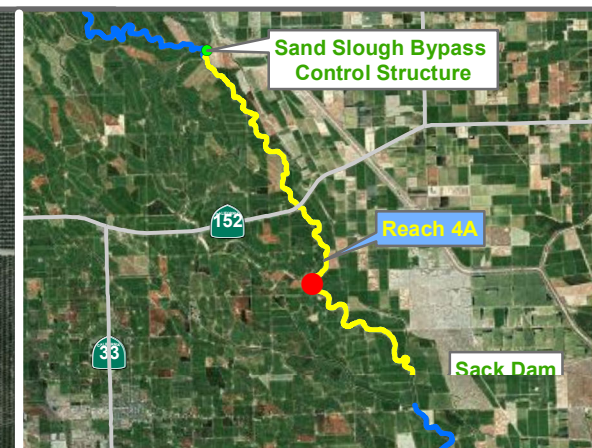
Monitoring Location MW-10-89

Reach = 4A
River Mile = 176.4
Madera County
Right Bank

X = -120.5445 Y = 37.0279 Status = Existing
(Horizontal Datum is NAD83)
Distance From River (ft) = 259
Reference Elevation (ft NAVD88) = 121.50
Site = TBD

Agency = USBR
Measurements:
Type = Realtime
Interval = Hourly
Timeseries unavailable

Description:
2 inch PVC casing AG

Ground Surface Elevation (ft) = 118.80
Monitoring Depth (ft) = 10-25 ft below gs

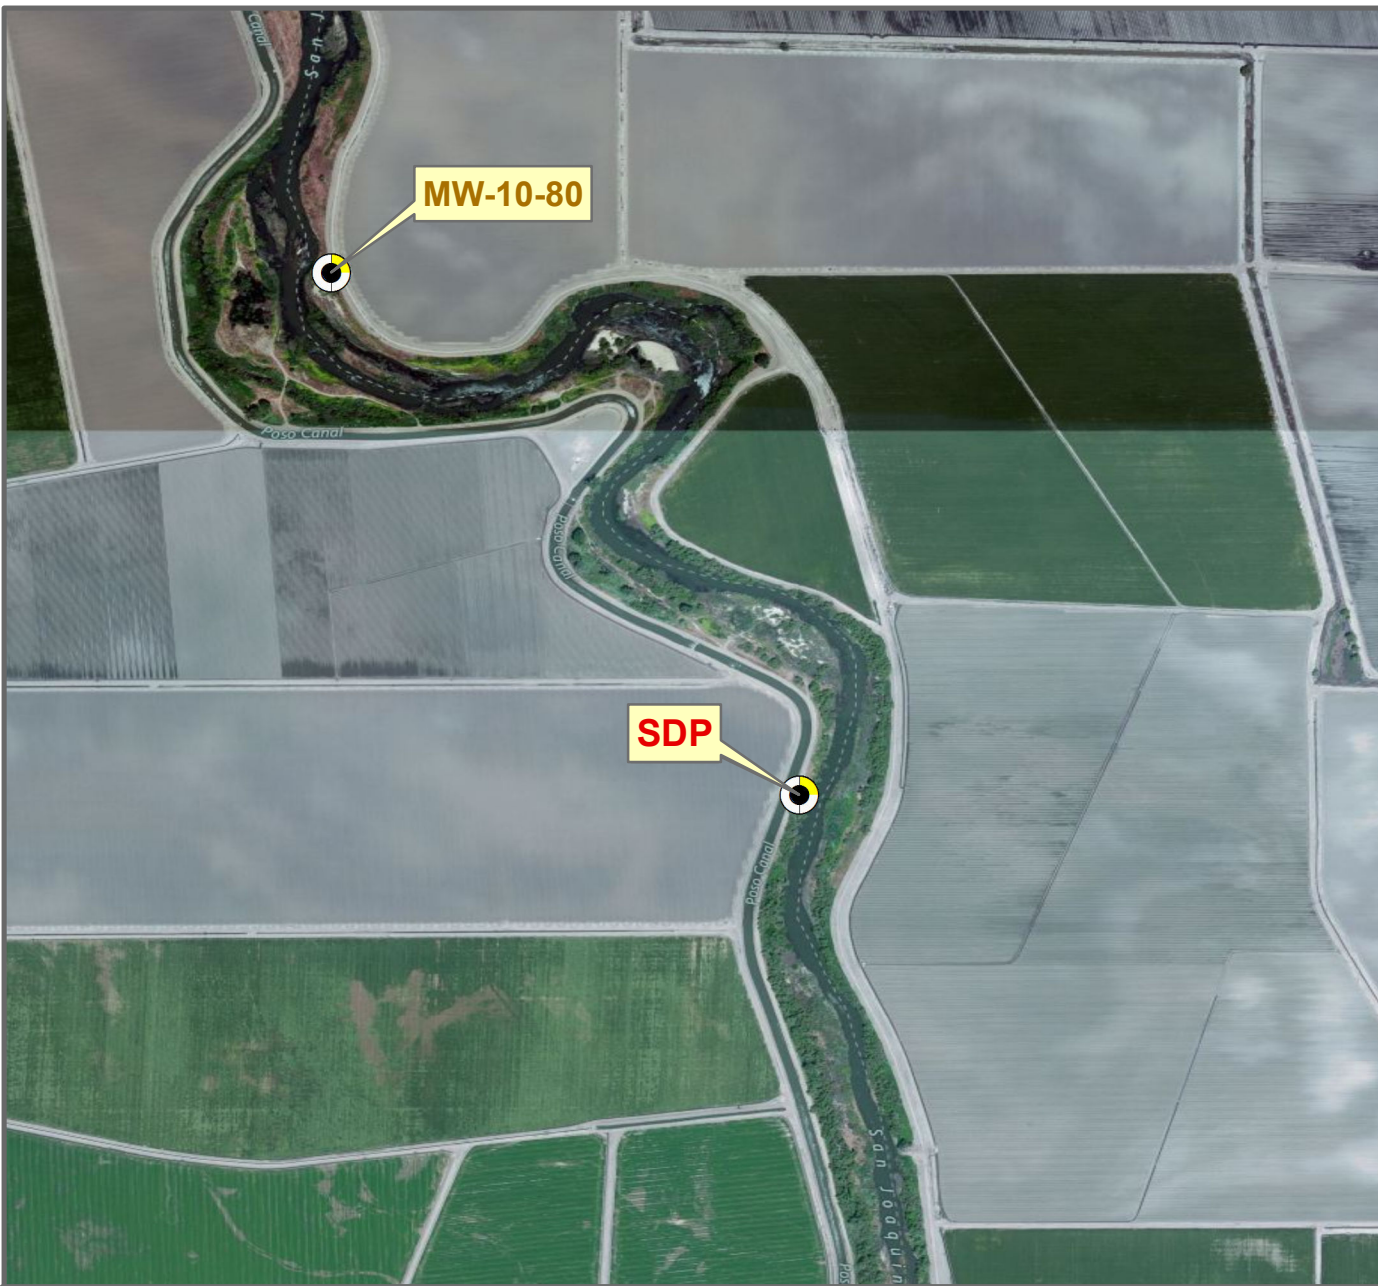
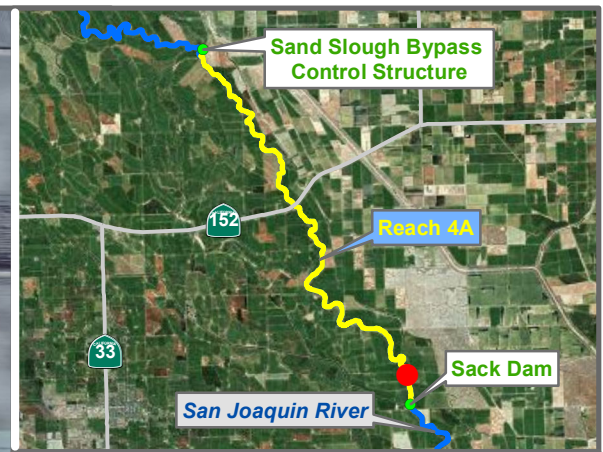
Monitoring Location SDP

Reach = 4A
 River Mile = 181.1
 Fresno County
 Left Bank

X = -120.5015 Y = 36.9940 Status = Existing
 (Horizontal Datum is NAD83)
 Distance From River (ft) = 113
 Reference Elevation (ft NAVD88) =
 Site = Near Dos Palos

Agency = DWR
 Measurements:
 Type = Telemetry
 Interval = 15 min
 Date Range = 12/3/2009 - 5/8/2012

Description:
 Sensor at real-time flow gaging station
