Reach 4A

Temperature Monitoring Sites

SAN JOAQUIN RIVER
RESTORATION PROGRAM

Preliminary Data

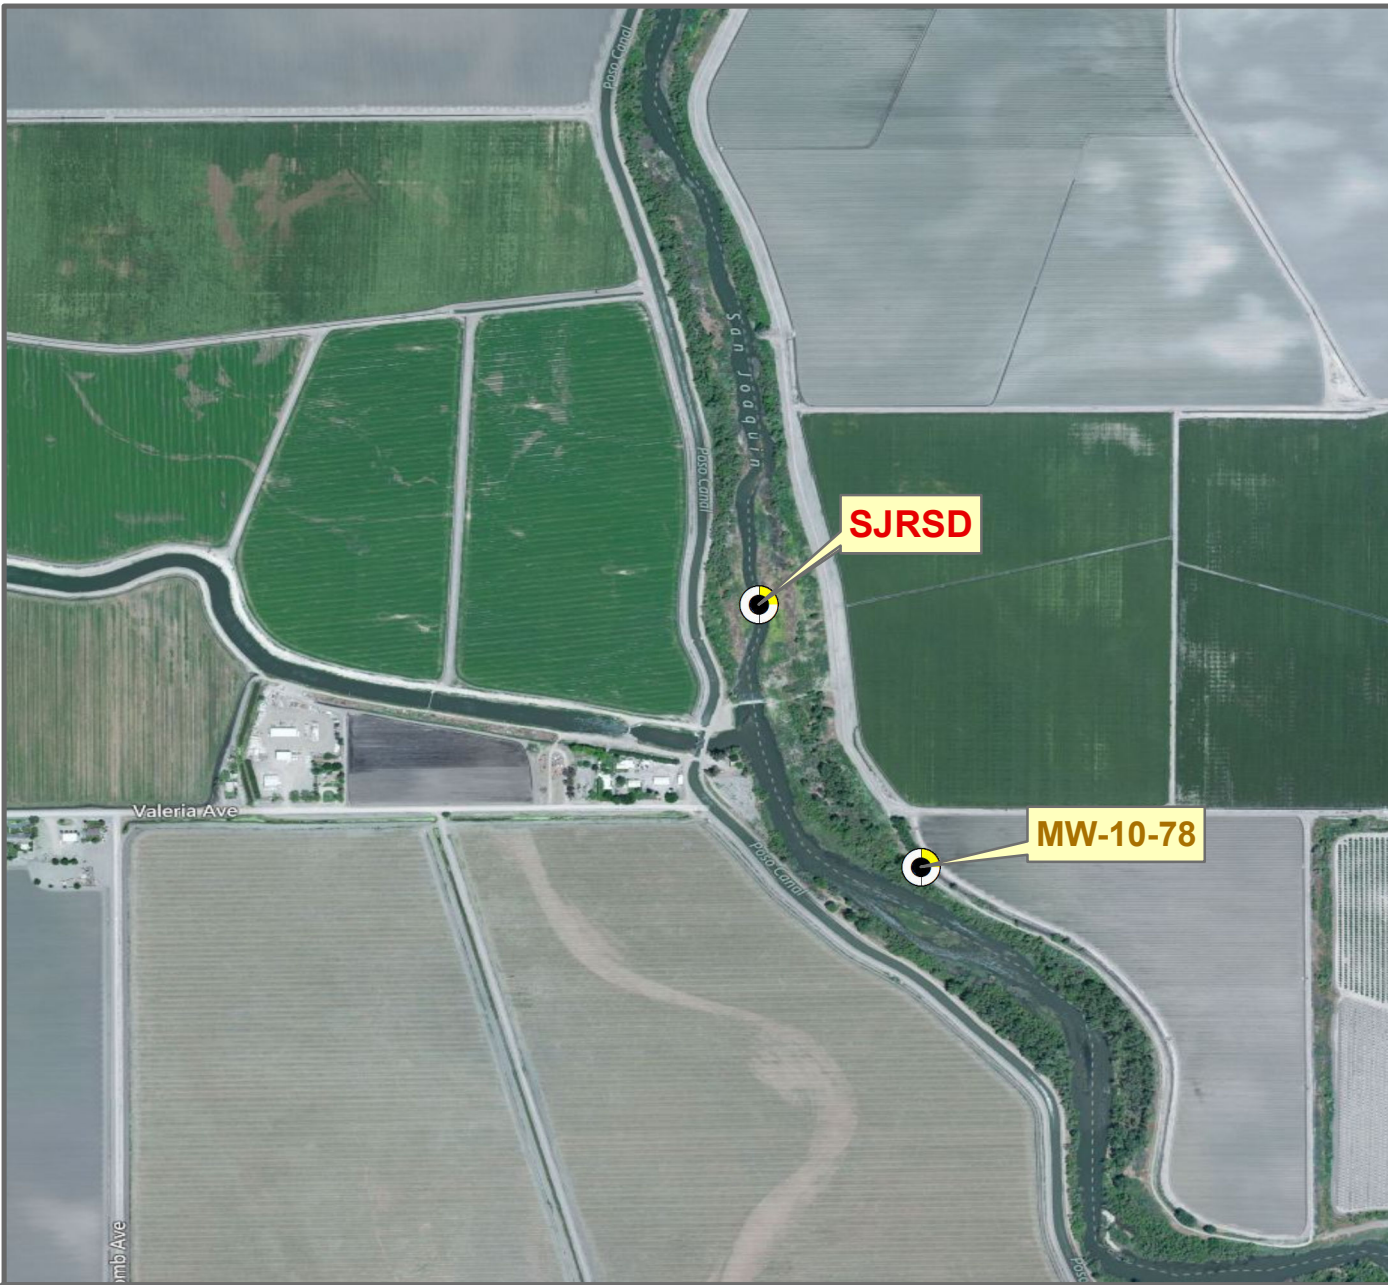
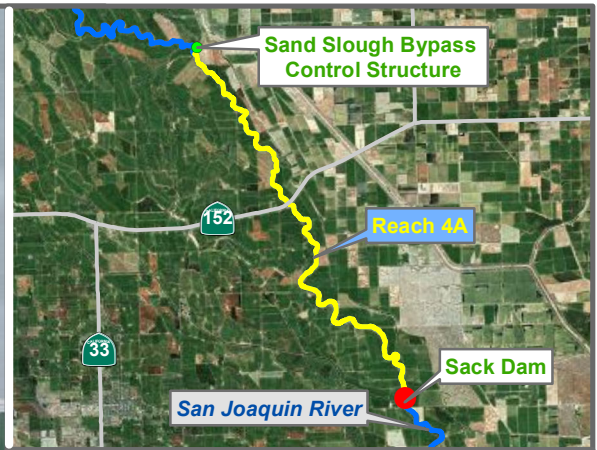
Monitoring Location SJRSD

Reach = 4A
 River Mile = 182.0
 Fresno County
 Left Bank

X = -120.5000 Y = 36.9851 Status = Lost
 (Horizontal Datum is NAD83)
 Distance From River (ft) = 4
 Reference Elevation (ft NAVD88) =
 Site = Sack Dam

Agency = DFG
 Measurements:
 Type = Datalogger
 Interval = Hourly
 Date Range = 3/4/2009 - 12/1/2010

Description:
 Downstream of dam. Cabled to rebar in MC. data lost during IFP 2010. Data lost during IFP 2010.

Ground Surface Elevation (ft) =
 Monitoring Depth (ft) = 1 ft above gs

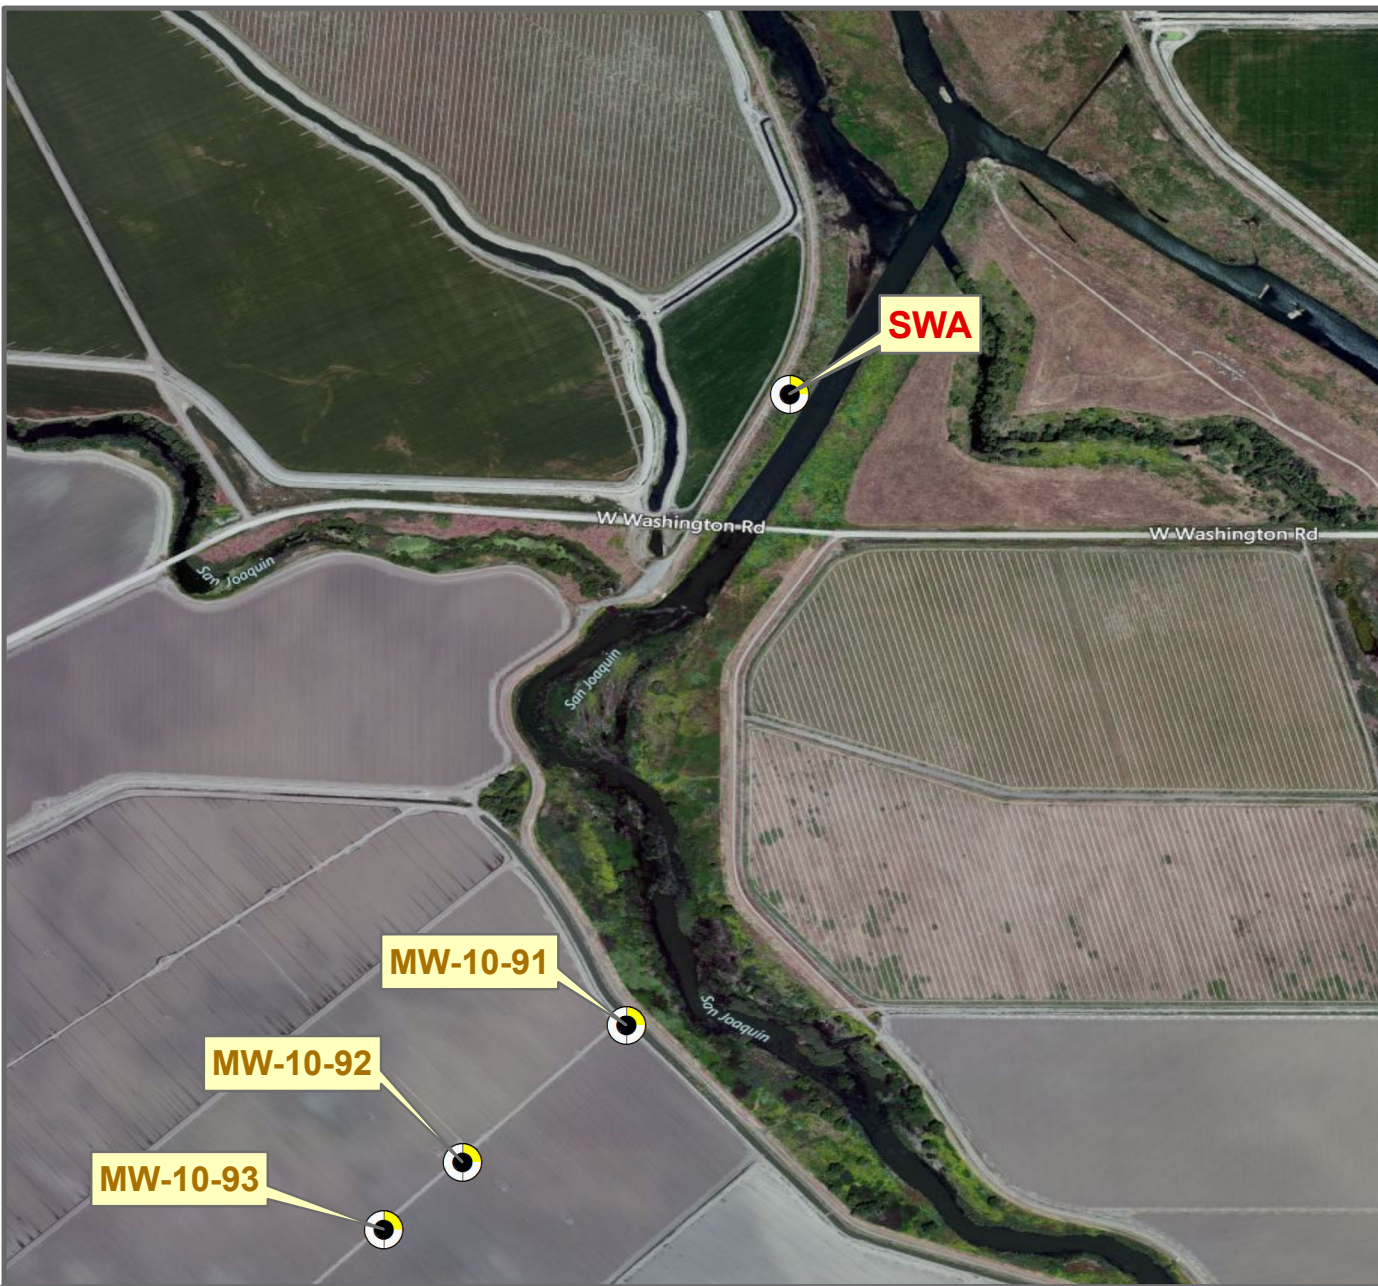
Monitoring Location SWA

Reach = 4A
 River Mile = 168.1
 Merced County
 Right Bank
 X = -120.5870 Y = 37.1153 Status = Existing
 (Horizontal Datum is NAD83)
 Distance From River (ft) = 163
 Reference Elevation (ft NAVD88) =
 Site = Washington Road

Agency = DWR
 Measurements:
 Type = Telemetry
 Interval = 15 min
 Date Range = 3/15/2010 - 5/8/2012

Description:
 Sensor at real-time flow gaging station

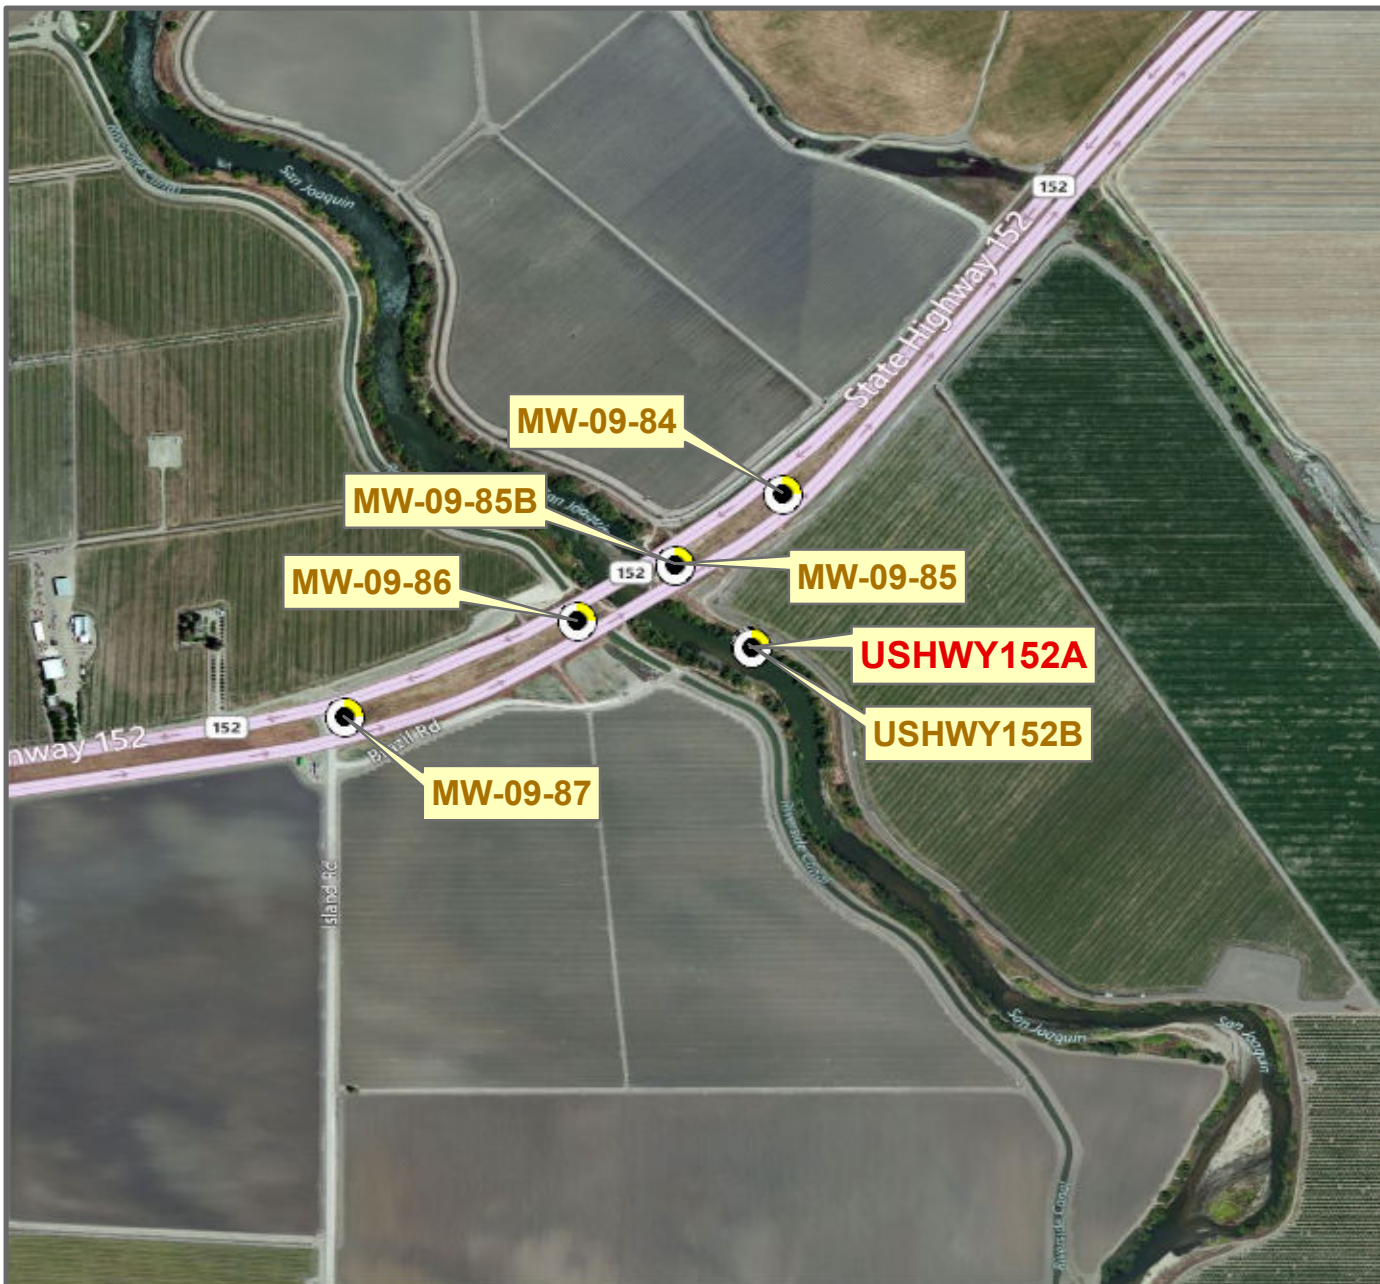
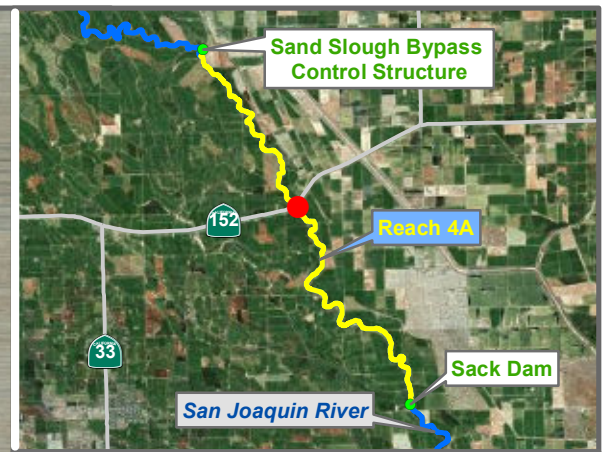
Monitoring Location USHWY152A

Reach = 4A
 River Mile = 174.0
 Merced County
 Right Bank

X = -120.5482 Y = 37.0552 Status = Existing
 (Horizontal Datum is NAD83)
 Distance From River Centerline (ft)=
 Reference Elevation (ft NAVD88) =
 Site = SJR Upstream of Highway 152

Agency = USBR
 Measurements:
 Type = Datalogger
 Interval = Hourly
 Timeseries unavailable

Description:
 Cabled to willow tree 50-55 ft downstream of second power pole south of highway 152. 5 ft downstream of SJRUSHWY152B.

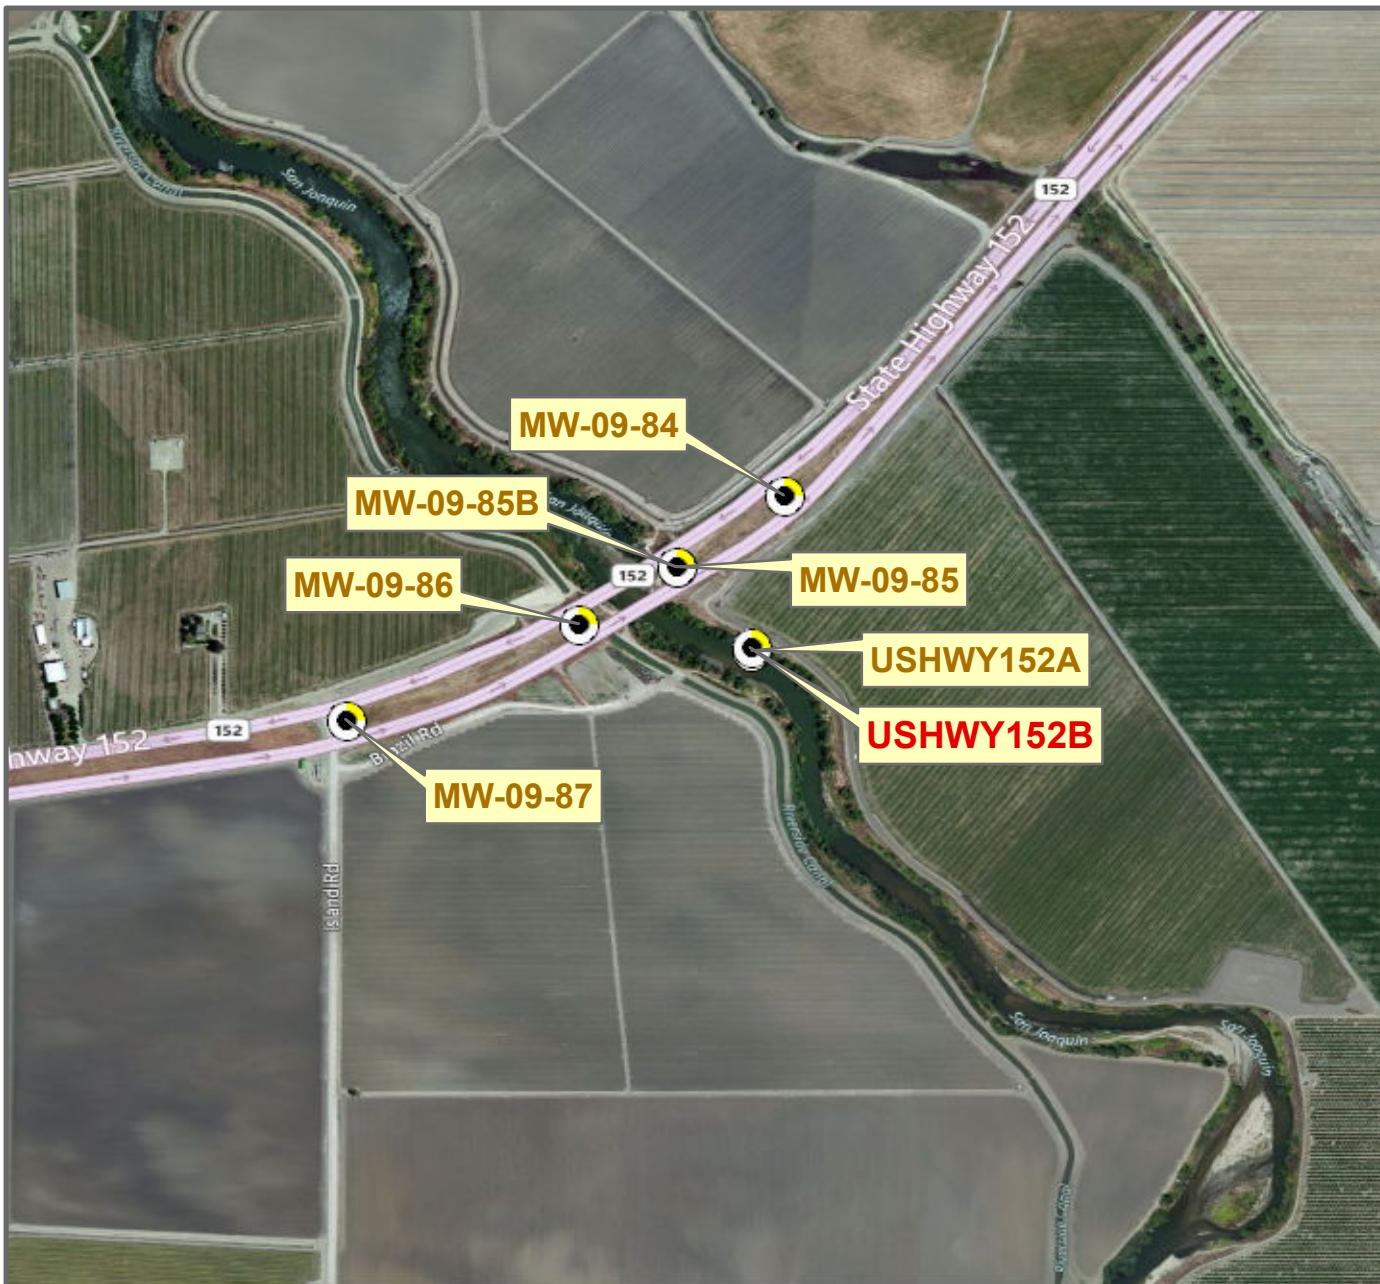
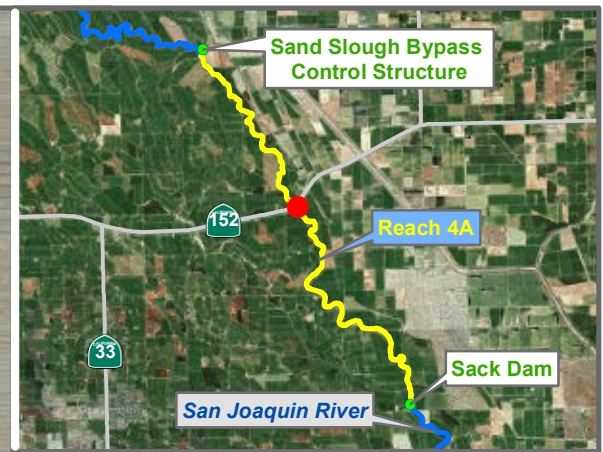
Monitoring Location USHWY152B

Reach = 4A
 River Mile = 174.0
 Merced County
 Right Bank

X = -120.5482 Y = 37.0552 Status = Existing
 (Horizontal Datum is NAD83)
 Distance From River Centerline (ft)=
 Reference Elevation (ft NAVD88) =
 Site = SJR Upstream of Highway 152

Agency = USBR
 Measurements:
 Type = Datalogger
 Interval = Hourly
 Timeseries unavailable

Description:
 Cabled to willow tree 50-55 ft downstream of second power pole south of highway 152. 5 ft upstream of SJRUSHWY152A.
