Monitoring of Vegetation along the San Joaquin River

2017 Report

Reach 2B, San Joaquin River

February 2018

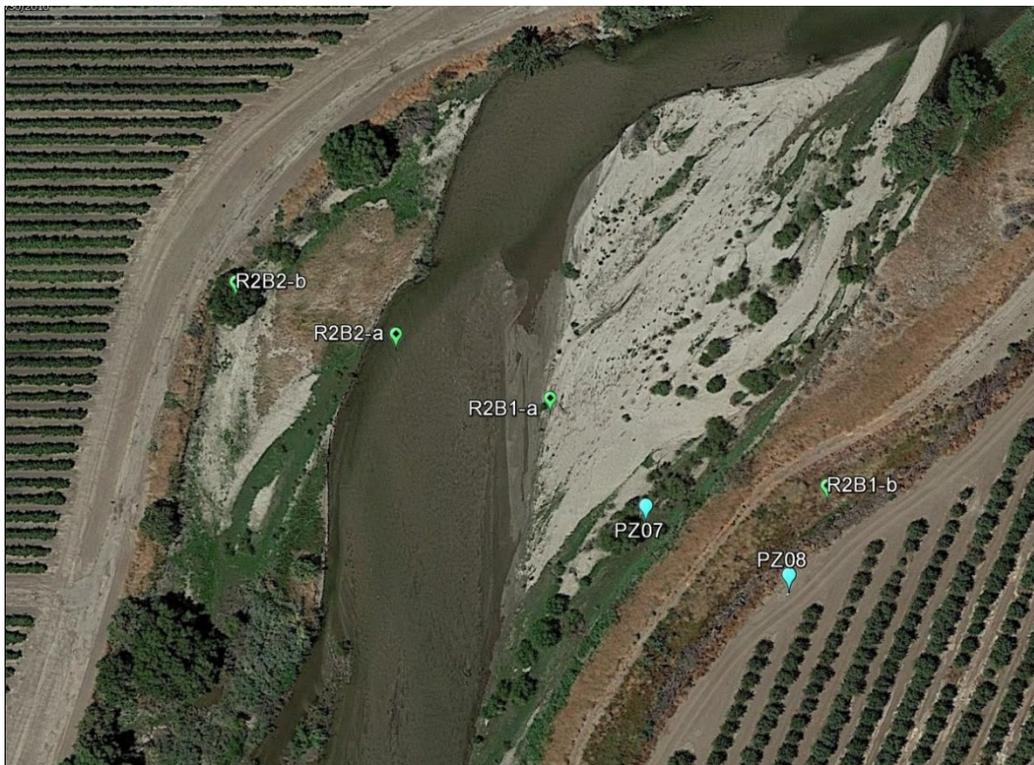
Figure 12. Locations of wells PZ-7 (floodplain) and PZ-8 (upper terrace) and endpoints of vegetation transects R2B-1 and R2B-2 within Reach 2B. Google Earth imagery December 2017.

Piezometers were installed in association with transects in Reach 2B in February 2013 (PZ-7 and PZ-8 in Figure 12). The hydrograph in Figures 13, 14, and 15 show groundwater depths at these piezometer sites from March through December 2013, from and May to November 2014, and from January 2016 to November 2017, respectively. Flow data included in the hydrographs were gathered at Station SJN (approximately 2 mi downstream). A correlation between flows and the depth of the water table is apparent, which indicates connectivity of the floodplain and river. In well PZ-7, which is located in the floodplain, the water table remained less than 4 ft from the surface when the channel held water and <1 ft when flows reached around 500 cfs or higher.

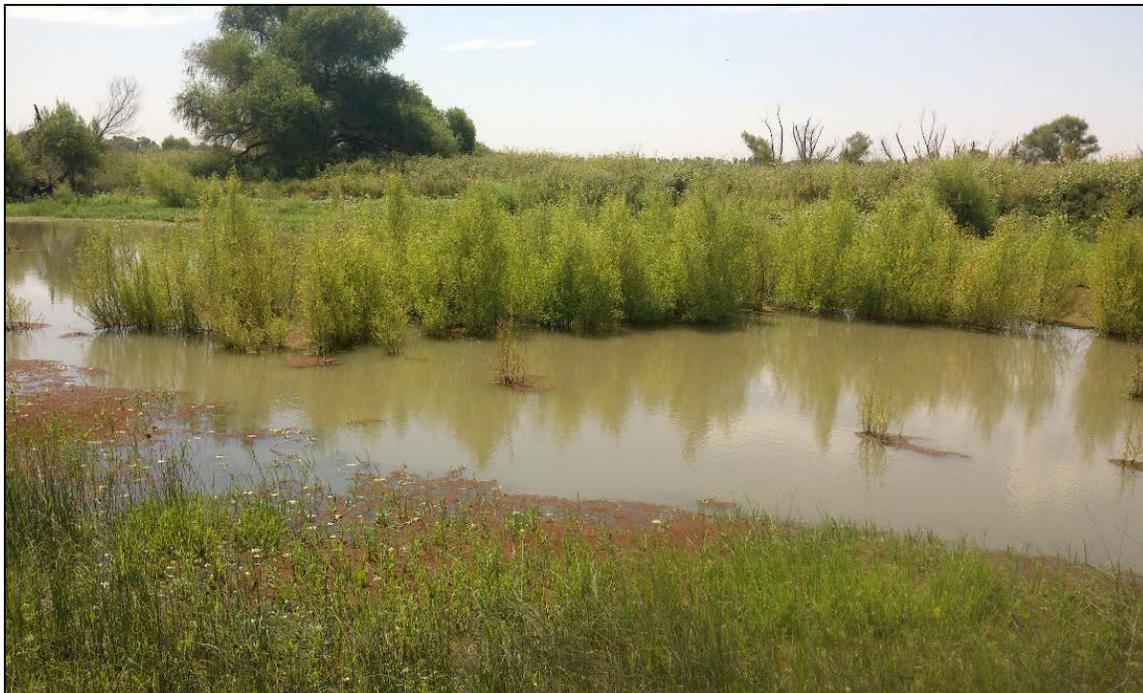
Figure 16. Goodding's willow (*Salix goodingii*) regeneration within the East Side Bypass channel, August 2017.

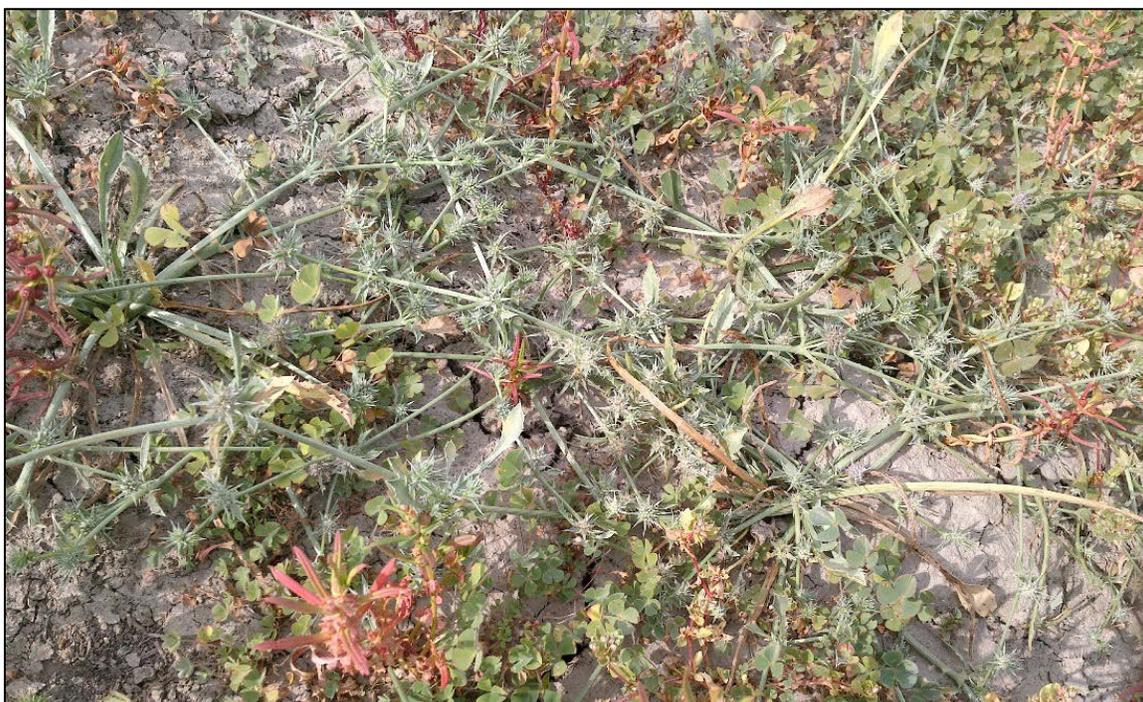
Figure 17. Delta button celery (*Eryngium racemosum*), a State-listed endangered plant, was detected in transects and surrounding areas within the East Side Bypass Reach, August 2017.

The California State endangered delta button celery was detected in transects within the ESB in 2011 and 2017 only (Figure 16). This species was also detected in areas surrounding transects in 2011, 2012, 2017.
