CHAPTER 3. FLUVIAL PROCESSES AND CHANNEL FORM

The size, shape, and form of the San Joaquin River (channel morphology) changes in different reaches between Friant Dam and the Merced River. This diversity between the reaches is caused by different geologic factors and the corresponding changes in fluvial processes. For example, the San Joaquin River courses through steep confined canyons of the Sierra Nevada, and the steep gradient and confined valley walls result in a high energy environment that is efficient in transporting most size classes of sediment (up to large boulders). As a result, the channel morphology is typified by high gradient, dominated by large substrate and exposed bedrock (non-alluvial), and small amounts of sediment storage (bars). Riparian vegetation is limited to individual trees in hydraulically sheltered areas, such as behind large boulders and along channel margins at the base of the valley walls. As the river exits the Sierra Nevada foothills, valley confinement and gradient decreases. Resulting channel morphology in this region is mostly alluvial, with a low gradient meandering channel, gravel/cobble substrate, multiple channels, and more extensive ripari

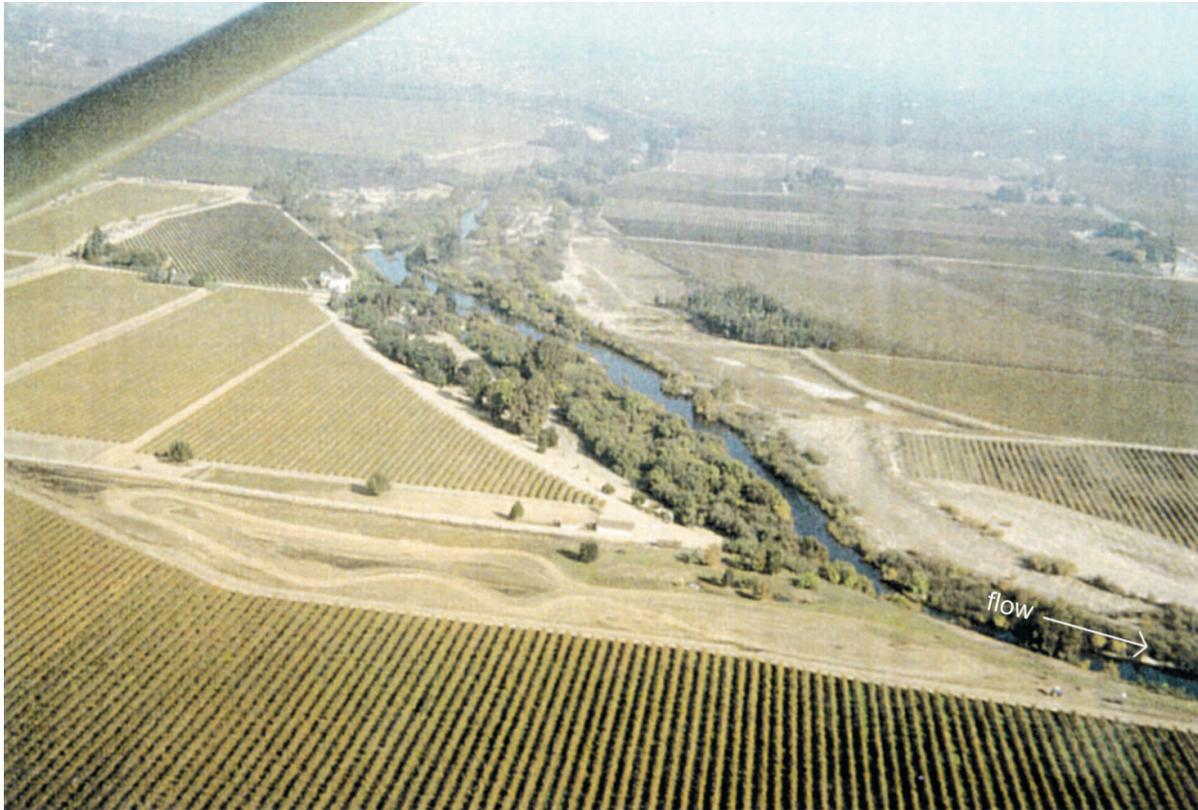
Figure 3-28. View upstream of the San Joaquin River at about RM 237. The channel is bounded by alluvial terraces, and has not been mined for sand and gravel in this specific location. From JSA and MEI (1998).

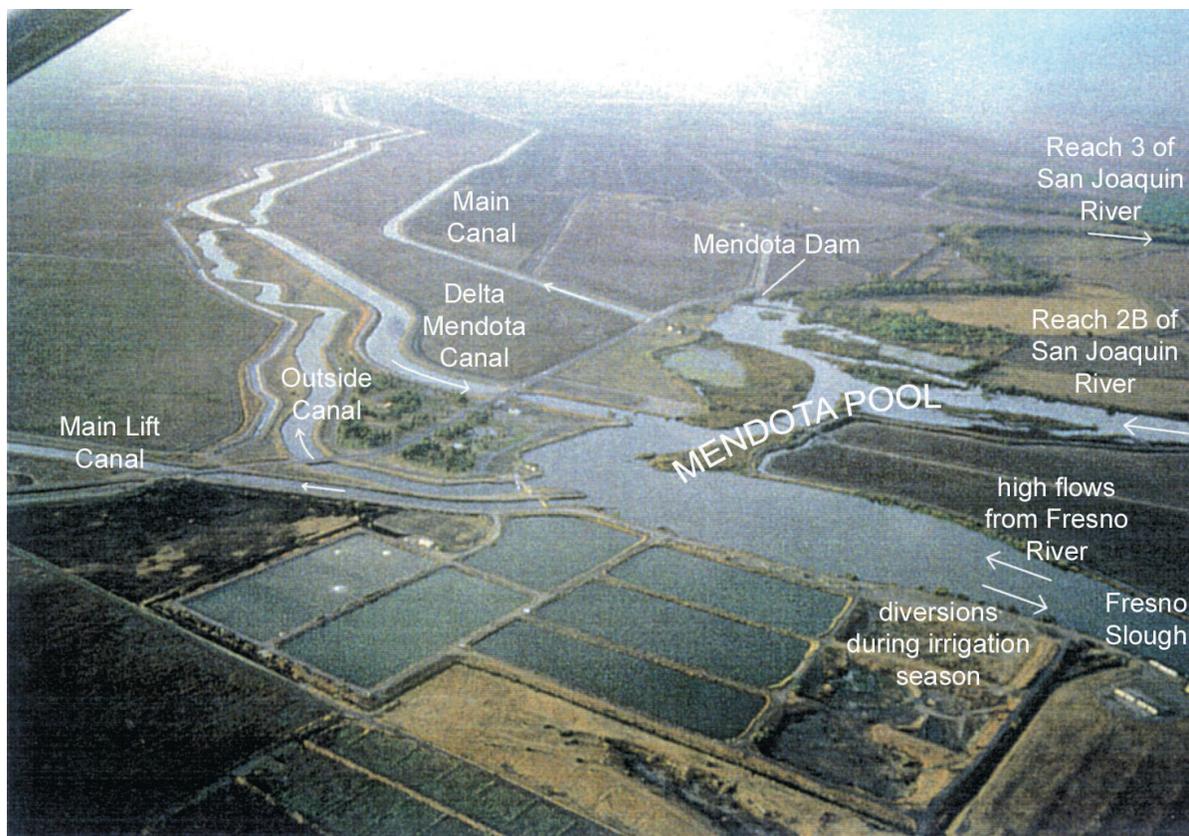
Figure 3-32. View of Mendota Pool at the Reach 2B/3 boundary (RM 205), looking north (downstream) into Reach 3 of the San Joaquin River. From JSA and MEI (1998).

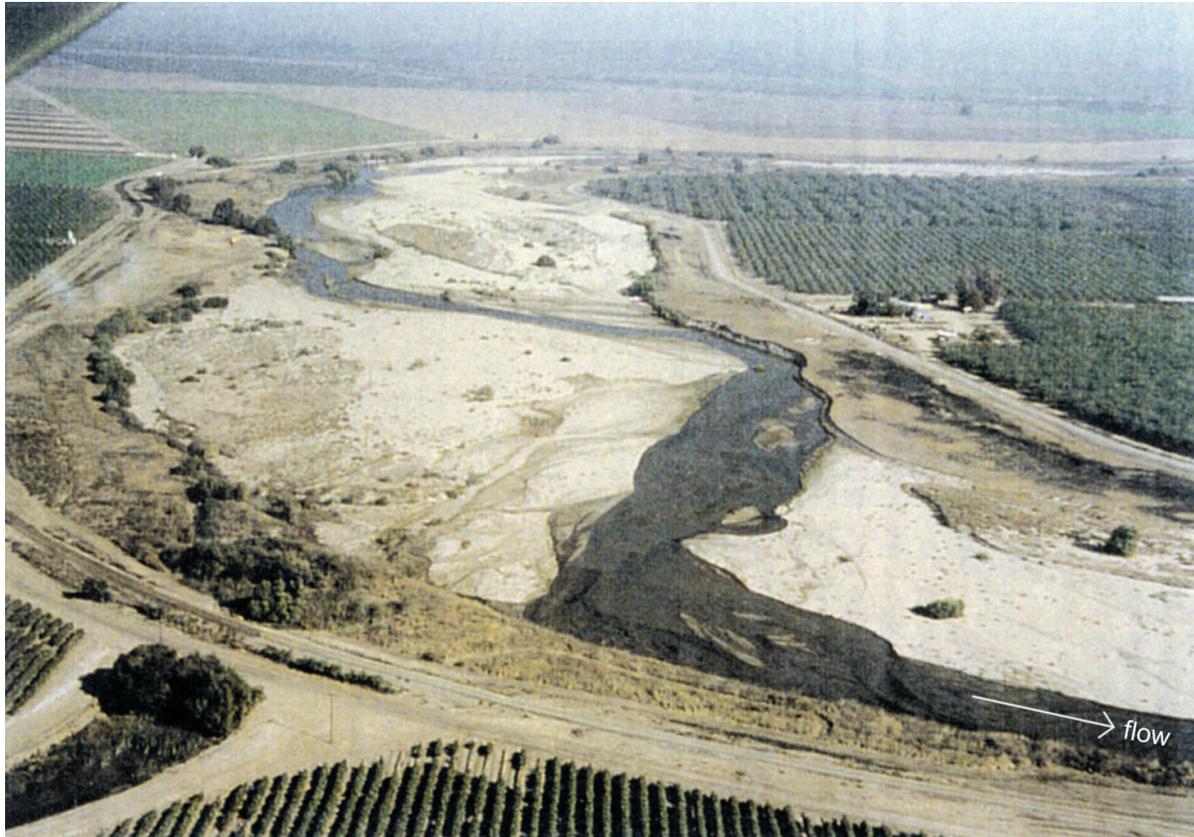
Figure 3-33. View looking upstream of sediment deposition in bed of the San Joaquin River in Reach 2A (RM 223) near the upstream end of the project levees and upstream of the Chowchilla Bifurcation Structure. This reach is usually dry most of the year. Erosion of the floodplain is the source of the majority of the sediment. From JSA and MEI (1998).

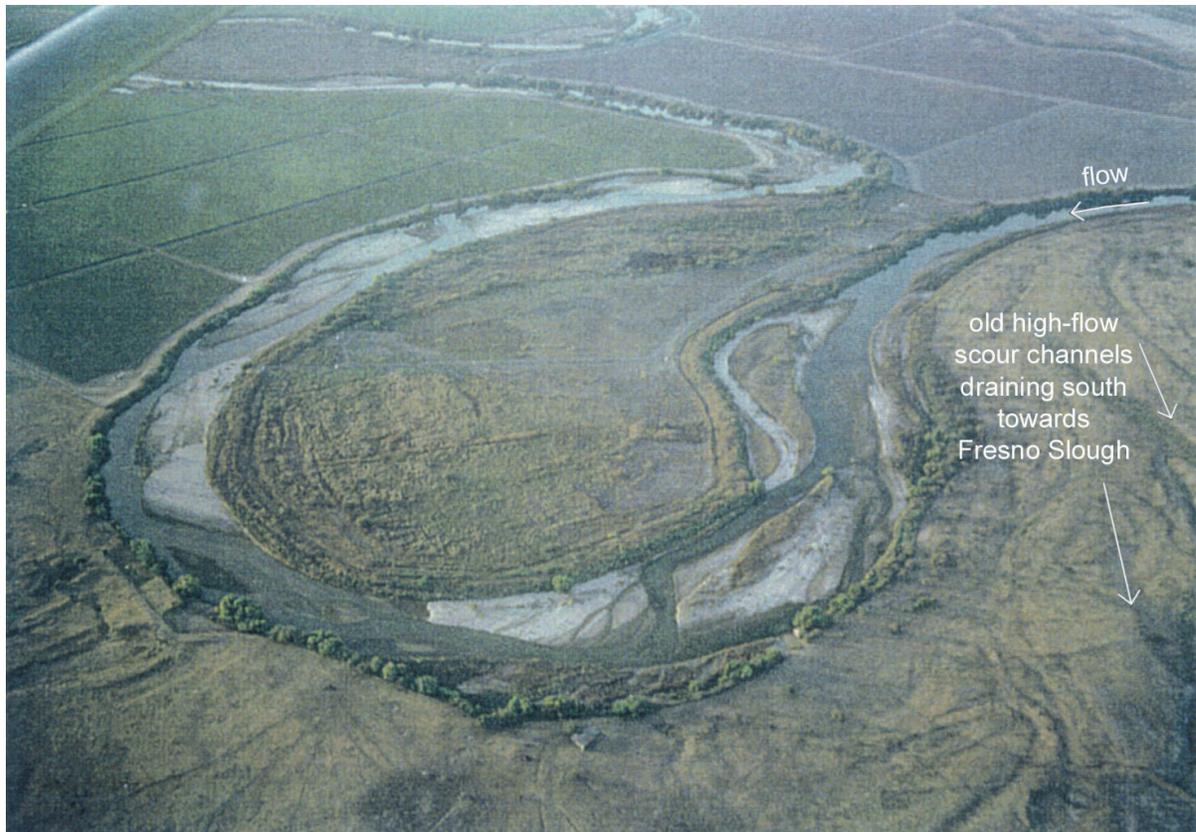
Figure 3-34. View looking downstream of a high amplitude bend in the San Joaquin River in Reach 2B (RM 215). Channel capacity is reduced by sediment deposition in the bed of the channel. Within-levée design capacity within this reach of the river is about 2,000 cfs. This reach is usually dry most of the year. From JSA and MEI (1998).

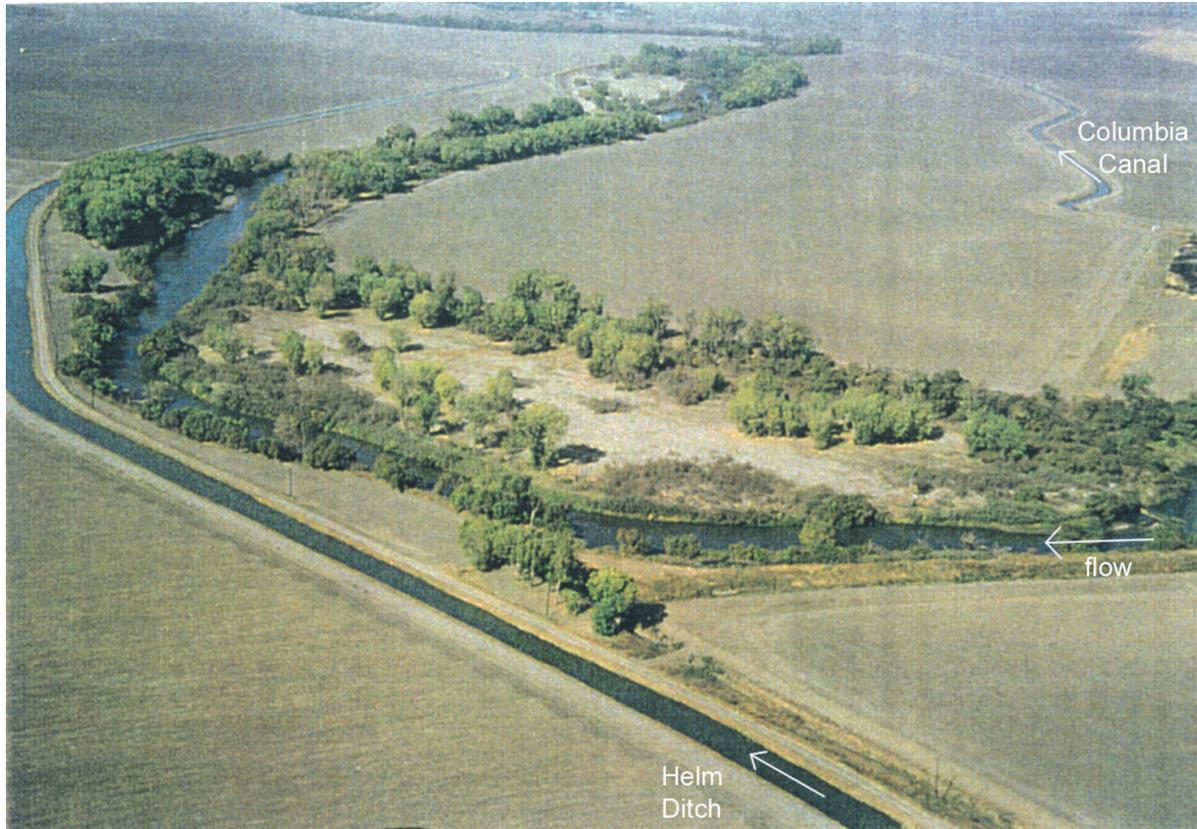
Figure 3-40. View looking downstream of the San Joaquin River at RM 200. The Columbia Canal is located on the right bank and the Helm Ditch is located on the left bank (looking downstream). The area between the river and the Helm Ditch is part of the historical floodplain of the river that has been isolated by a local levee. The Helm Ditch is situated on the margin of a terrace with about 8 feet of relief. From JSA and MEI (1998).

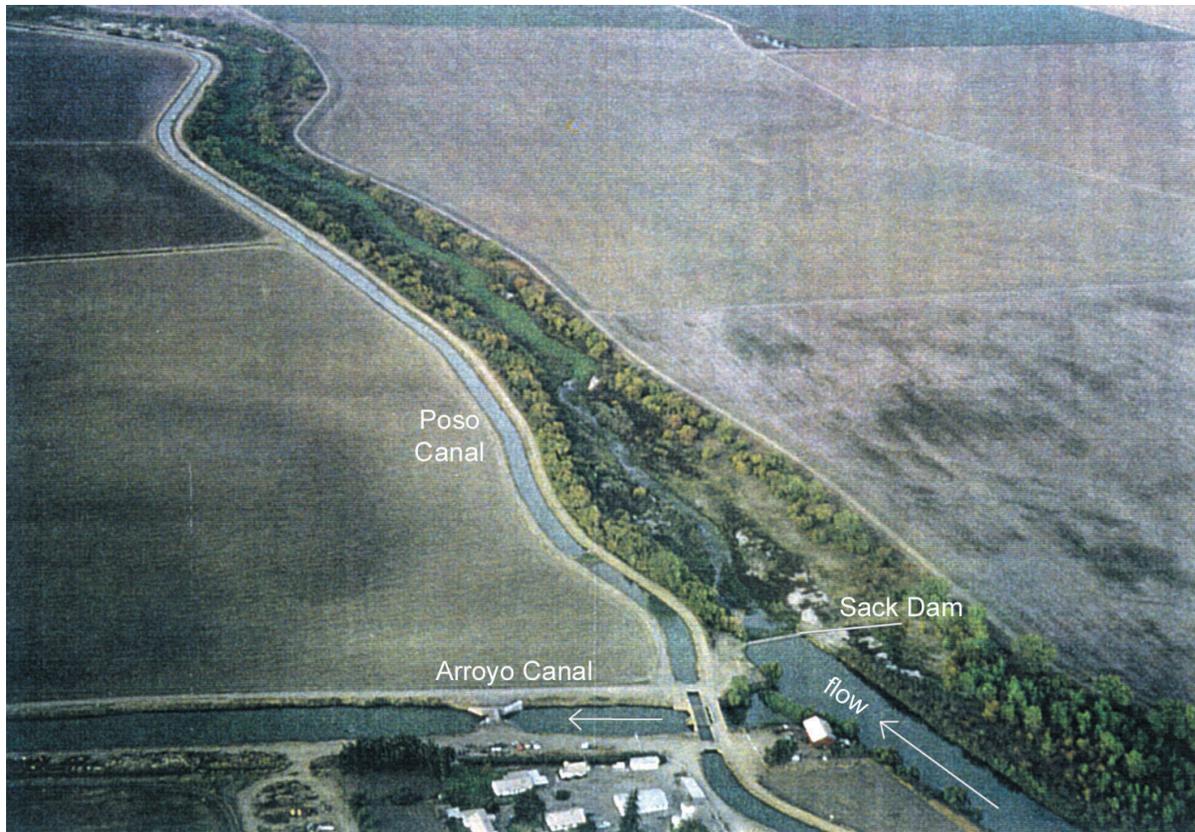
Figure 3-41. View looking downstream of Sack Dam and the headgates for the Arroyo Canal at RM 182. The dam is the terminus for Delta-Mendota water conveyed down the San Joaquin River. The Poso Canal parallels the river on the left bank. From JSA and MEI (1998).

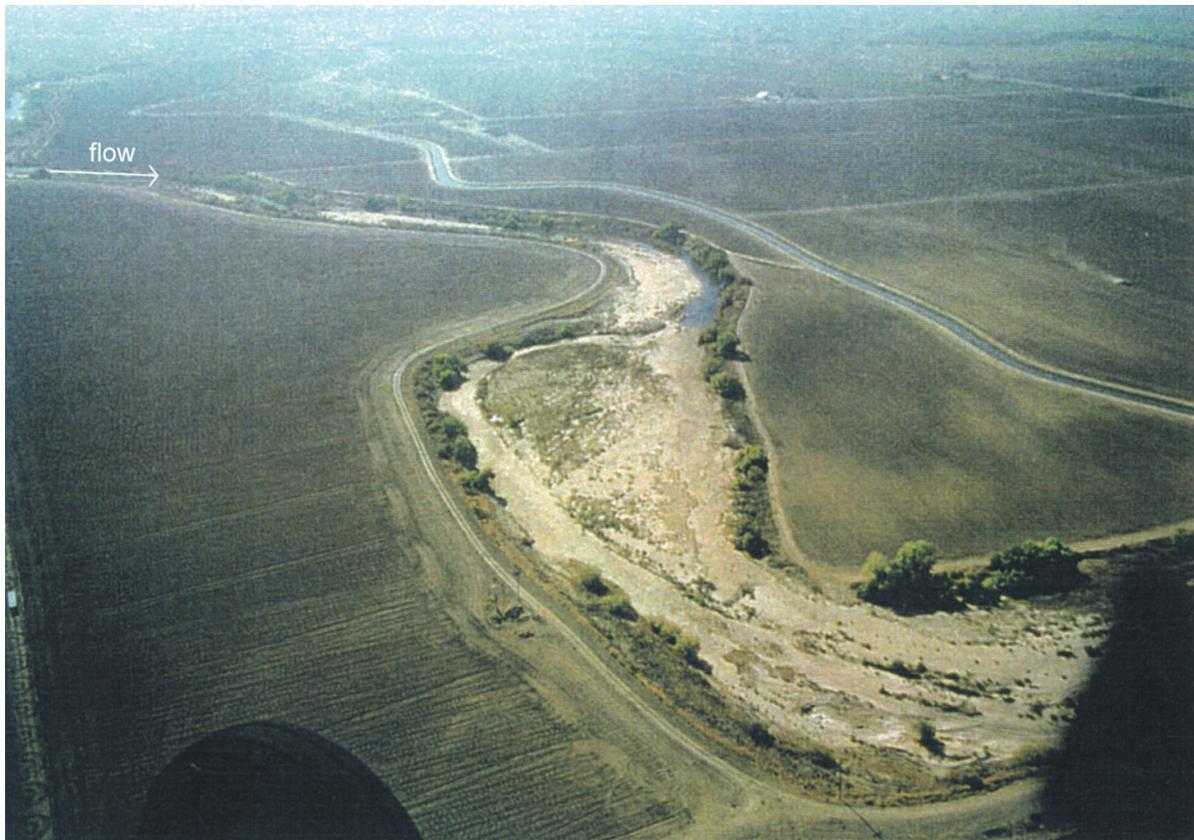
Figure 3-49. View looking upstream at sediment deposition in the bed of the San Joaquin River at about RM 175. Much of the sand appears to be derived from bank erosion. The within-levee capacity in this reach of the river is about 4,500 cfs. From JSA and MEI (1998).

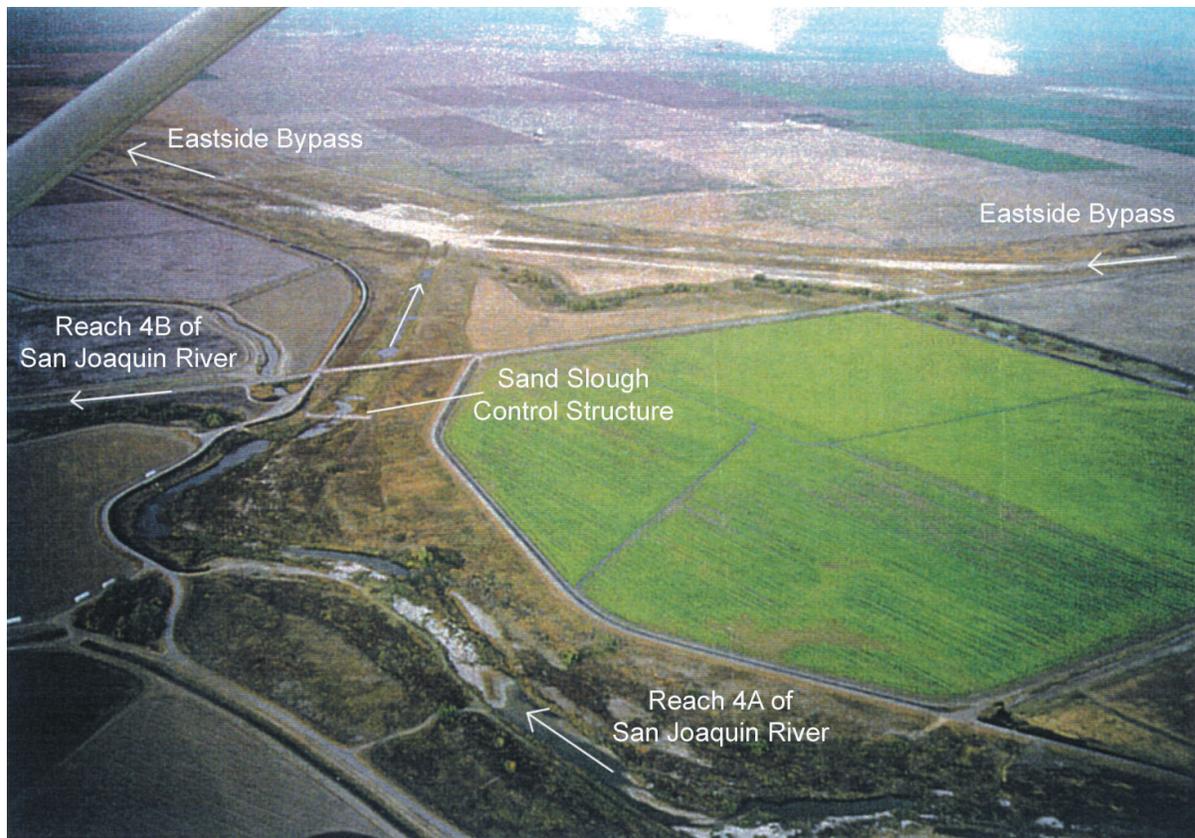
Figure 3-50. View looking downstream at the Sand Slough control structure reach of the San Joaquin River at RM 168. The San Joaquin River upstream of the structures bifurcates into San Joaquin River (left channel, well vegetated banks), Sand Slough (center channel, unvegetated banks), and the Eastside Bypass. Note sediment deposit deposition in the bypass channel. Design capacity of the bypass channel is about 16,500 cfs. From JSA and MEI (1998).

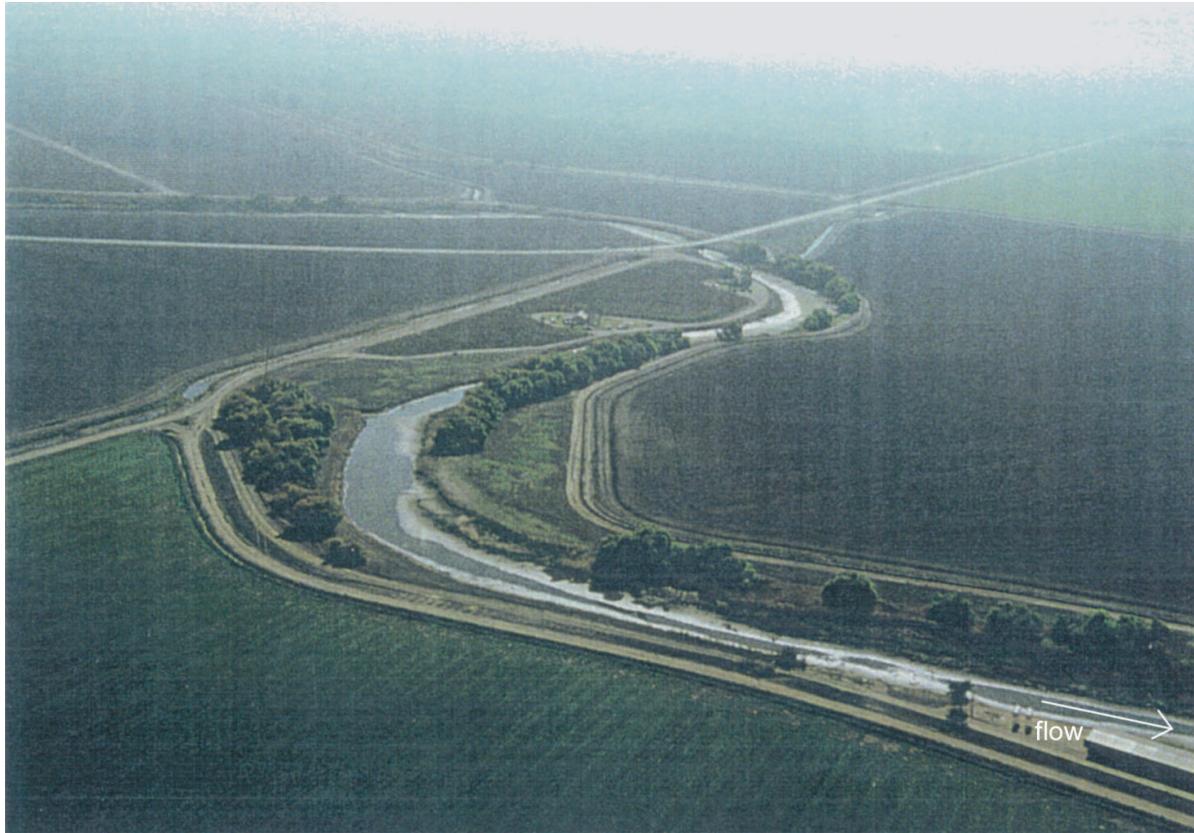
Figure 3-51. View looking upstream at the San Joaquin River at Turner Island Road crossing, RM 157. Design capacity of the channel and levees is about 1,500 cfs; however, actual capacity in many portions of this reach is much less. From JSA and MEI (1998).

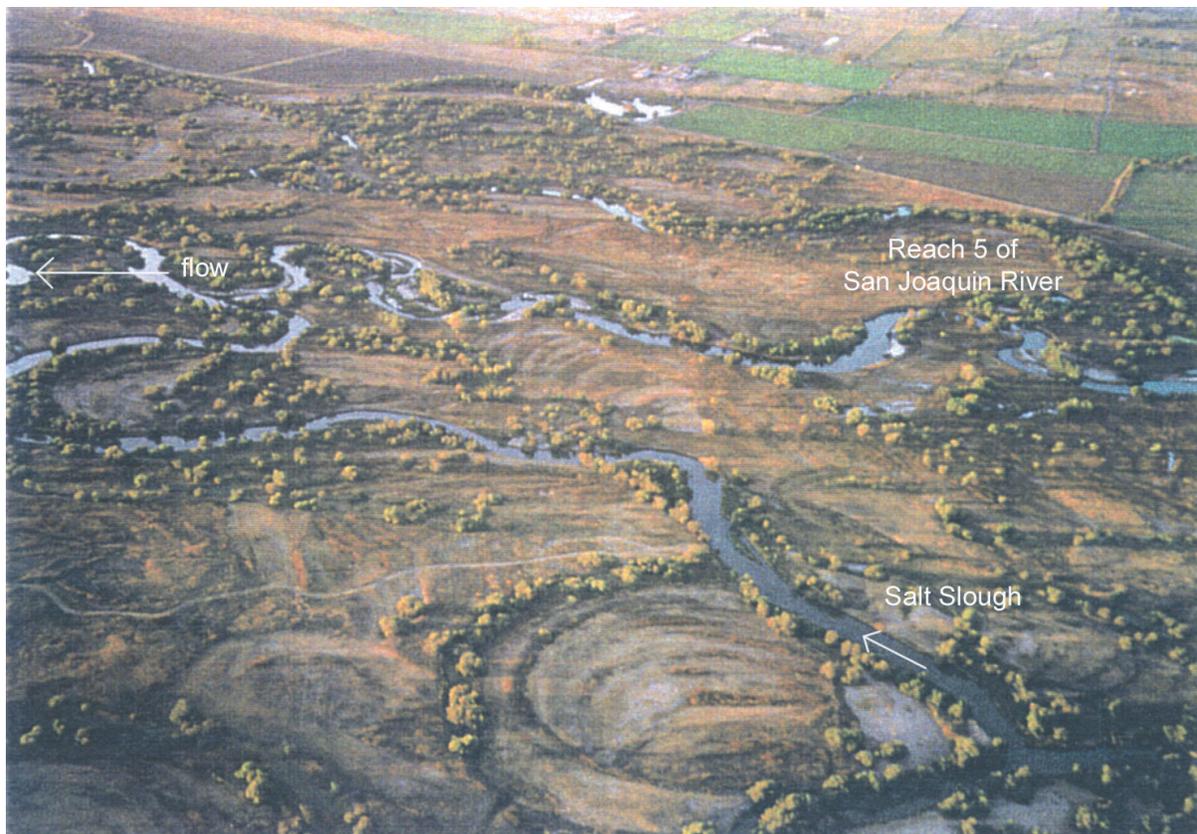
Figure 3-55. View looking downstream at confluence of Salt Slough (left channel) and San Joaquin River at RM 127.7. Note the multiple anabranch channels(sloughs)and the meander scroll topography on the floodplain. From JSA and MEI (1998).
