## 2010 Annual Technical Report

**SAN JOAQUIN RIVER**  
RESTORATION PROGRAM

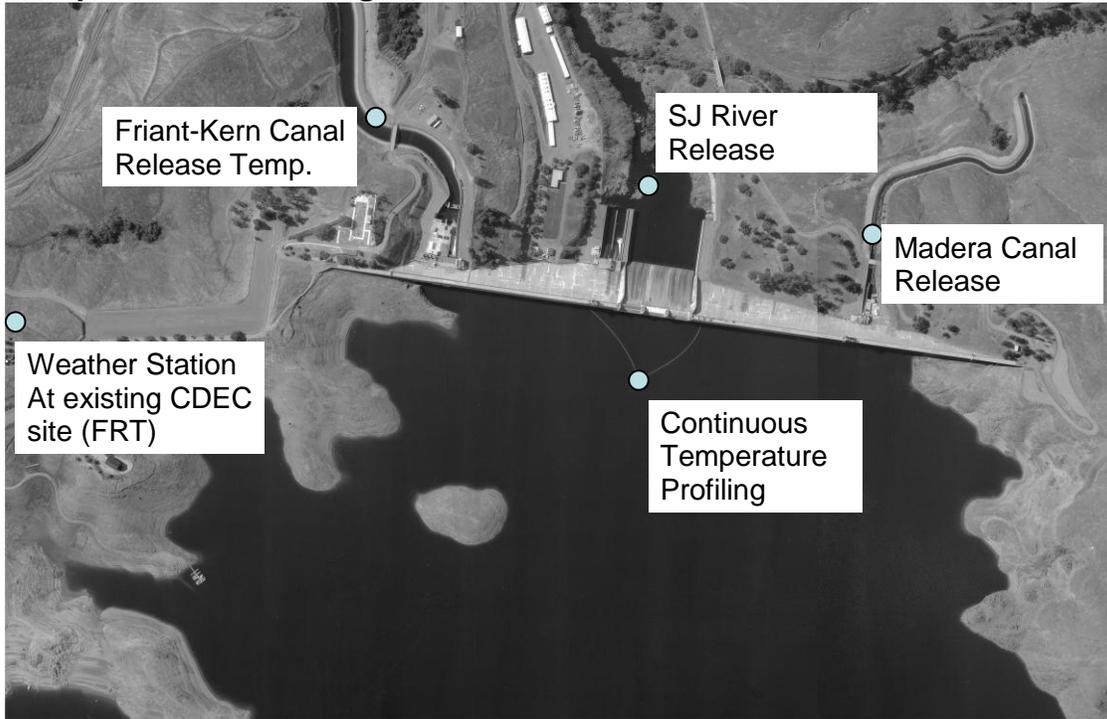
**Figure B-1**  
**Temperature Monitoring and Weather Station Locations near Friant Dam**

Sites not shown: Kerckoff Powerplant and Fish Hatchery Release Temperatures

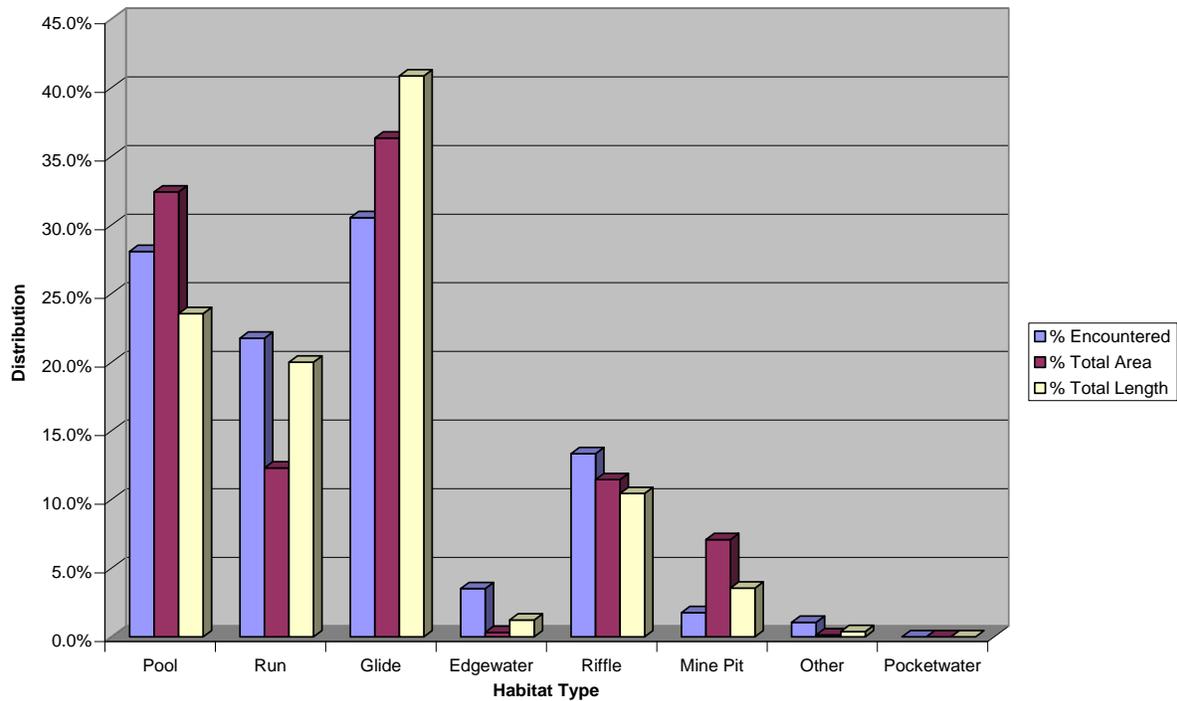
**Figure B-9: Distribution of Habitat Types in Reach 2**

In Reach 2, 285 distinct habitat units were identified. Glides were again the most dominant habitat type (30.5%), and consumed most (36.3%) of the area of the river that was surveyed (see **Table B-5** and **Figure B-9** for HU distribution details).

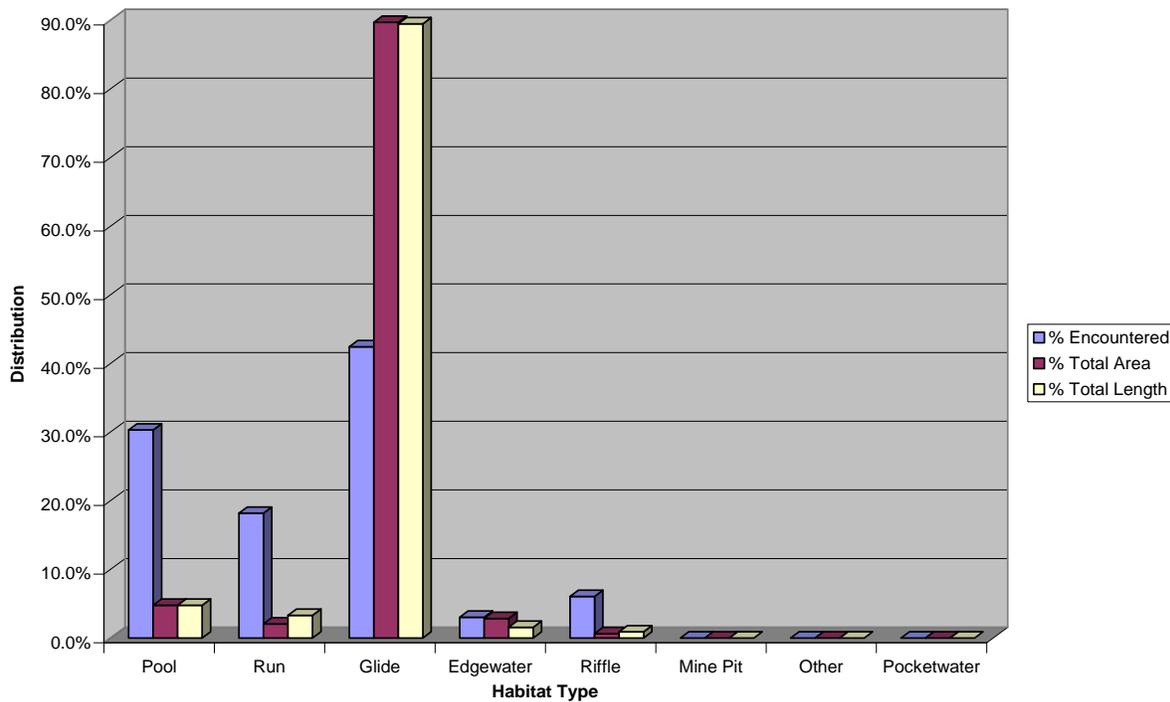
**Figure B-10: Distribution of Habitat Types in Reach 4A**

Reach 4A consisted of 33 distinct habitat units were encountered with glides being the most abundant habitat type (42.4%) consuming (89.7%) of the area of the river that was surveyed (see **Table B-6** and **Figure B-10** for HU distribution details).

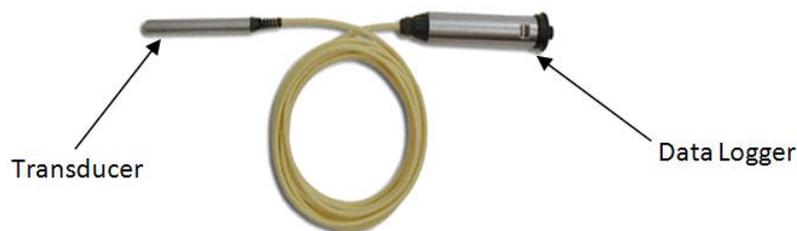
**Figure B-11. Water level recorder**

As shown in **Figure B-11**, this particular type of recorder, Global Water-WL16U, is an integrated unit consisting of a submersible transducer (pressure sensor) connected to the data logger with a standard 25-foot cable (longer cable lengths are available). The pressure transducer unit was installed in the channel bed and the data logger was installed at the shore to provide easy access to download the data. Refer to the 2009 ATR for more detailed information about installation methods.

The data from the recorders will be downloaded periodically at sufficient frequency to insure that storage capacity of individual data loggers is not exceeded. These water stage readings were used to compute WSE. As shown in **Figure** , the transducer was installed at the center of the 2-inch diameter PVC pipes anchored on the channel bed. The WSE was calculated by adding stage reading to the respective top of pipe elevation, which was surveyed using a total station, and subtracting a half of the outside diameter of the pipe.

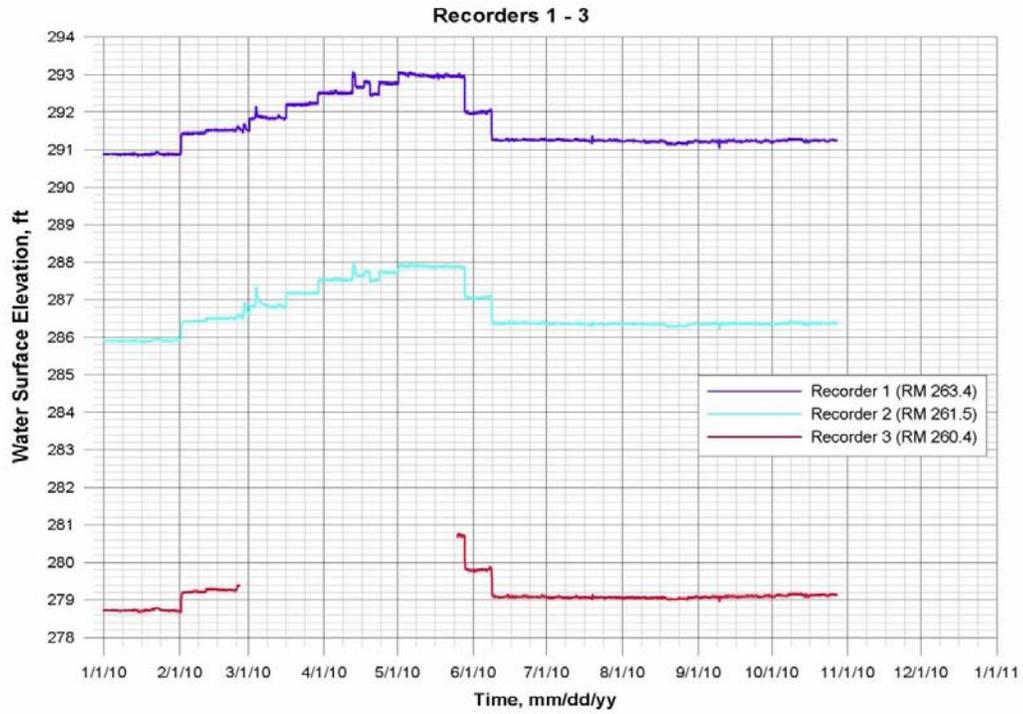
**Figure B-13. Recorders 1, 2, & 3 elevation data**

According to **Figure** through **Figure** , a discontinuity can be observed in the data from Recorders 3 and 4. During the data down load on May 25, 2010, it was observed that the Recorder 4 stopped functioning from March 3, 2010 because of unexpected battery exhaustion. In addition, Recorder 3 was found off-line and the data logger storage was empty. The actual reason for this loss of data has not been determined. These recorders were brought back on-line on May 25, 2010 with new batteries. Batteries for other recorders were also replaced with new ones and it was made sure that all the recorders were functioning well.

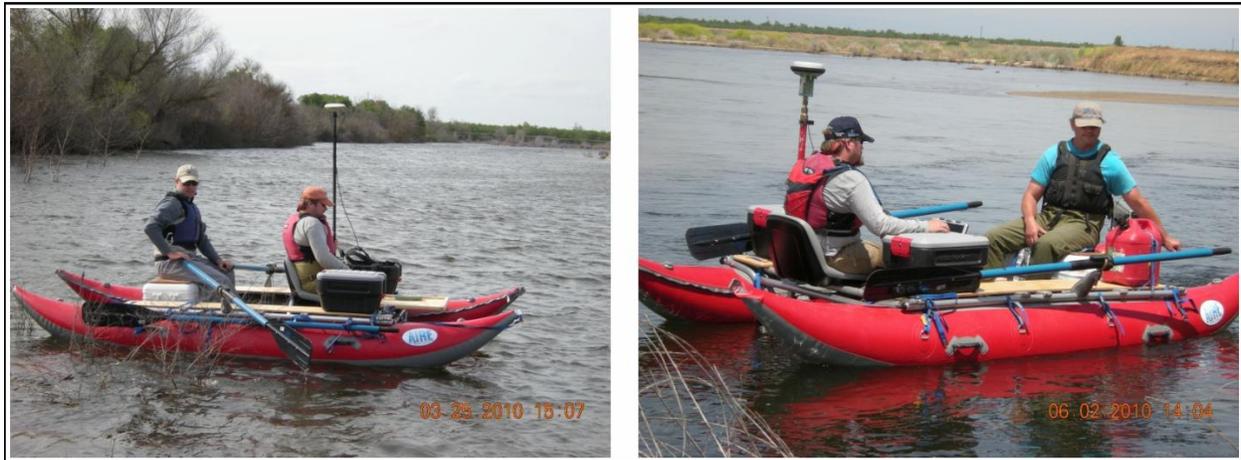
**Figure B-17. Cataraft equipped with echo-sounder and survey-grade GPS rover**

Multiple cross sections were surveyed by navigating the cataraft across the channel at the close vicinity of the selected monitoring cross-section at each site. Longitudinal profiles were surveyed by navigating in zigzag path from upstream to downstream of the selected cross-section. The travelling paths were kept consistent as much as possible at each set of survey. The xyz data was then converted to station elevation data using Microsoft Excel. Thalweg (a line connecting minimum elevation points) profiles were determined from the channel bed surveys and stationed on the Tetra Tech 2009 hydraulic model station line.

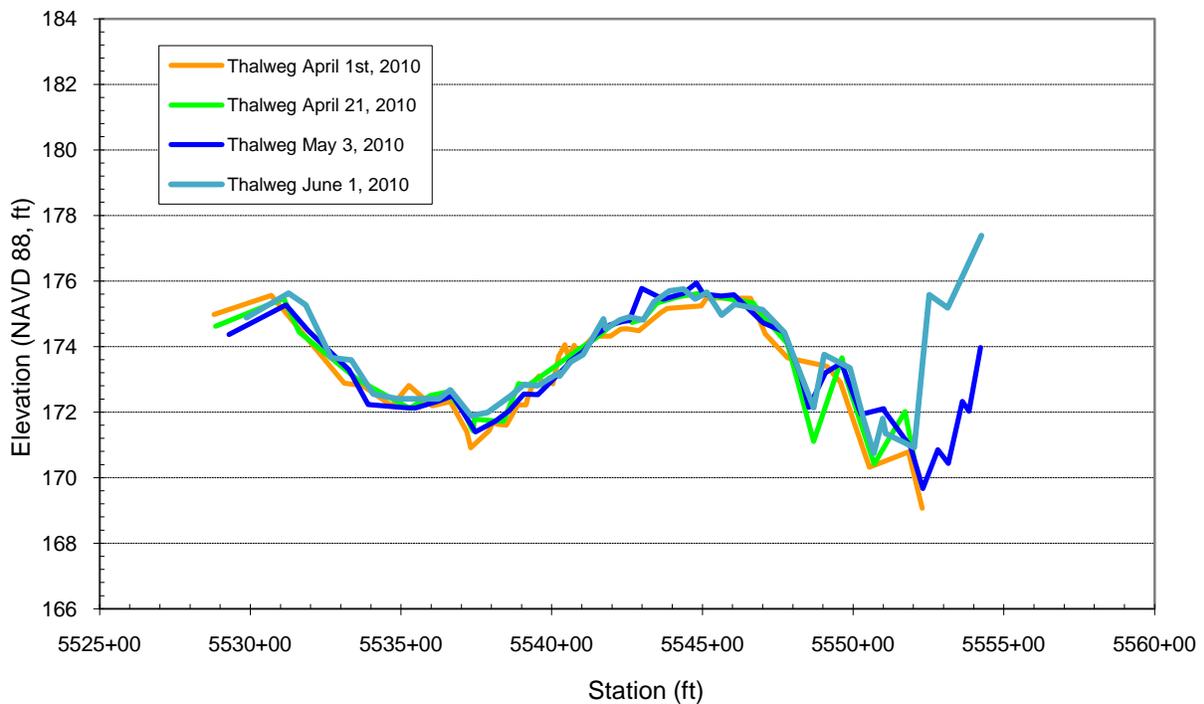
**Figure B-18. Profile view of the thalweg during the spring 2010 bathymetric surveys at M6.5**

General scour was not observed over the range of surveyed flows (600cfs to 1,250cfs). Local man-made influences at Sites M6.5 and M10 make it very difficult to measure general scour at these locations. If appropriate, based on more detailed analysis of the data, future data collection at these sites will most likely focus only on flow events exceeding 2,000cfs. The location of the sites should be re-evaluated prior to future monitoring activities to determine whether the sites should be shifted to locations where there is less influence from local man-made features.

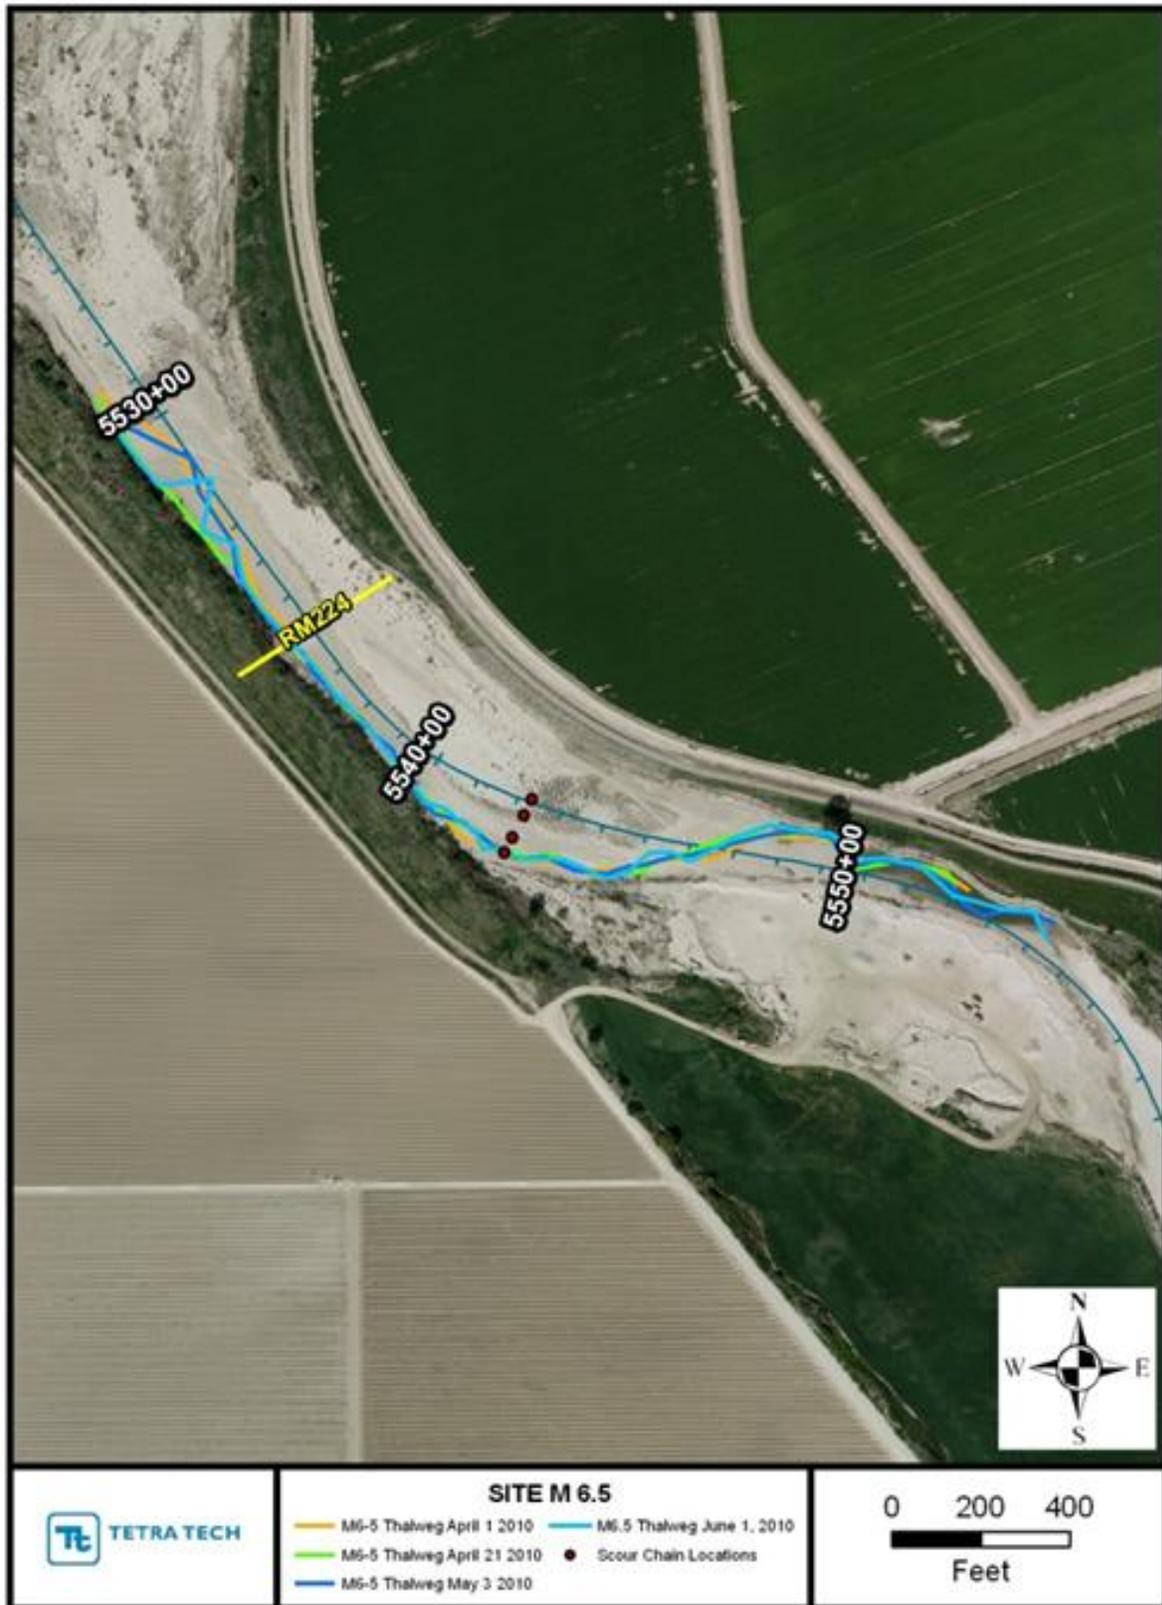
**Figure B-19. Plan view showing the location of the thalweg during the spring 2010 bathymetric surveys at M6.5**

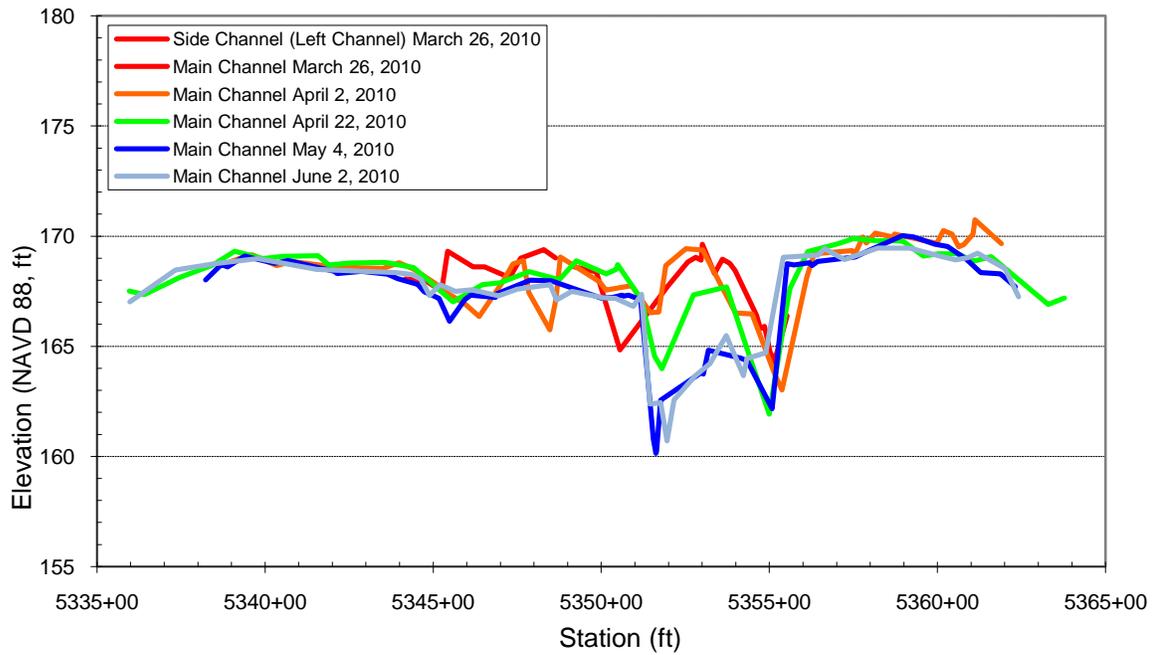
**Figure B-20. Profile view of the thalweg during the spring 2010 bathymetric surveys at M10**

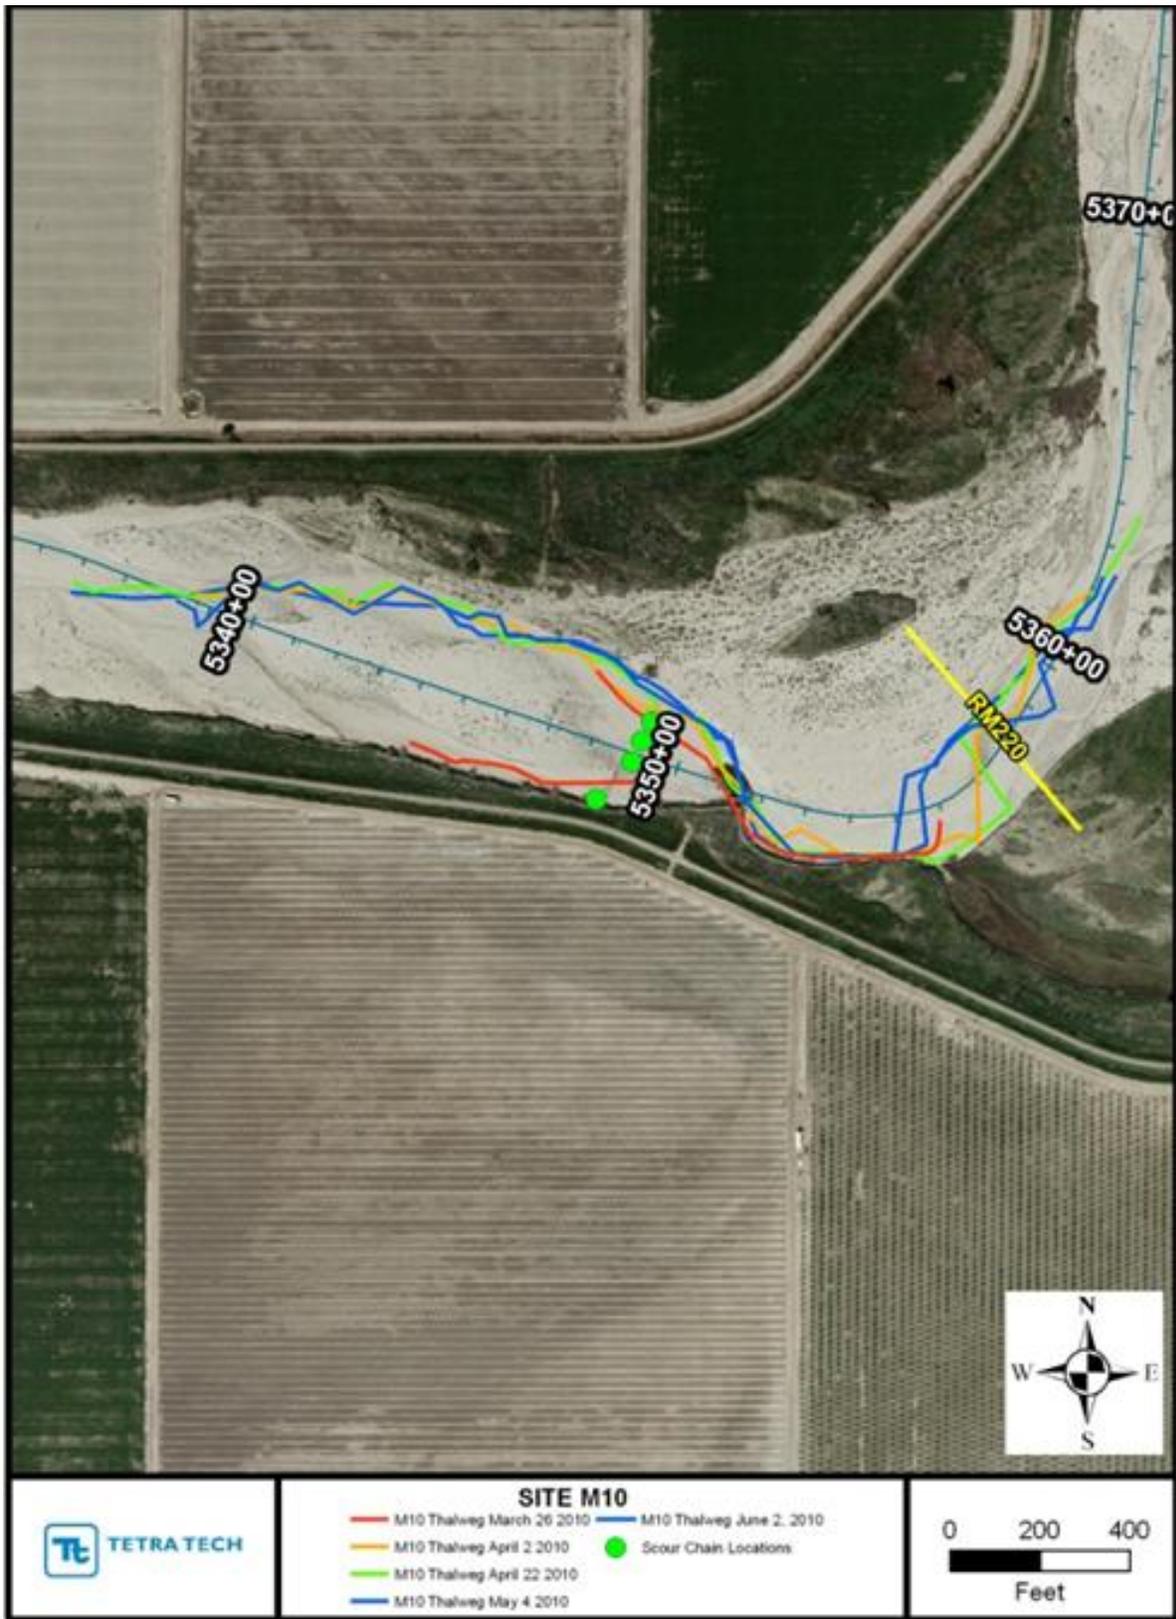
Figure B-21. Plan view showing the location of the thalweg during the spring 2010 bathymetric surveys at M10

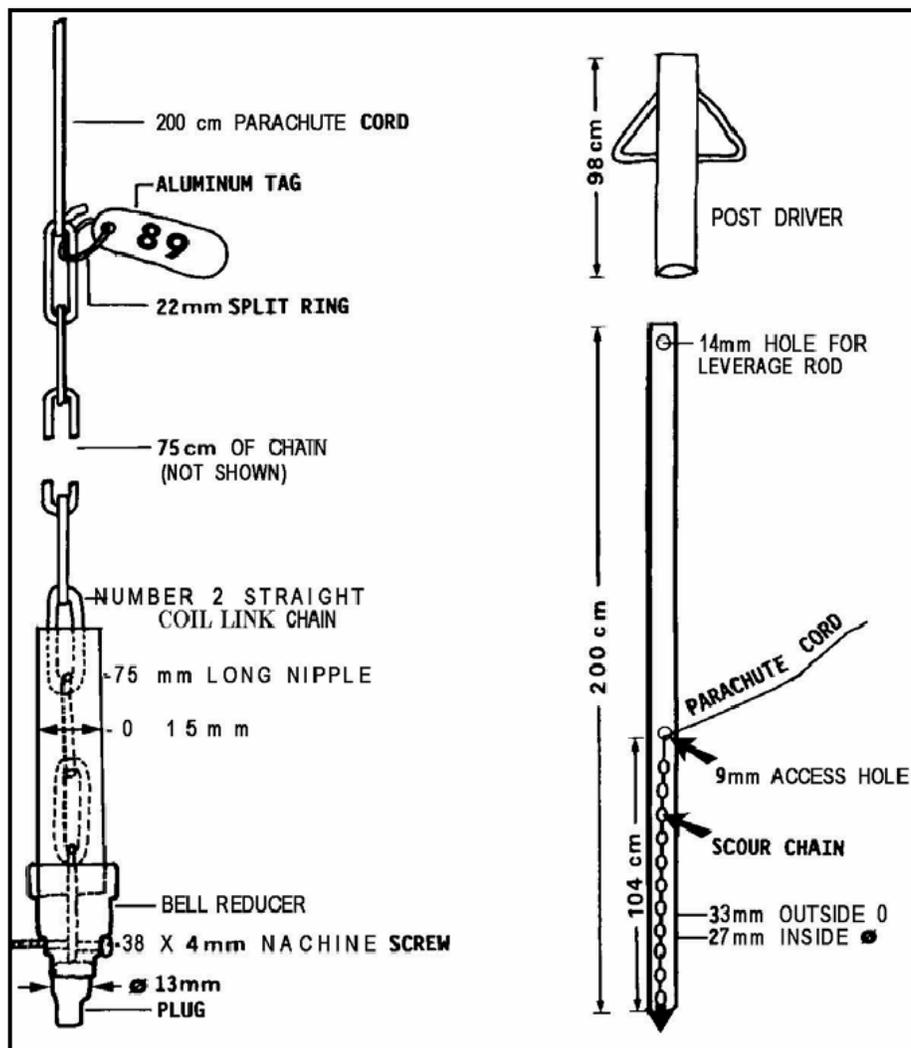
An approximately 2-foot deep hole was dug before the pipe was driven into the ground. Then the pipe with the chain inside was pounded into the ground with a post driver keeping the free end of the chain inside the notch made at the edge of the pipe to prevent the chain from possible damage while pounding. The pipe was then pulled out, leaving the chain buried in the ground. The sand that was removed from the hole was then shoveled back into place to bring the surface back as close to original conditions as possible. The length of the excess chain above ground was measured to determine the length of the chain below the surface. Photos showing the process of installing the chains are shown in the 2009 ATR.

**Figure B-22. Schematic showing the chain and pipe assembly**

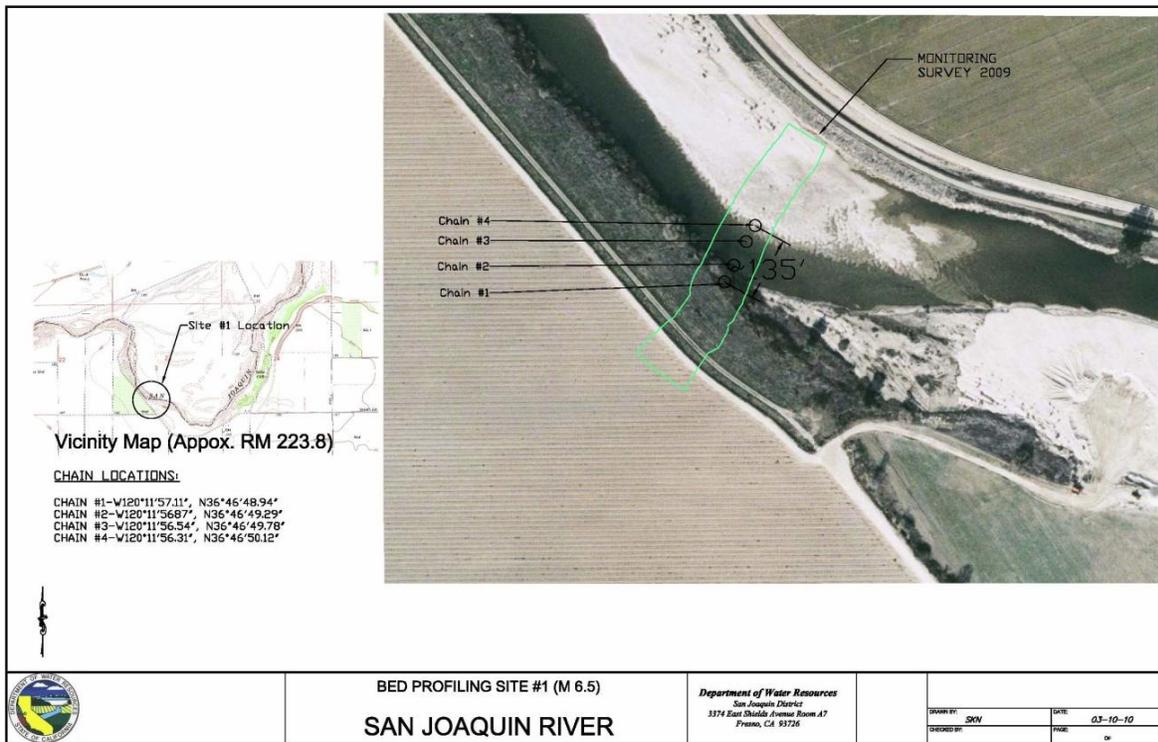
**Figure B-24. Location of scour chains at site M6.5 in Reach 2A**

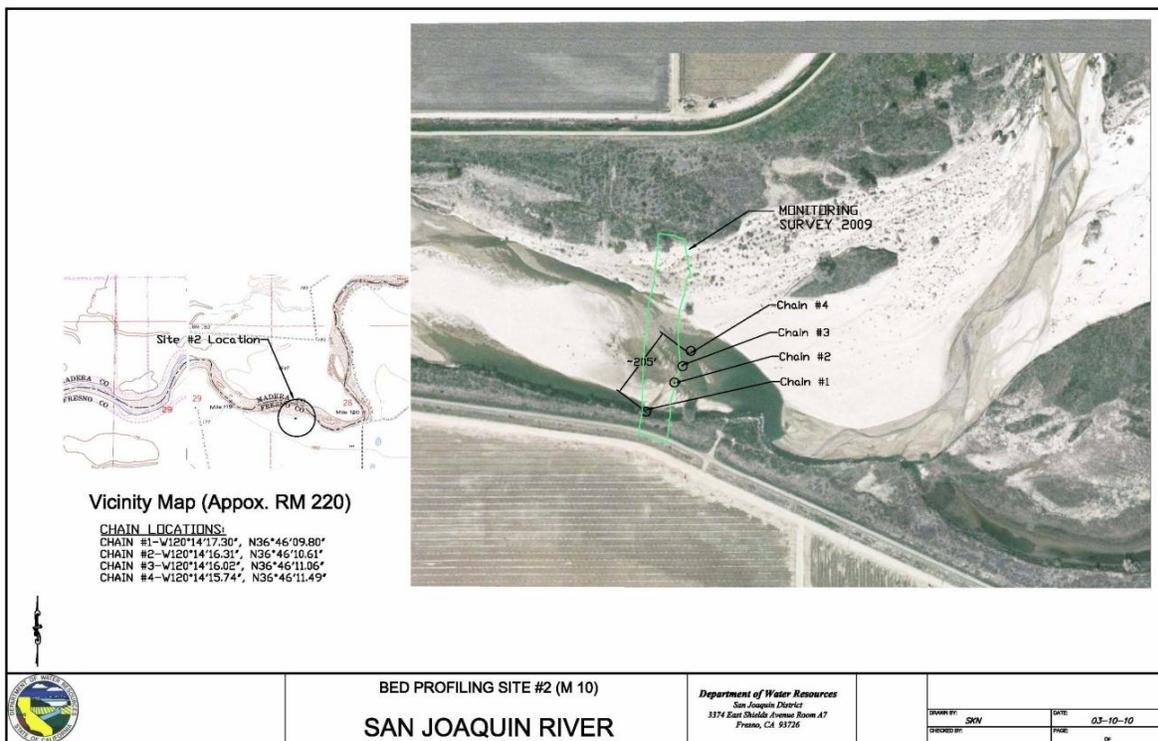
**Figure B-25. Location of scour chains at site M10 in Reach 2A**

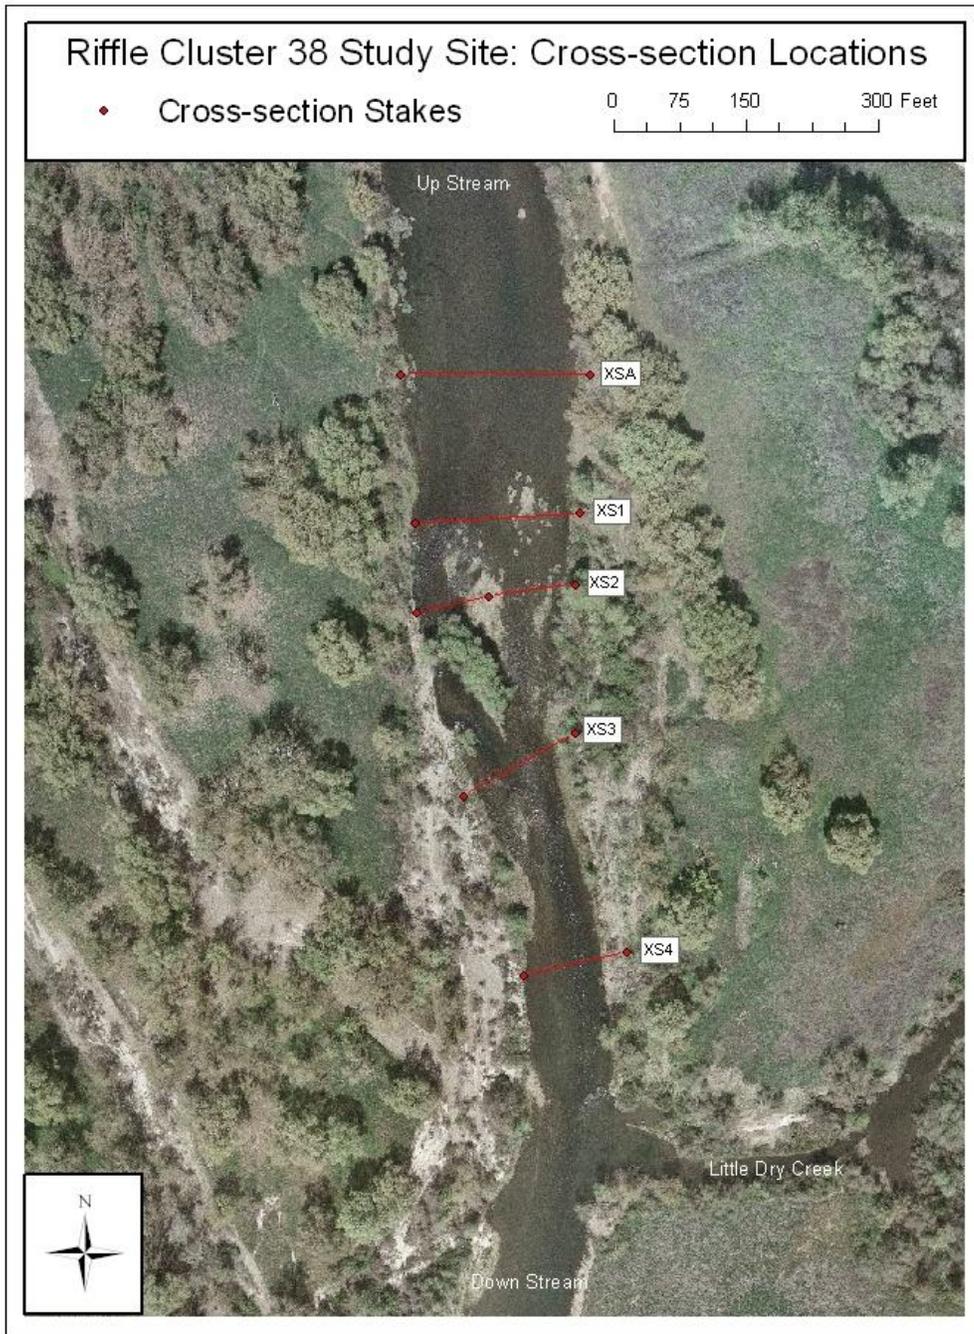
**Figure B-28:** Map showing Riffle Cluster 38 study site’s staked cross-sections XSA, XS1, XS2, XS3, and XS4.

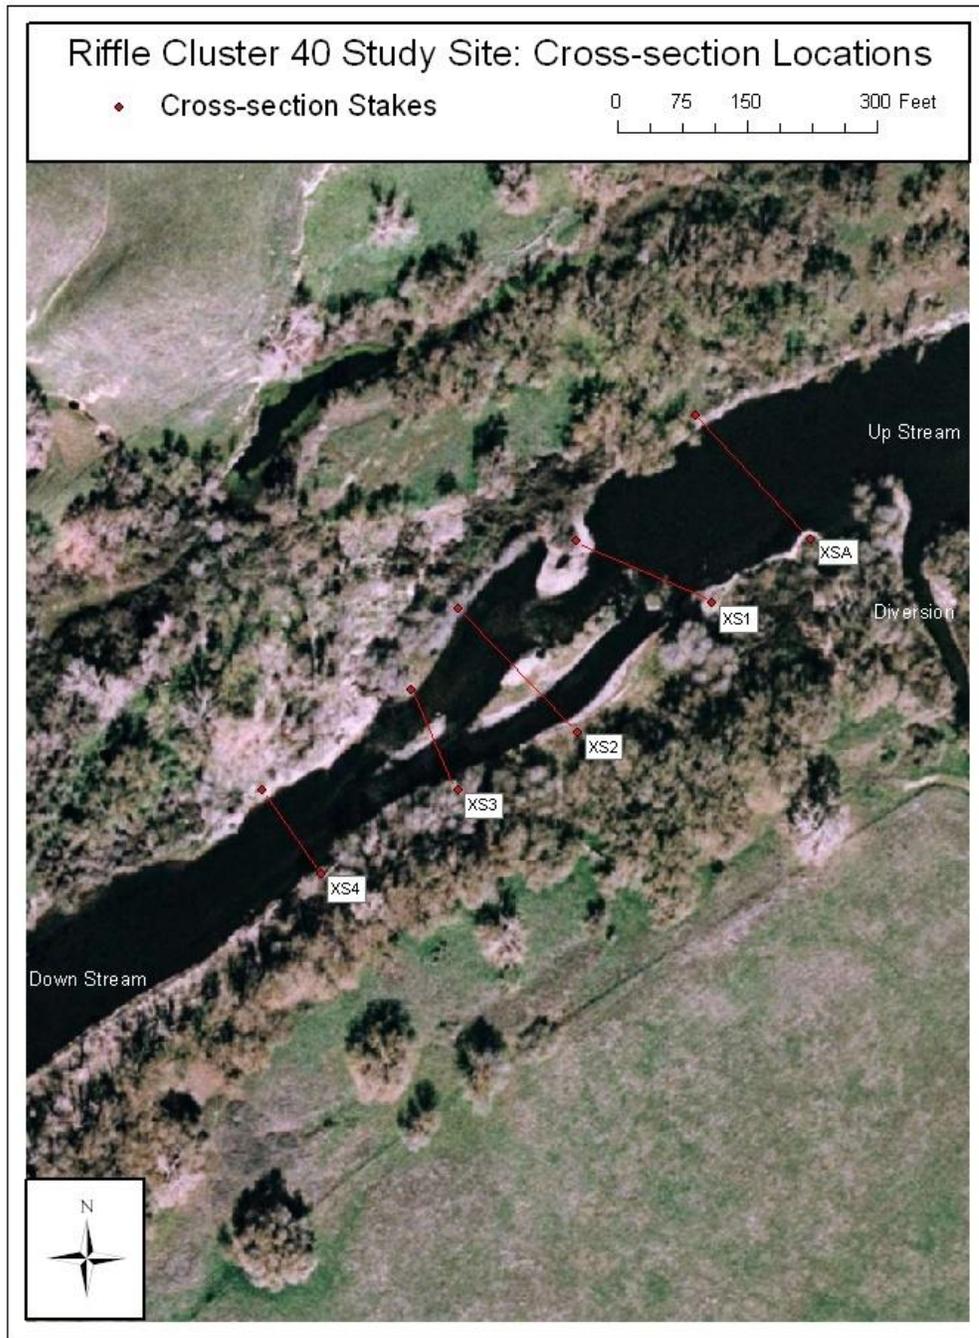
**Figure B-29:** Map showing Riffle Cluster 40 study site’s staked cross-sections XSA, XS1, XS2, XS3, and XS4.

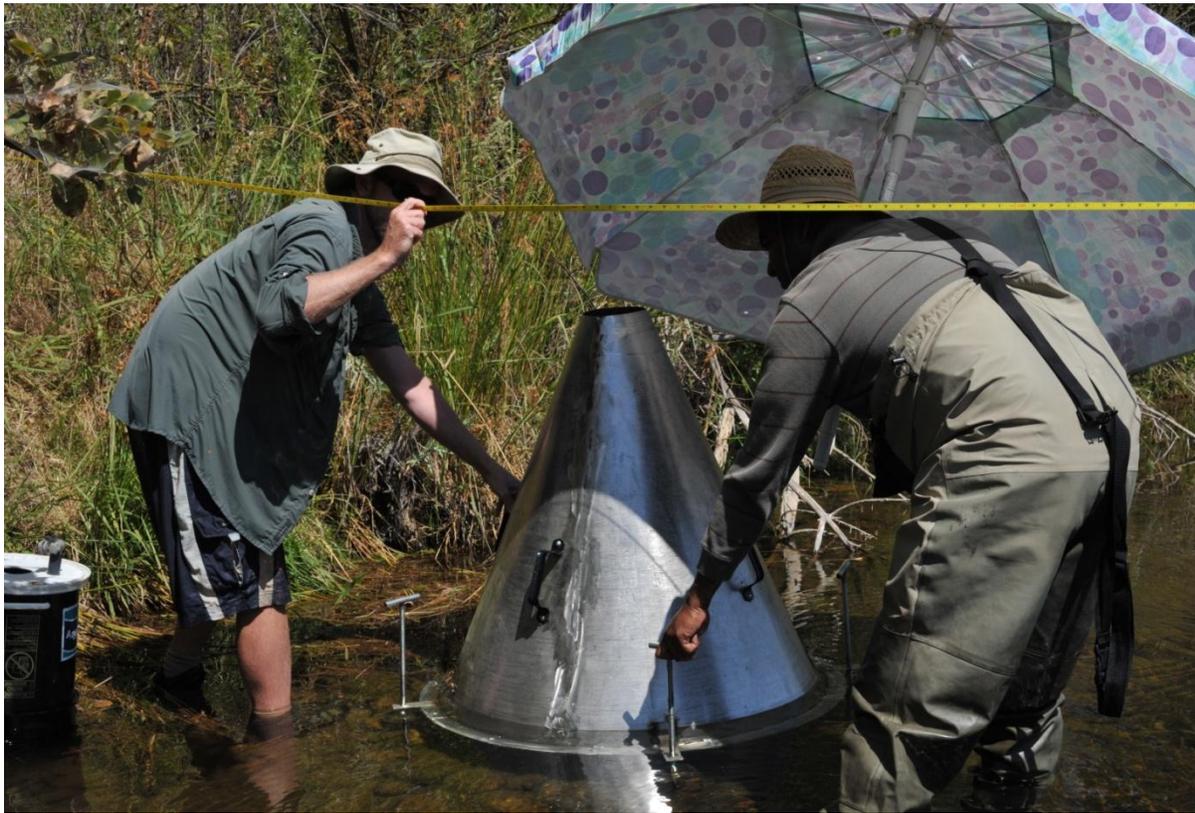
**Figure B-30: Bed photography surveying using the photocone device.** The yellow stretched tape is used to note each photograph's position along the cross-section. The umbrella is used to block light from entering both around the edges of the cone as well as into the hole behind the camera. Two people are needed to carry and hold the photocone in position while the third person takes photographs and records notes. Note the size of the photocone relative to the viewing bucket shown in the lower left corner of this figure.

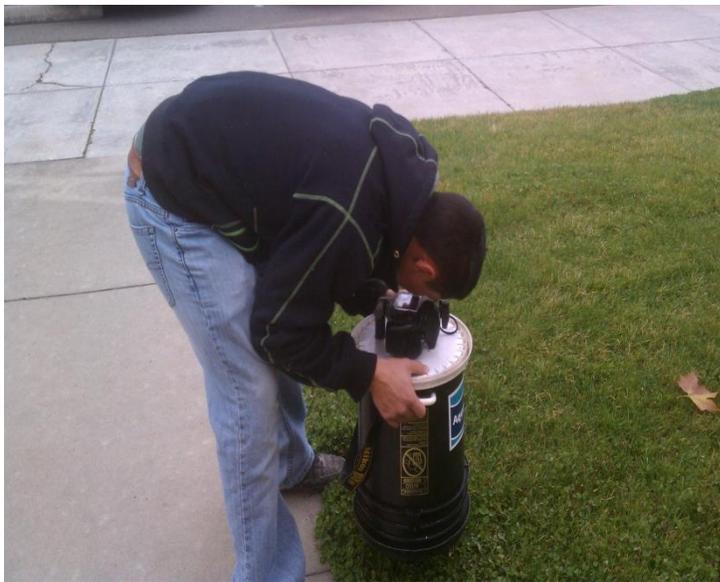
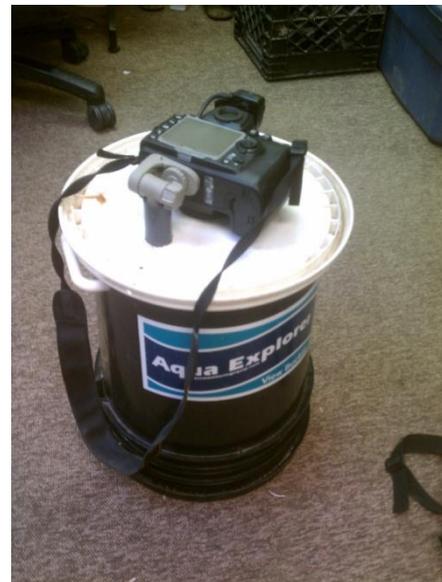
**Figure B-31: The viewing bucket photographing device.** The bottom of the viewing bucket is made of plexiglass, while the top lid has a circular hole the same size as the camera's lens thereby preventing light from entering the bucket from around the lens and producing a glare. The camera is fitted to a bracket on the bucket's lid (right photo) for ease of photographing (left photo) while in difficult flow conditions.

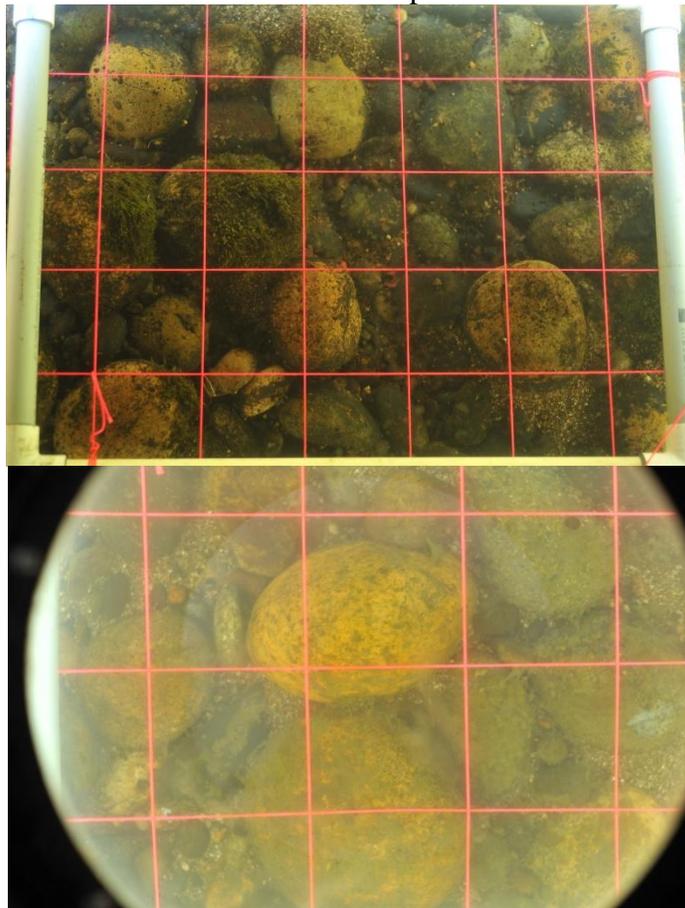
**Figure B-32: Bed photographs taken from the photocone (above) and viewing bucket (below).**

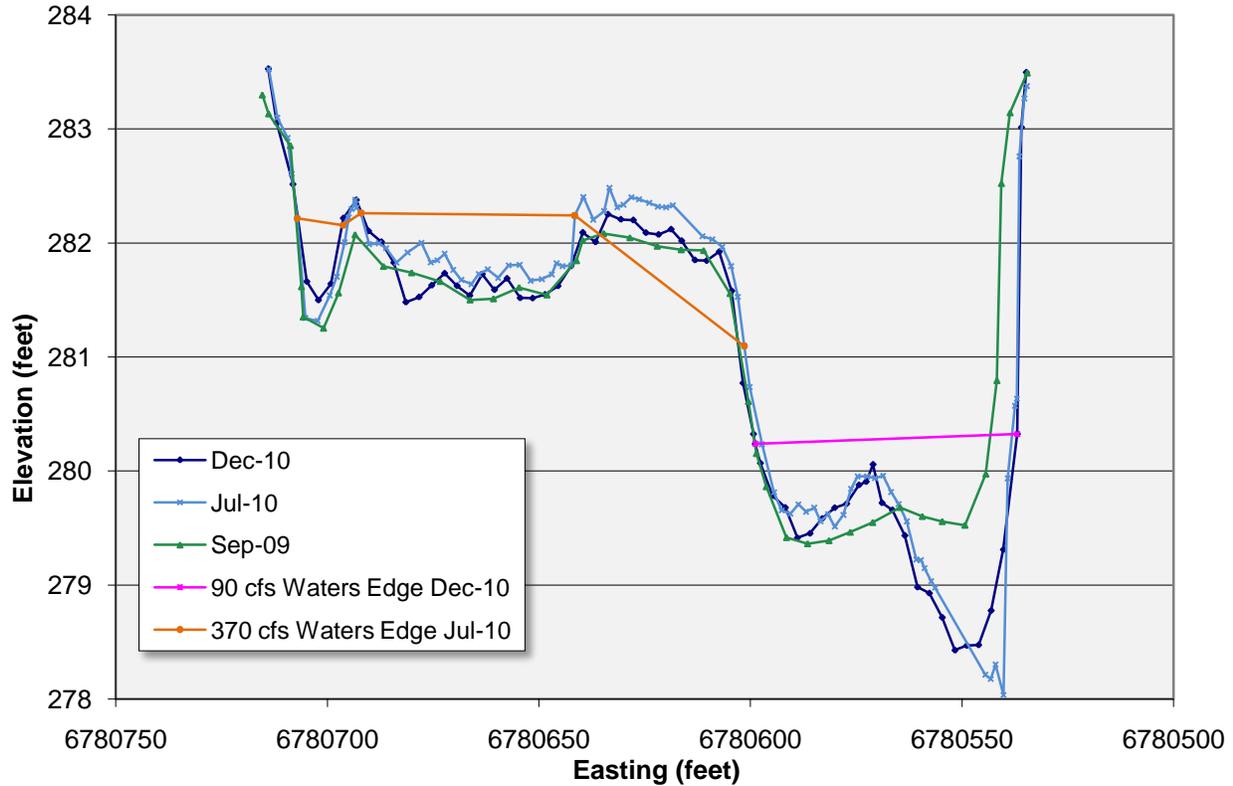
**Figure B-35. SJR RC38 XS2, ReTopo Surveys**

**Figure B-35: Bed elevation change illustrated from 3 topographic surveys of Riffle Cluster 38's XS2 from September 2009 through December 2010.** The low flow channel and thalweg are seen from 6780600 to about 6780560 ft and display the most dynamic response with up to 0.5 ft of net deposition, up to 1.5 ft of net scour, and 6 ft of bank retreat by July 2010. Bed elevation change on the bar, between 6780700 and 6780600 ft, is attributed to building and removal of debris piles.

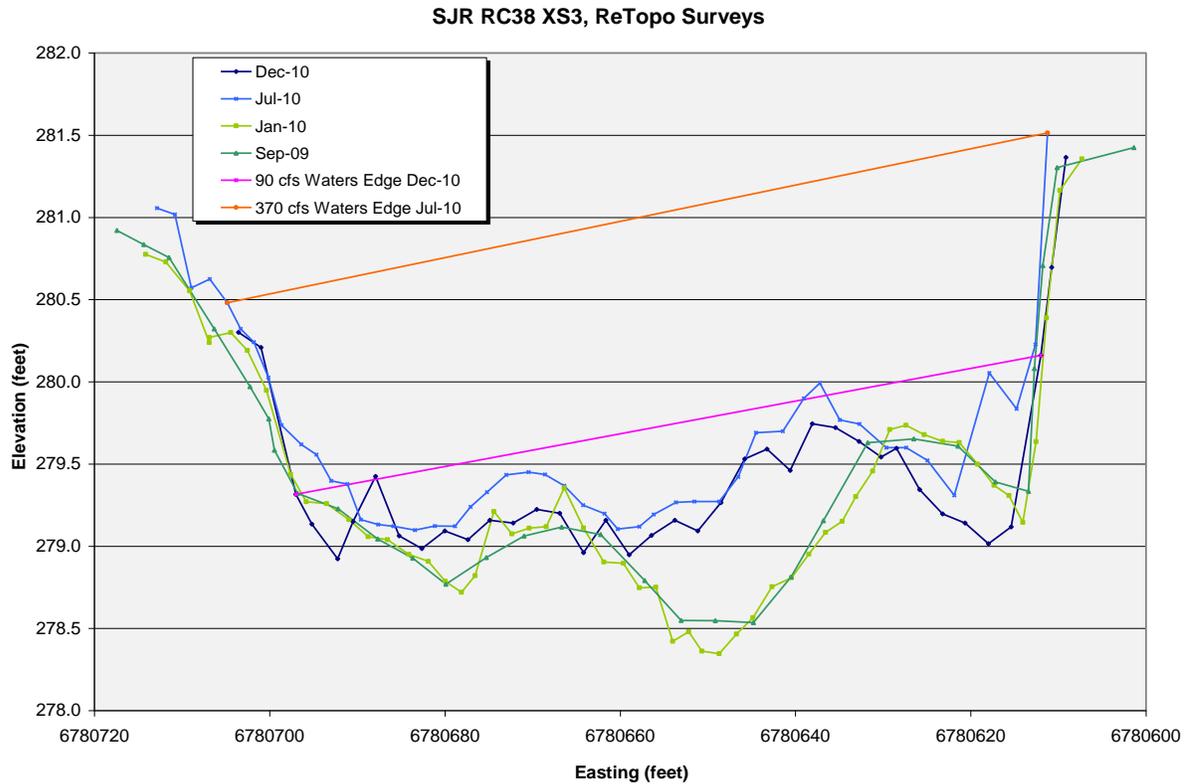
**Figure B-36: Bed elevation change illustrated from 4 topographic surveys of Riffle Cluster 38's XS3 from September 2009 through December 2010.** The thalweg is seen between 6780640 and 6780670 ft. This area displays the largest elevation change with up to 1 ft of net deposition after January 2010. This bed elevation change is associated with a large woody debris pile that was deposited approximately 10 to 40 ft upstream of XS3 between approximately 6780660 and 6780630 ft.

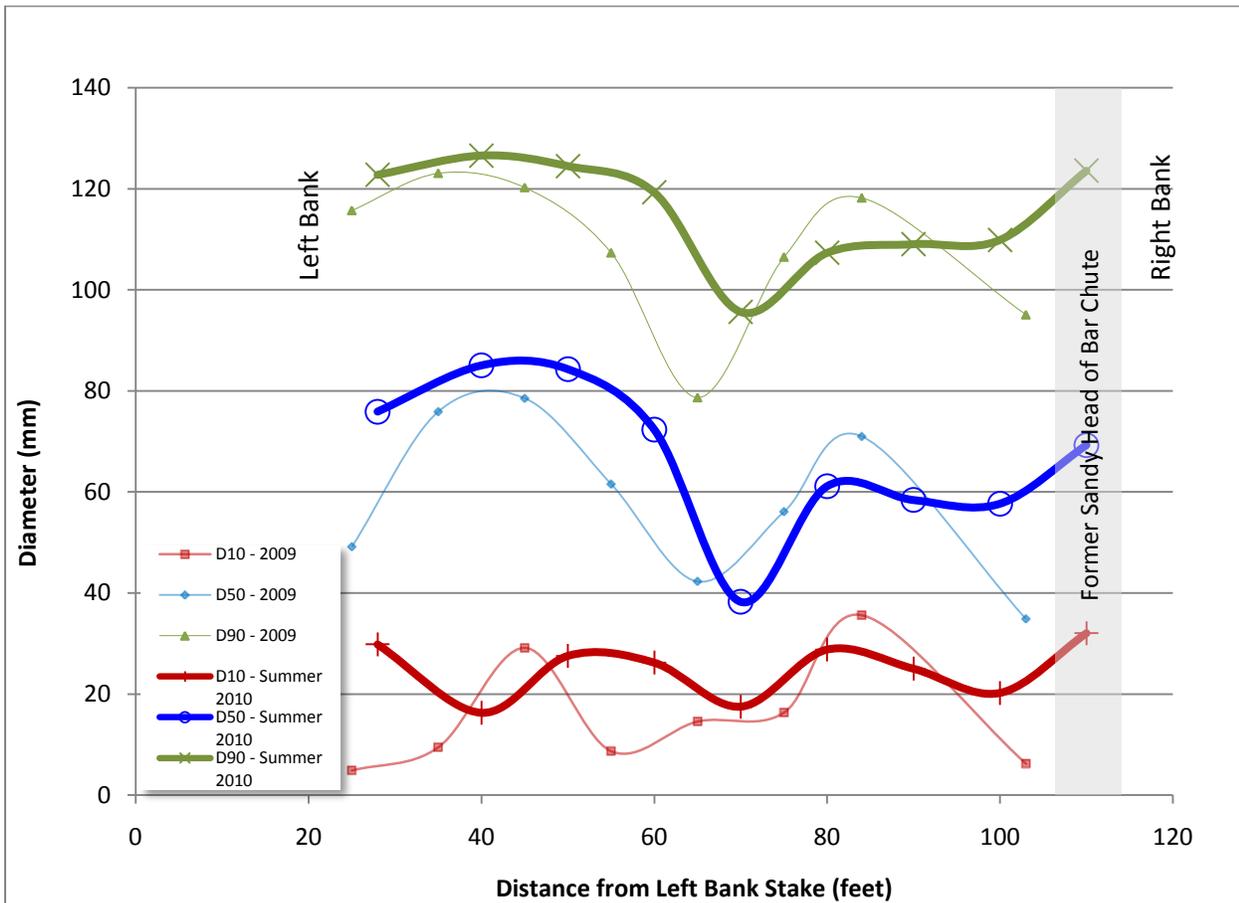
**Figure B-37: A comparison of pebble count results from RC38 XS3.** Thin lines show trends in sample statistics from the baseline Summer 2009 pebble counts. Thick lines show trends in follow-up Summer 2010 pebble counts. Symbol locations indicate the center of each pebble count sample, which were 10 ft wide. Note the change from a sandy margin to a coarser surface along the right bank.
