## 2010 Annual Technical Report

**SAN JOAQUIN RIVER**  
RESTORATION PROGRAM

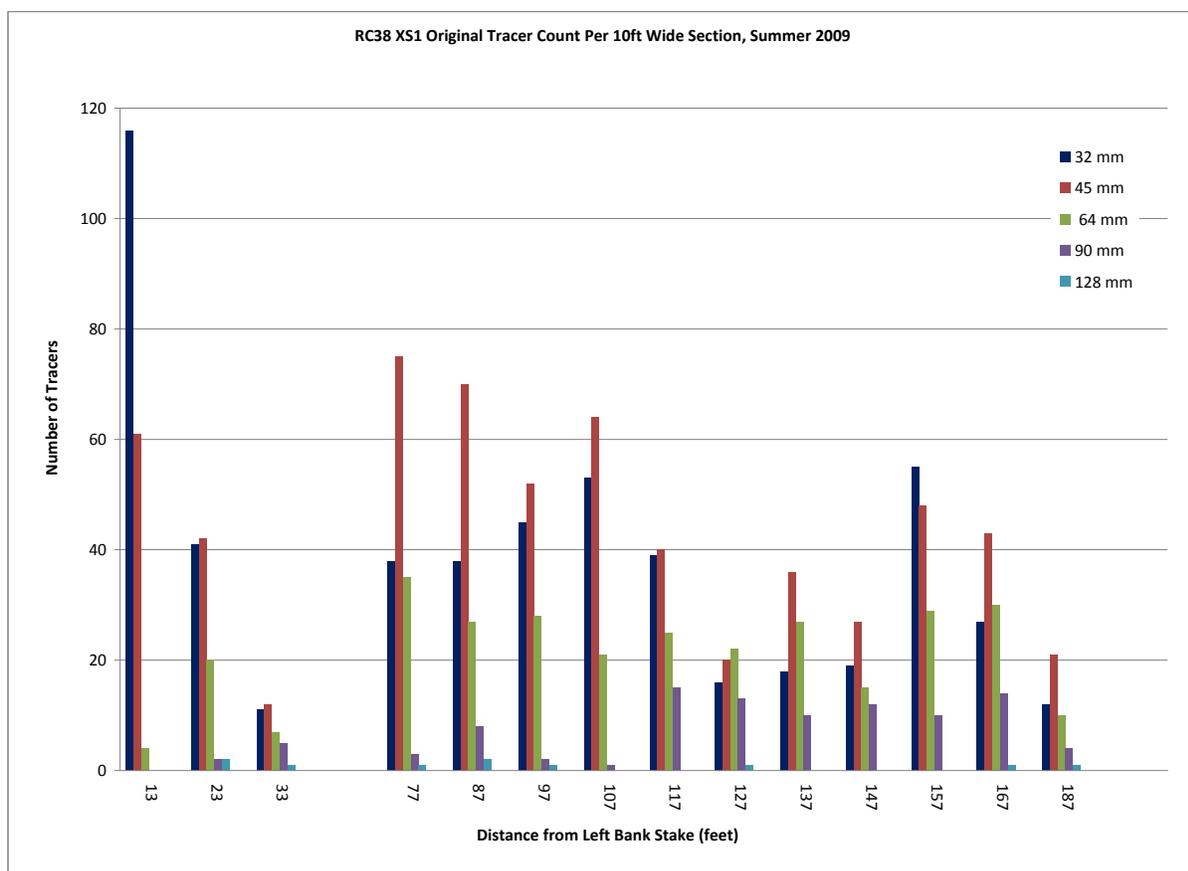
**Figure B-38: The number of tracers by size class placed along XS1 in ~10 ft sections.** The distance indicated along the horizontal axis indicates the midpoint of each section. The difference in the number of tracers in each 10 ft section is a reflection of the flow conditions. Higher flow conditions had fewer tracers due to attempts to reduce presence of personnel's disturbance of the bed. Relative proportion of each size class is a reflection of the change in bed texture along the cross-section. The gap from 38 to 72 ft is because of the presence of vegetation patches.

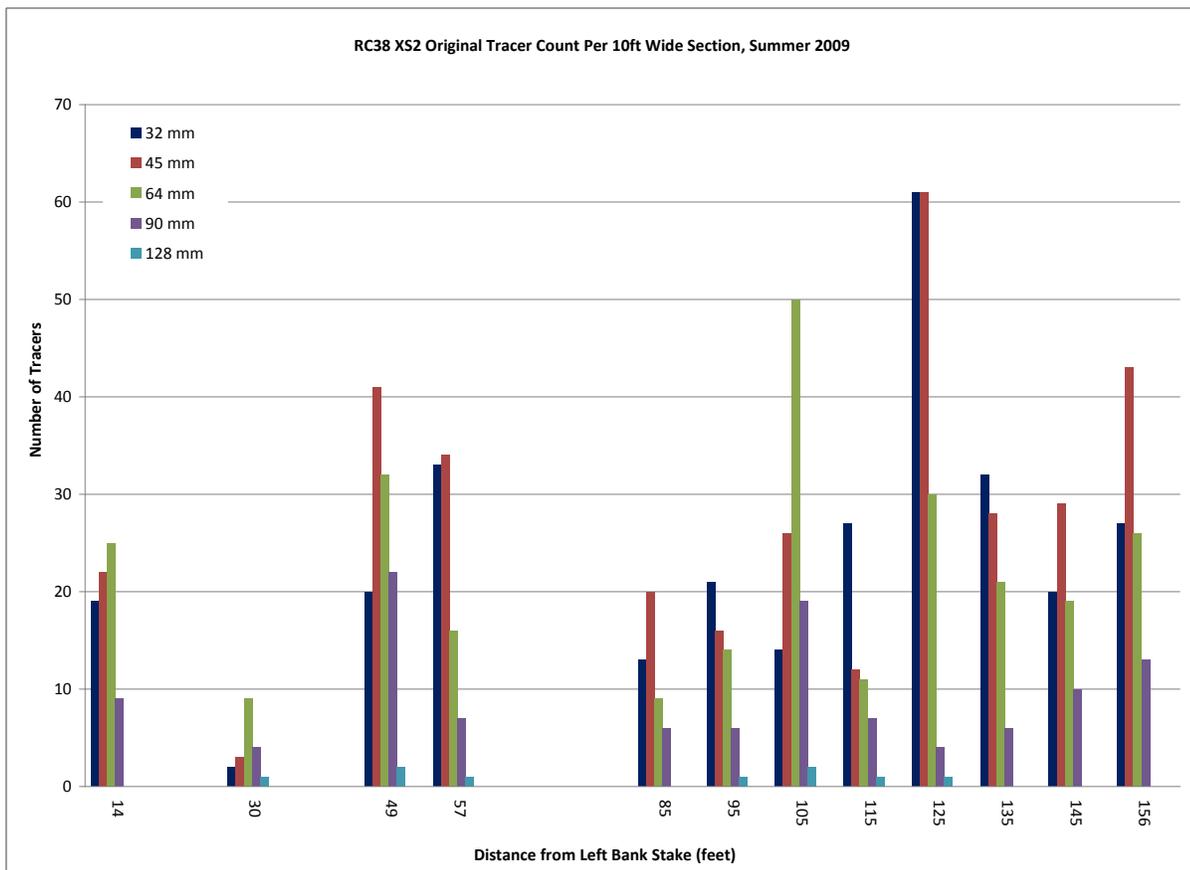
**Figure B-39: The number of tracers by size class placed along XS2 in ~10 ft sections.** The distance indicated along the horizontal axis indicates the midpoint of each section. The gaps from 19 to 25 ft, 35 to 44 ft, and 62 to 80 ft are because of the presence of vegetation patches.

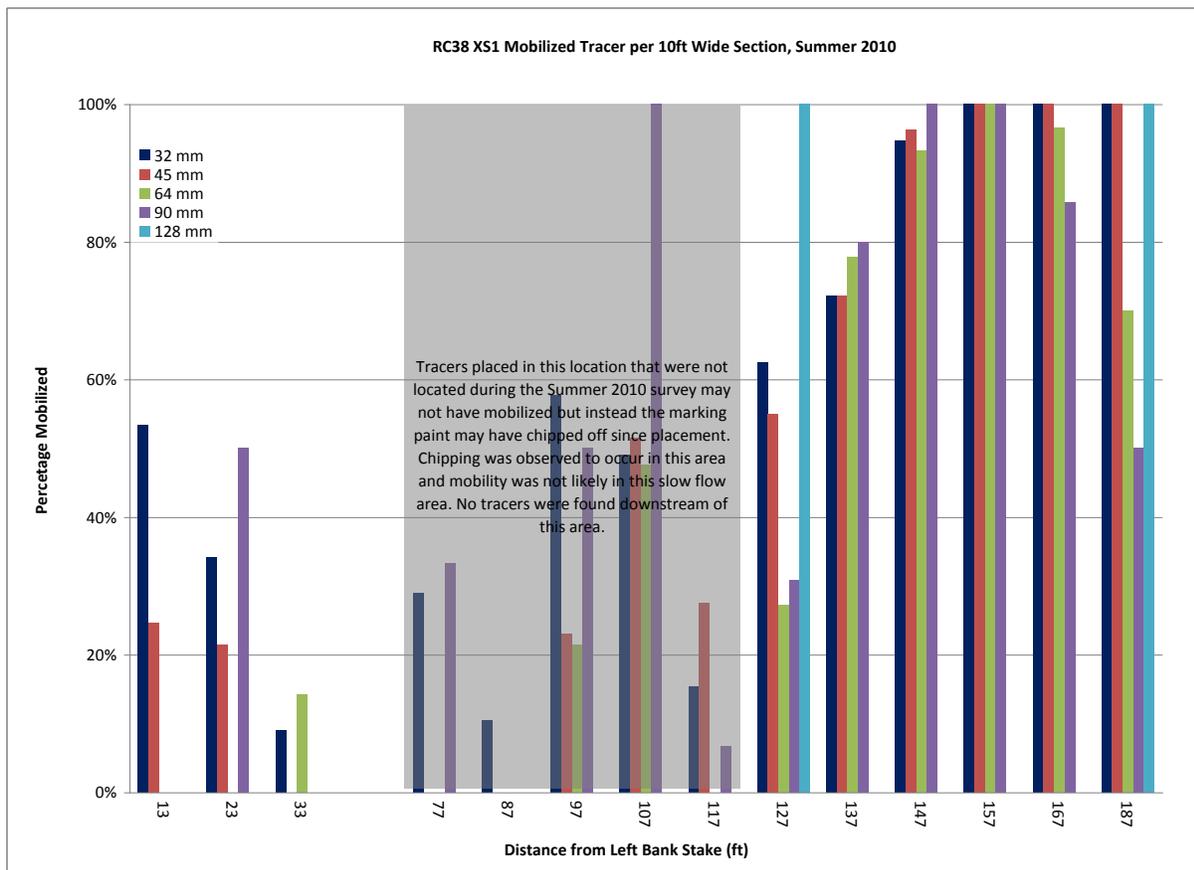
**Figure B-41: The percent of absent tracers during the Summer 2010 survey as compared to the original number placed by size class along XS1.** The distance indicated along the horizontal axis indicates the midpoint of each section. The thalweg along the right bank (right side of graph) suggests general mobility occurred since placement of the tracers. Partial mobility is indicated away from the thalweg area. However, absence of tracers between 77 to 107 ft from the left bank stake may be the result of paint chipping rather than mobility. Therefore, the mobility predicted by the absence of such tracers in this area should be considered an overestimate.

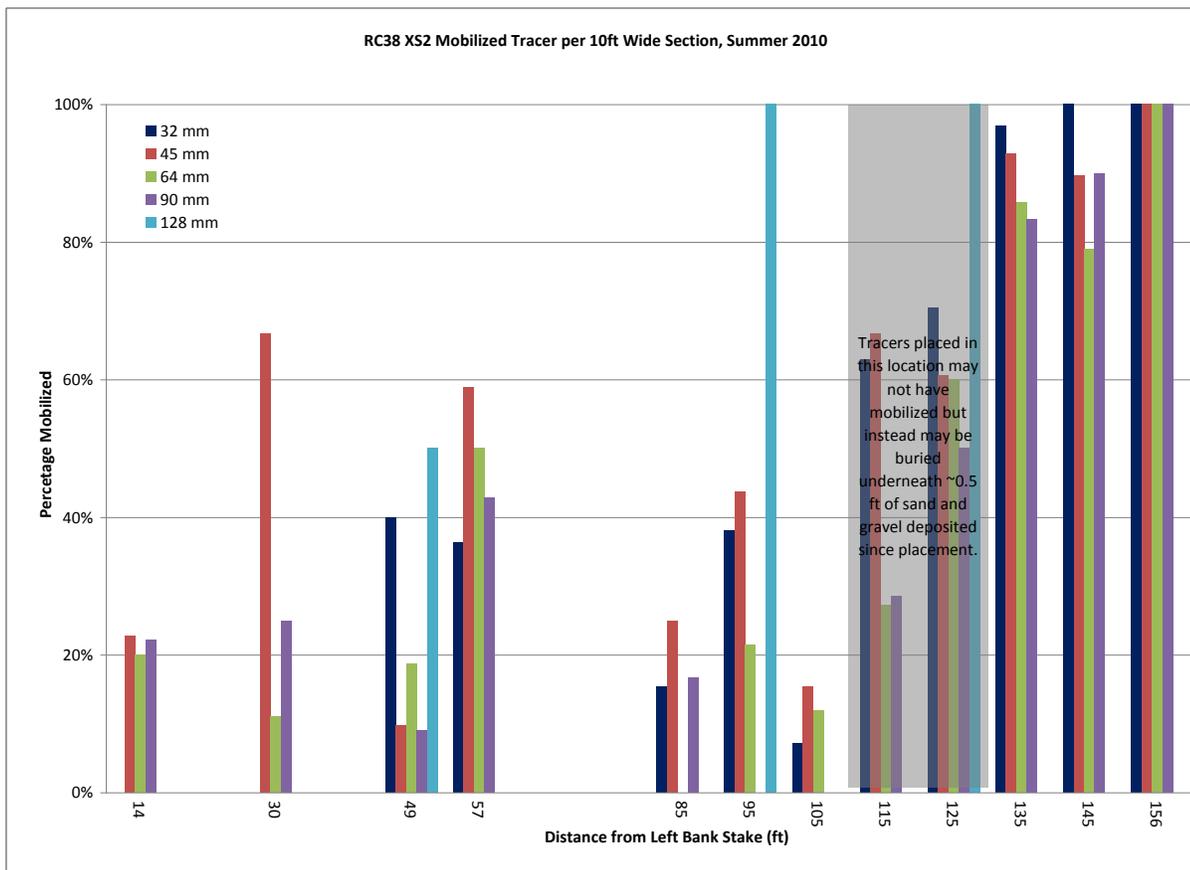
**Figure B-42: The percent of absent tracers during the Summer 2010 survey as compared to the original number placed by size class along XS2.** The thalweg along the right bank (right side of graph) shows general mobility occurred since placement of the tracers. Partial mobility is indicated away from the thalweg area. However, absences of tracers from between 110 to 130 ft may be the result of burial by sand and gravel since placement. Those particles located in this buried area were located beneath up to 0.5 ft of sediment. Therefore, apparent mobility indicated by the absence of tracers in this area should be considered an overestimate.

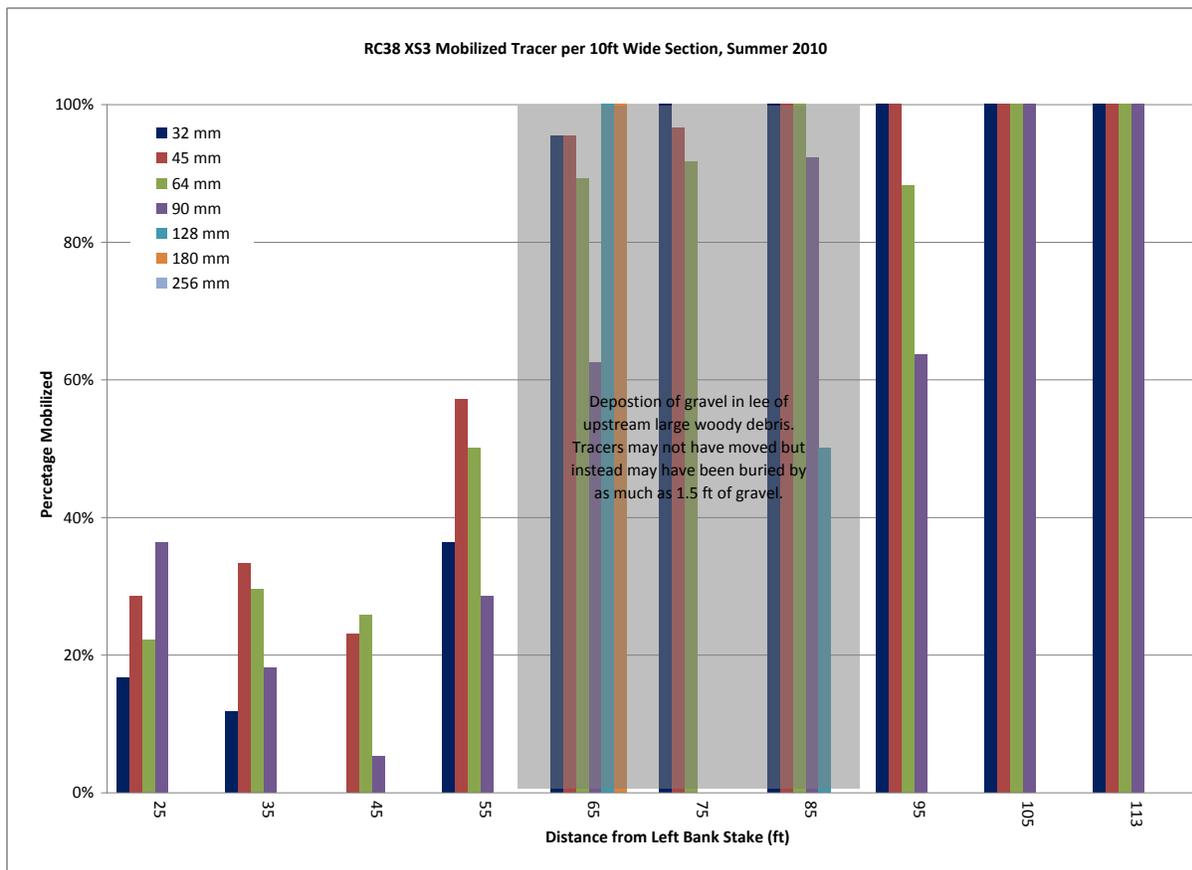
**Figure B-43: The percent of absent tracers during the summer 2010 survey as compared to the original number placed by size class along XS3.** The thalweg along the right bank shows general mobility occurred since placement of the tracers. Partial mobility is indicated away from the thalweg area. However, absence of tracers from between 60 to 90 ft from the left bank stake may be the result of burial by as much as 1 ft of gravel since placement. Therefore, apparent mobility indicated by the absence of tracers in this area should be considered an overestimate. Located mobilized tracers were surveyed in January 2010 and summer 2010. Their locations are illustrated on Figures 18 and 19. The distance they traveled since placement is illustrated on Figures 20 and 21.

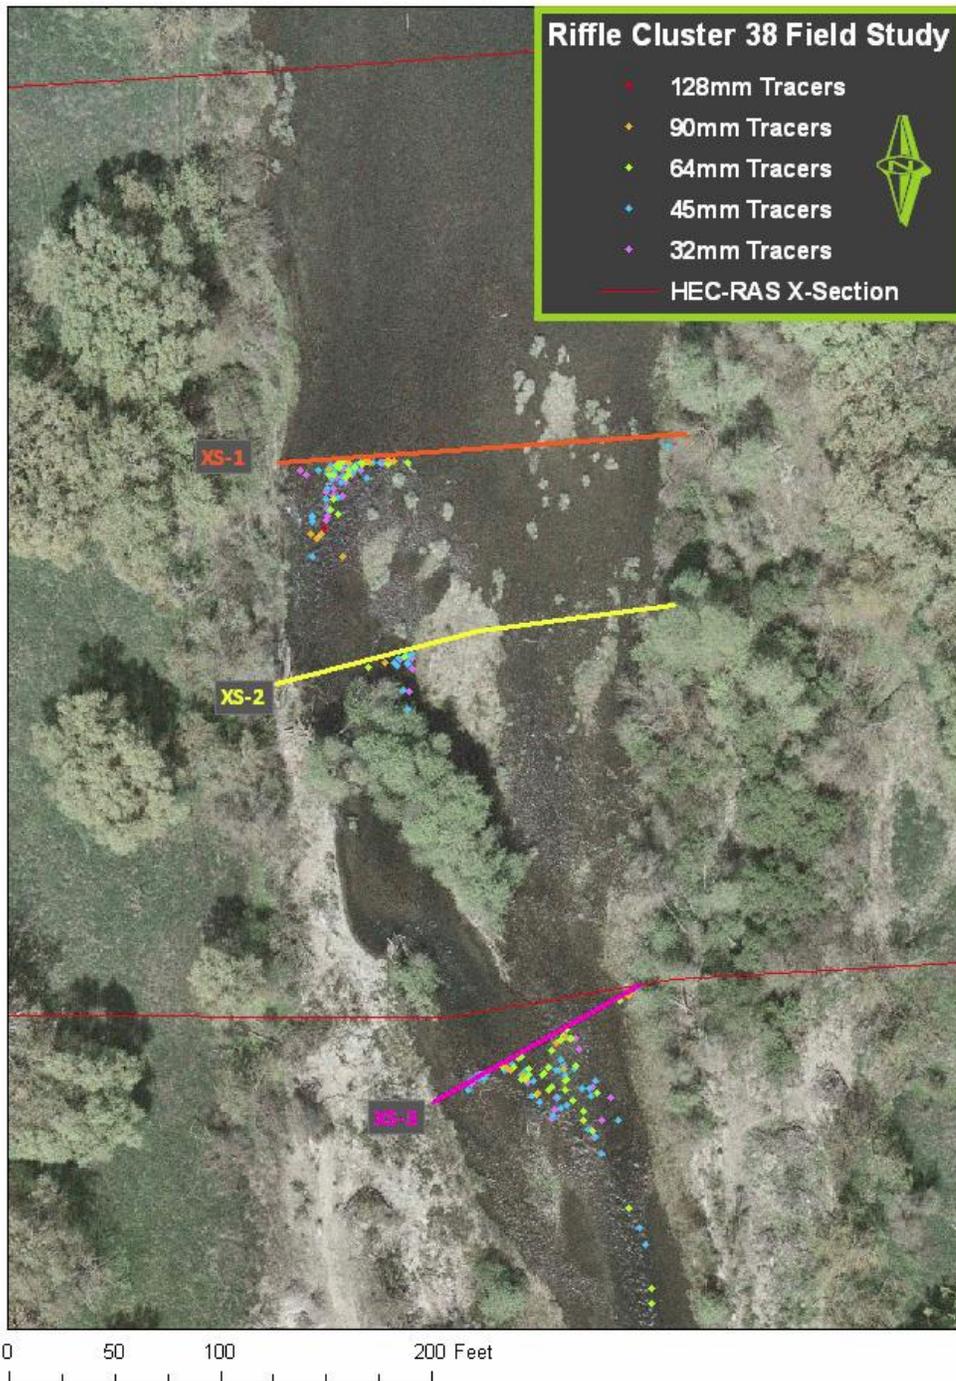
**Figure B-44: Pilot tracer survey results showing mobilized tracers as of January 2010.** Orange, yellow, and pink lines indicate original lines of placement. Dots indicate located mobilized tracers with the color indicating size class.

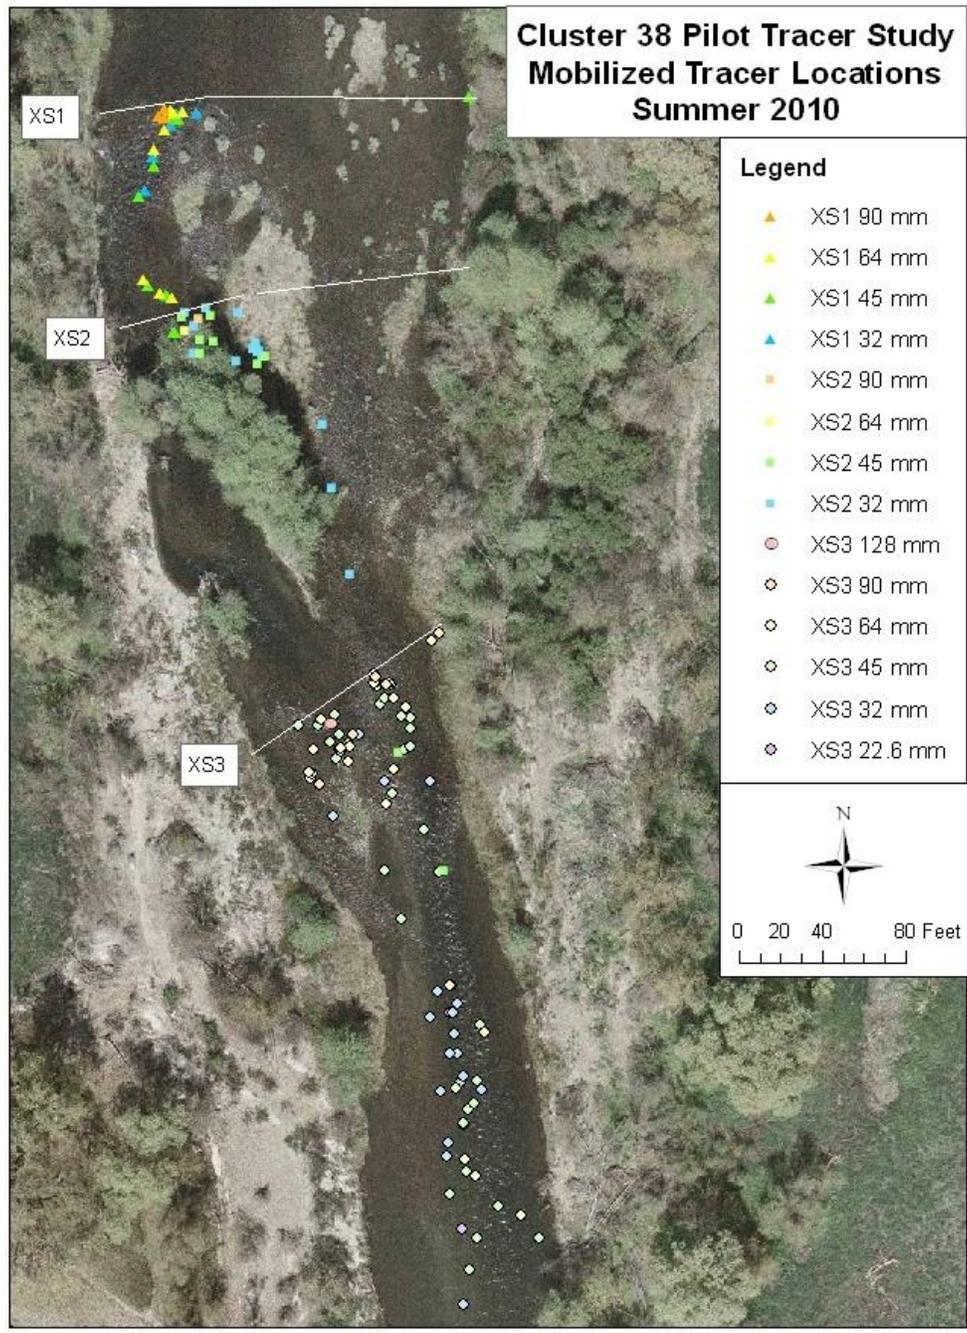
**Figure B-45: Pilot tracer survey results showing mobilized tracer positions as of Summer 2010.** White lines indicate original lines of placement. Triangle, square, and dot symbols indicate tracers from XS1, XS2, and XS3, respectively, and color indicates size class.

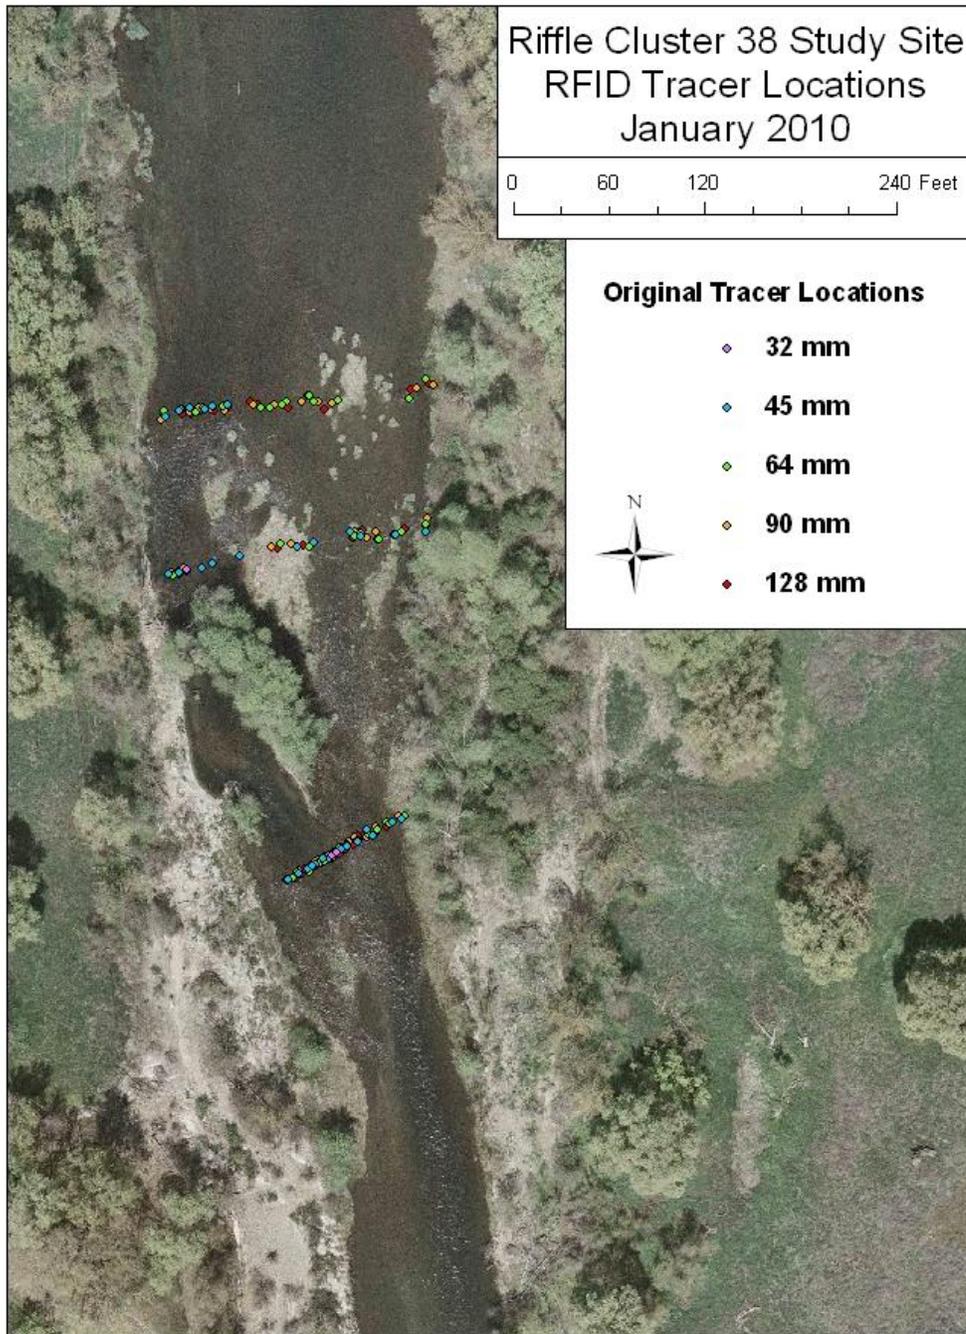
**Figure B-48: Riffle Cluster 38 RFID tracer locations as placed in January 2010.** Three lines of tracers are 2 to 7 ft upstream of cross-section lines shown in Figure 2. Dots represent tracers and colors represent size class.

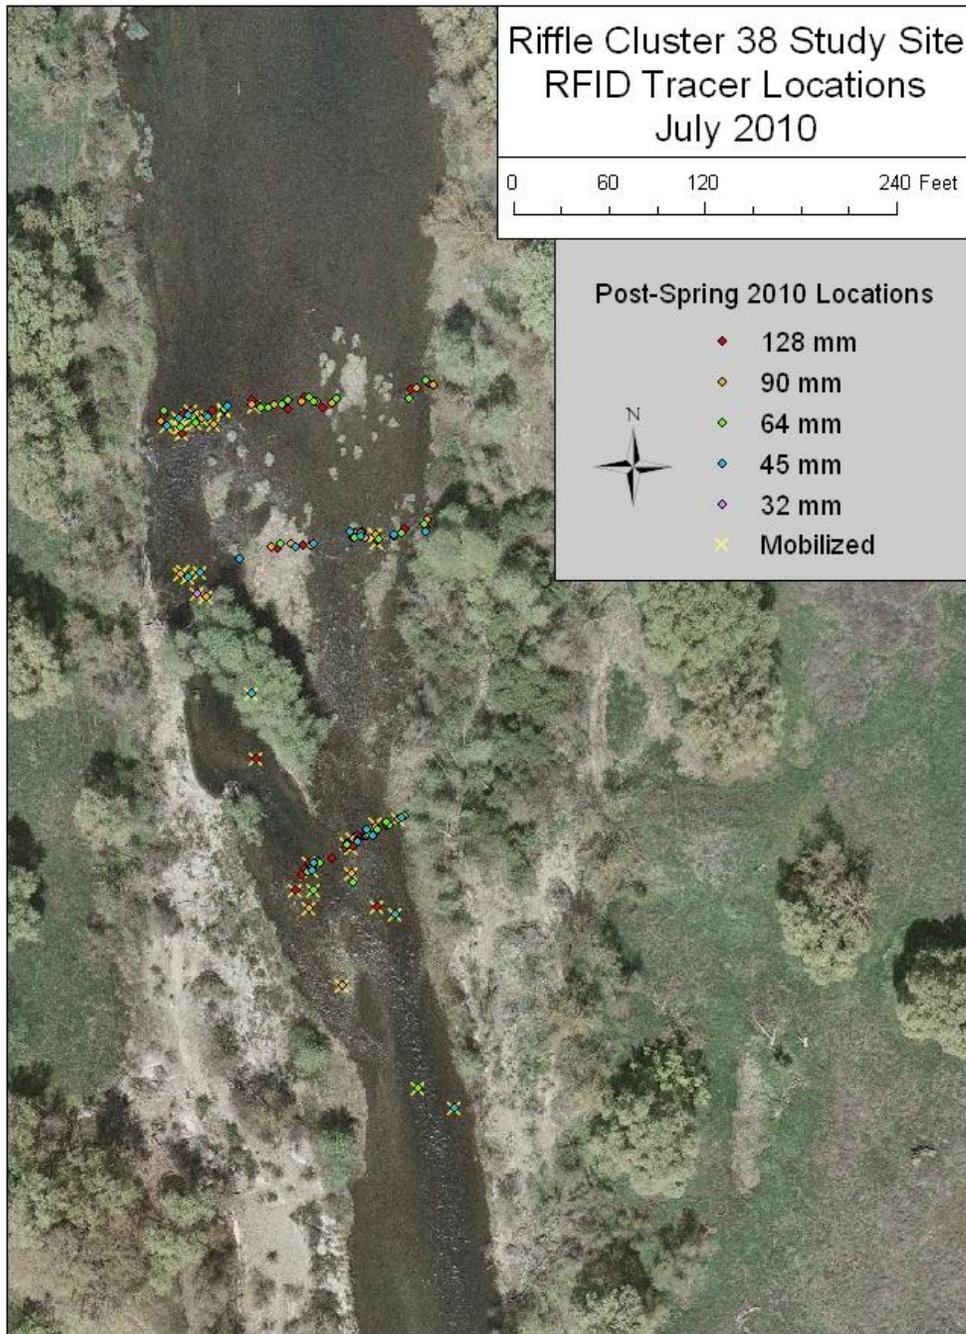
**Figure B-49: Riffle Cluster 38 RFID tracer locations after Spring 2010 flows that reached a peak of 1,700 cfs (USGS). Yellow crosses indicate those tracers that moved >1.5 ft since January 2010.**

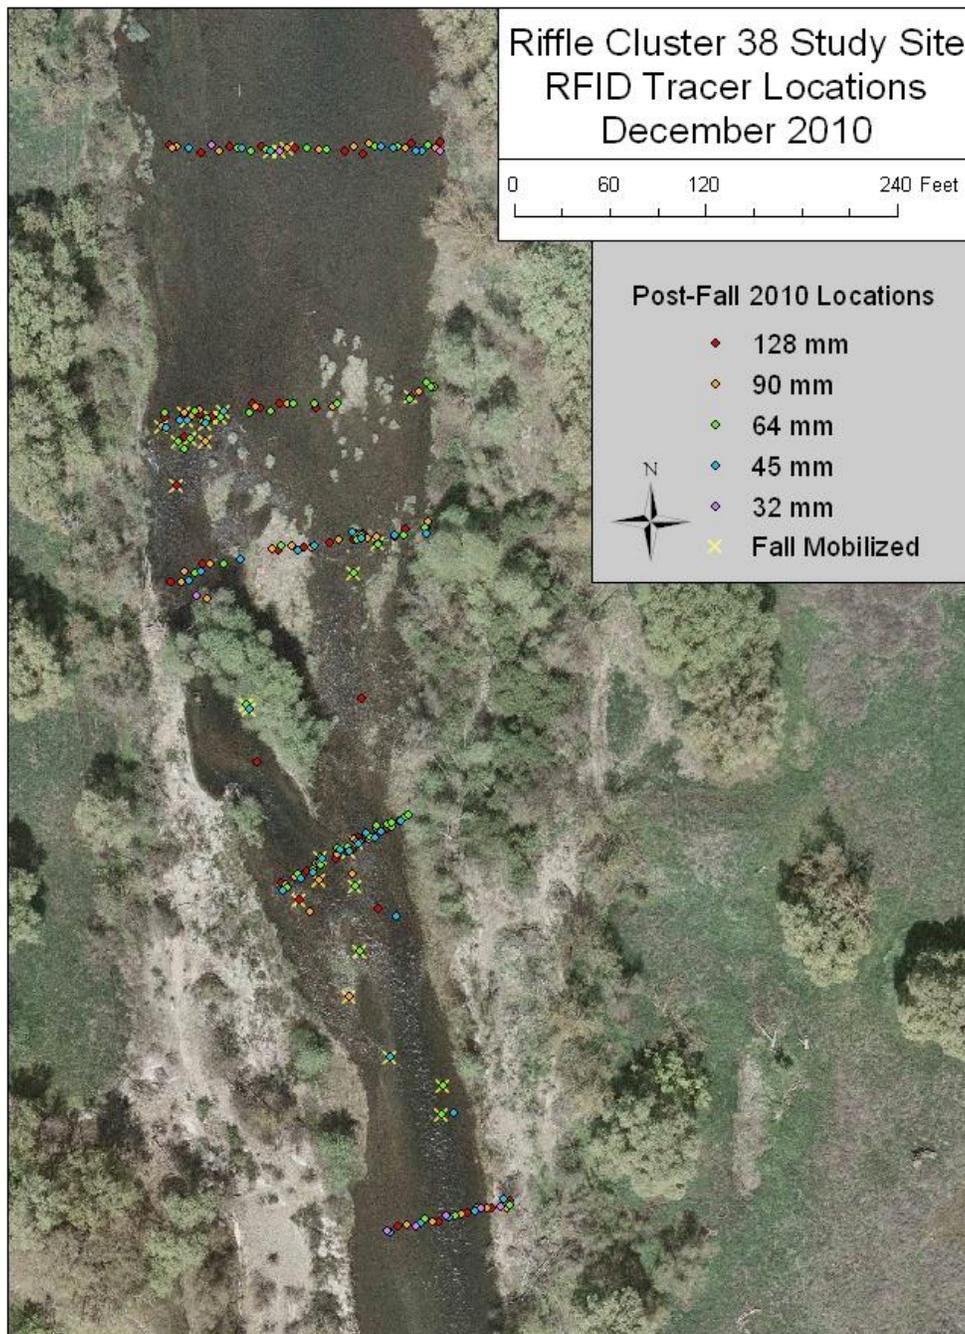
**Figure B-52: Riffle Cluster 38 RFID tracer locations after the Fall 2010 flows, which reached a peak of 721 cfs (USGS).** Yellow crosses indicate those tracers that moved >1.5 ft since surveyed in Summer 2010.

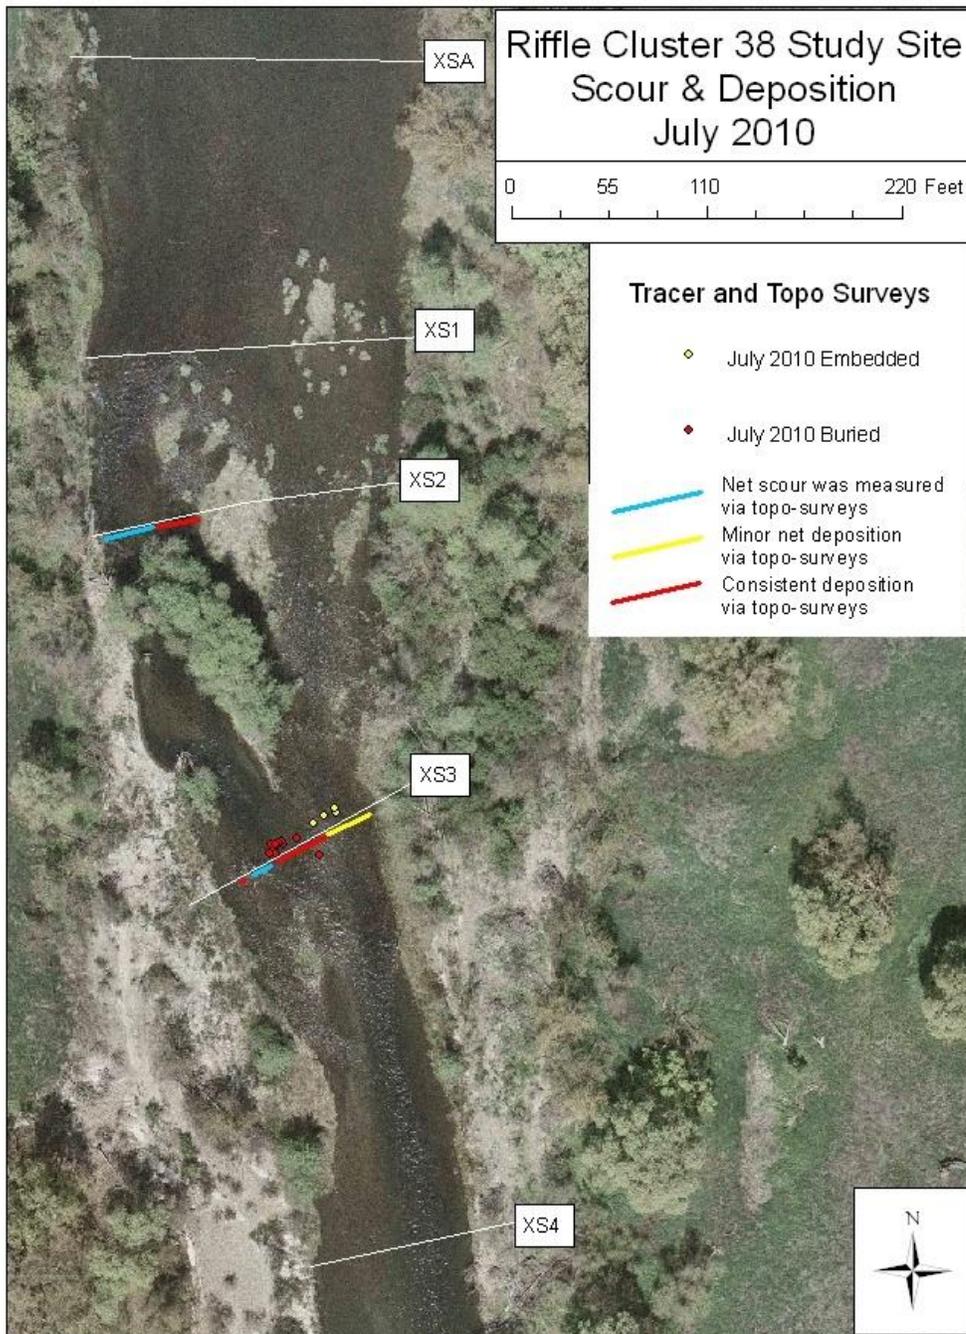
**Figure B-54: Buried and embedded RFID tracers after Spring 2010 flows that reached a peak of 1,700 cfs (USGS). Yellow indicates minor net deposition and embeddedness, red indicates substantial net deposition and burial, and blue indicates net scour.**

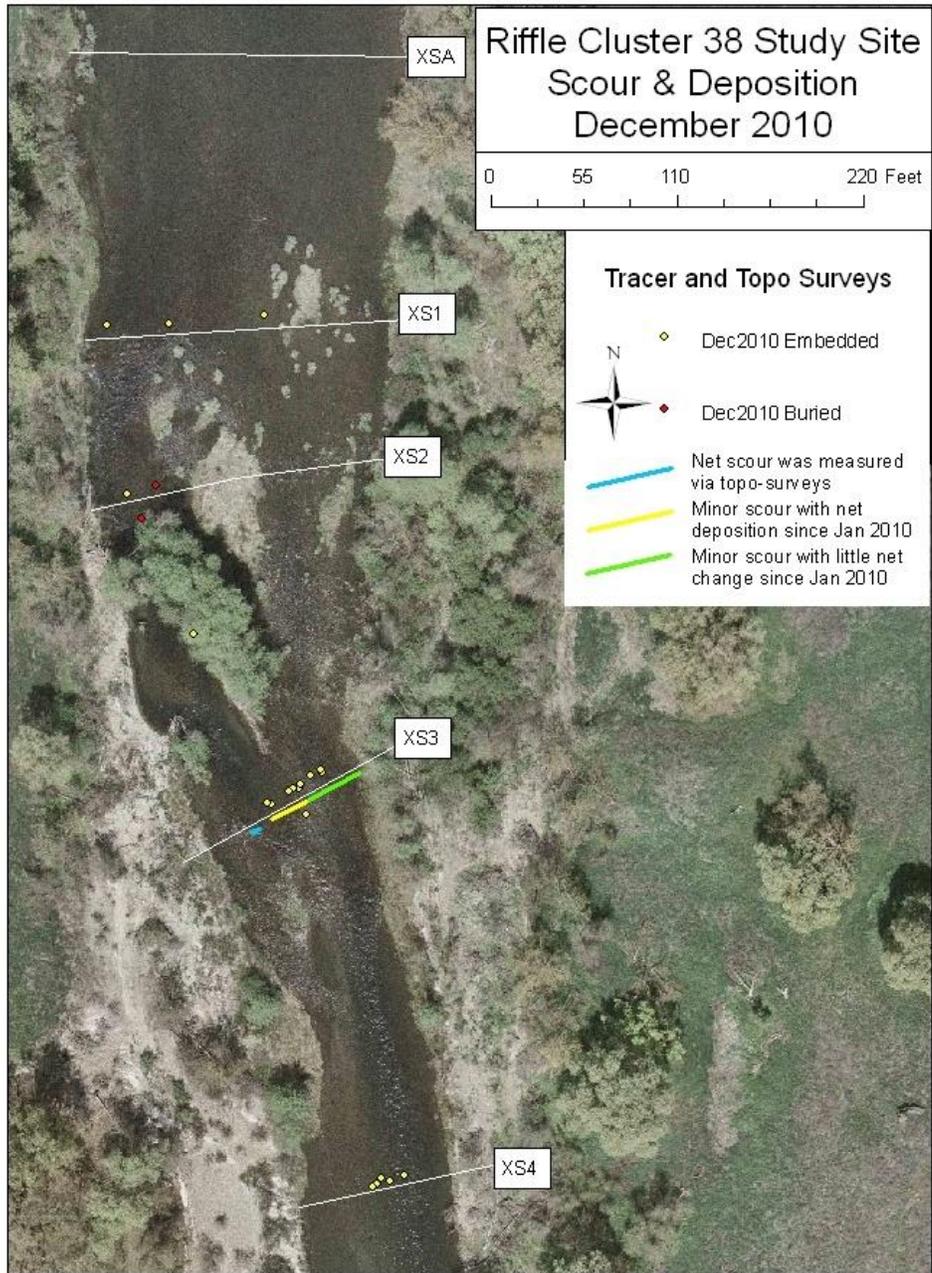
**Figure B-55: Buried and embedded RFID tracers after Fall 2010 flows that reached a peak of 721 cfs (USGS).** Yellow indicates minor scour but net deposition and embeddedness, green indicates minor bed elevation loss with only slight net change since January 2010, blue indicates net scour, and red indicates burial.

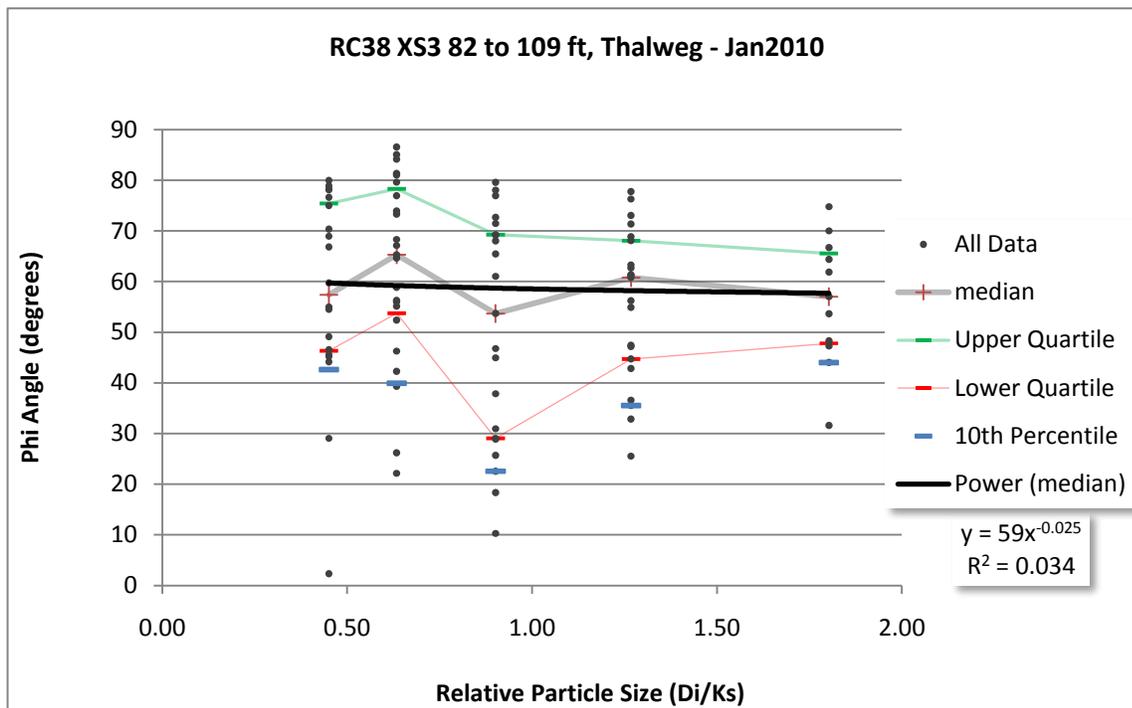
**Figure B-56: Phi angle trends with size class (Di) relative to the median particle size (Ks) within the thalweg area of RC38 XS3 before LWD altered the channel surface. Note the consistent median phi angle of greater than 55 degrees across all size classes.**

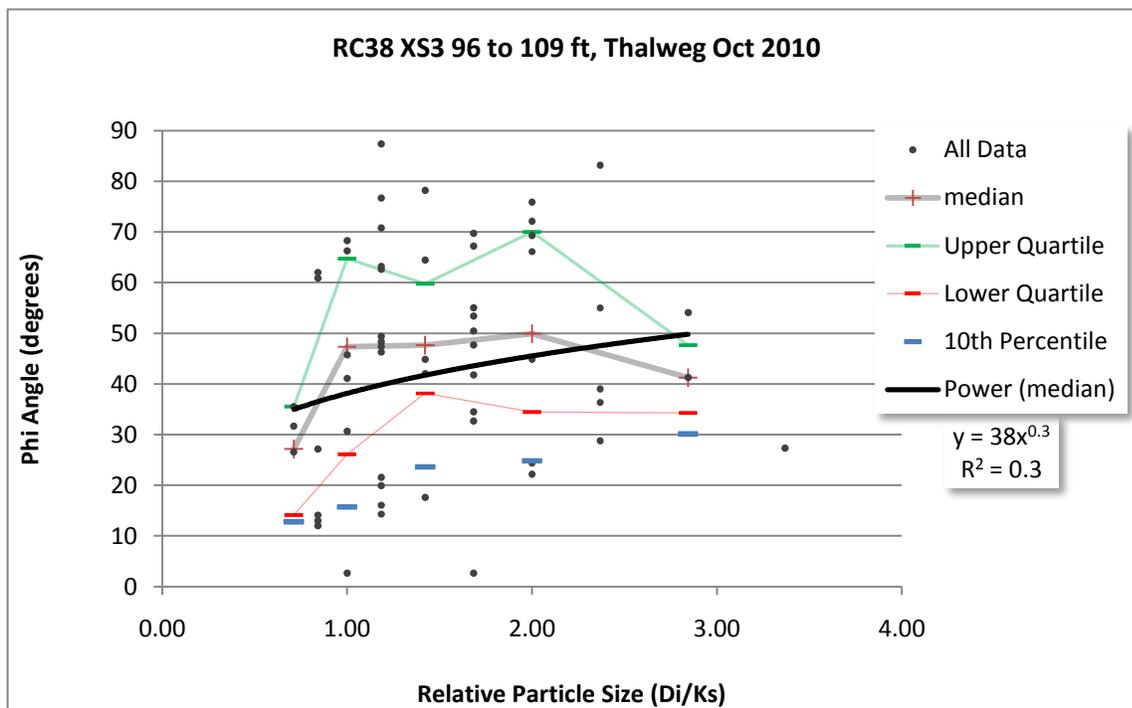
**Figure B-57: Phi angle trends with size class (Di) relative to the median particle size (Ks) within the thalweg area of RC38 XS3 after LWD has altered the channel surface. Note the reduced phi angles to less than 50 degrees.**

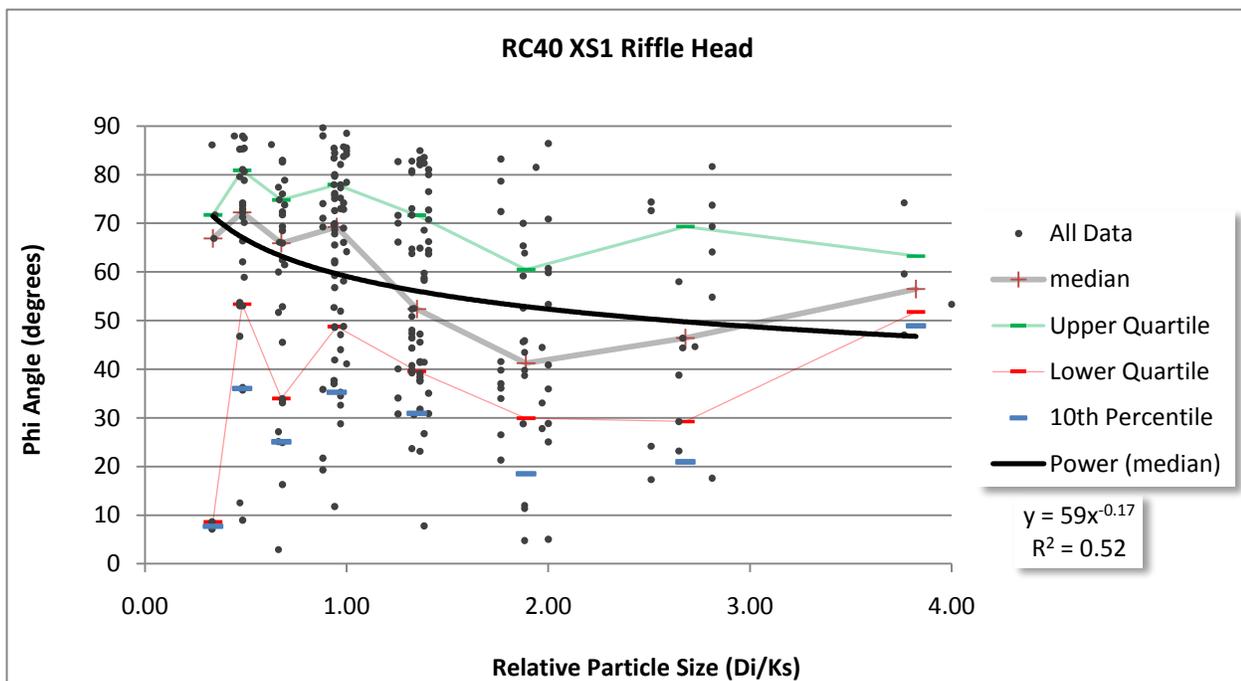
**Figure B-58: Phi angles calculated from force gauge measurements across the entire channel at RC40 XS1.** Note the variance in individual measurements about the median. Comparison of median phi angle trends per geomorphic area also show variability. This is illustrated in Figure 33 which shows each separately measured area’s median phi angle trends combined for RC38.

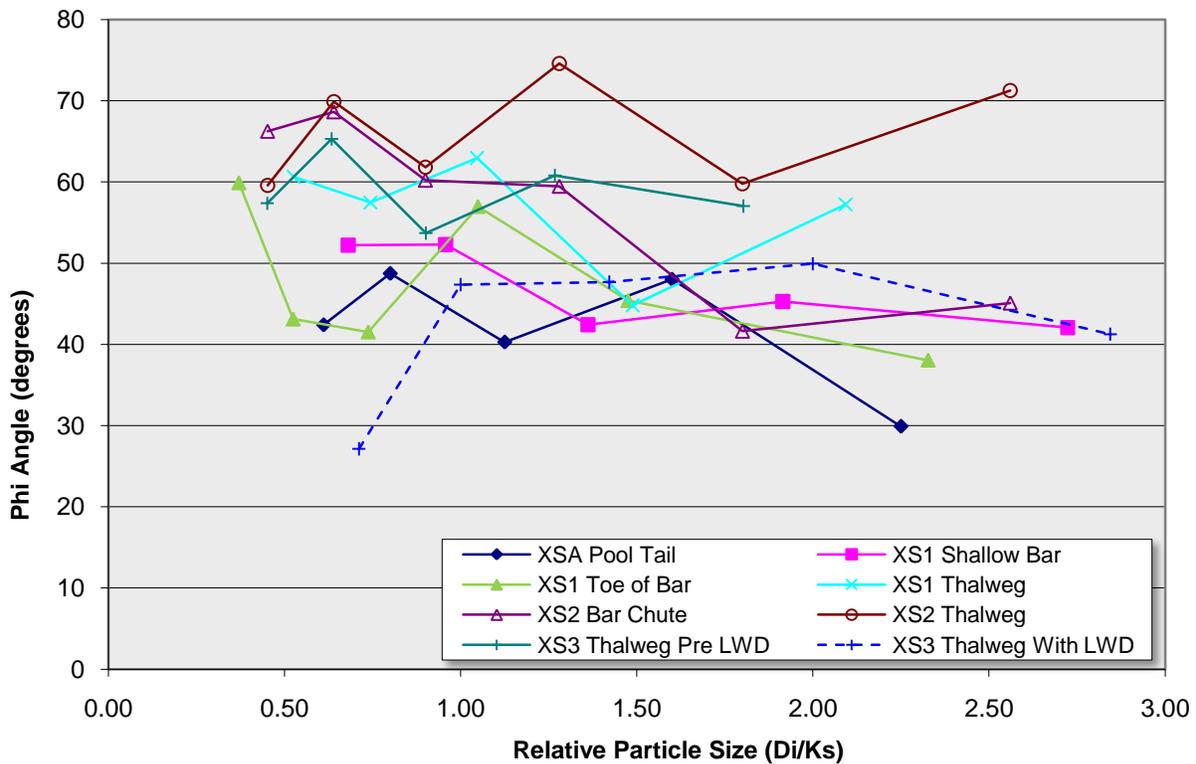
**Figure B-59: Median phi angle trends relative to the normalized particle size from force gauge measurements at all RC38 sample areas.** Note the variance in median phi angle trends per sample area.

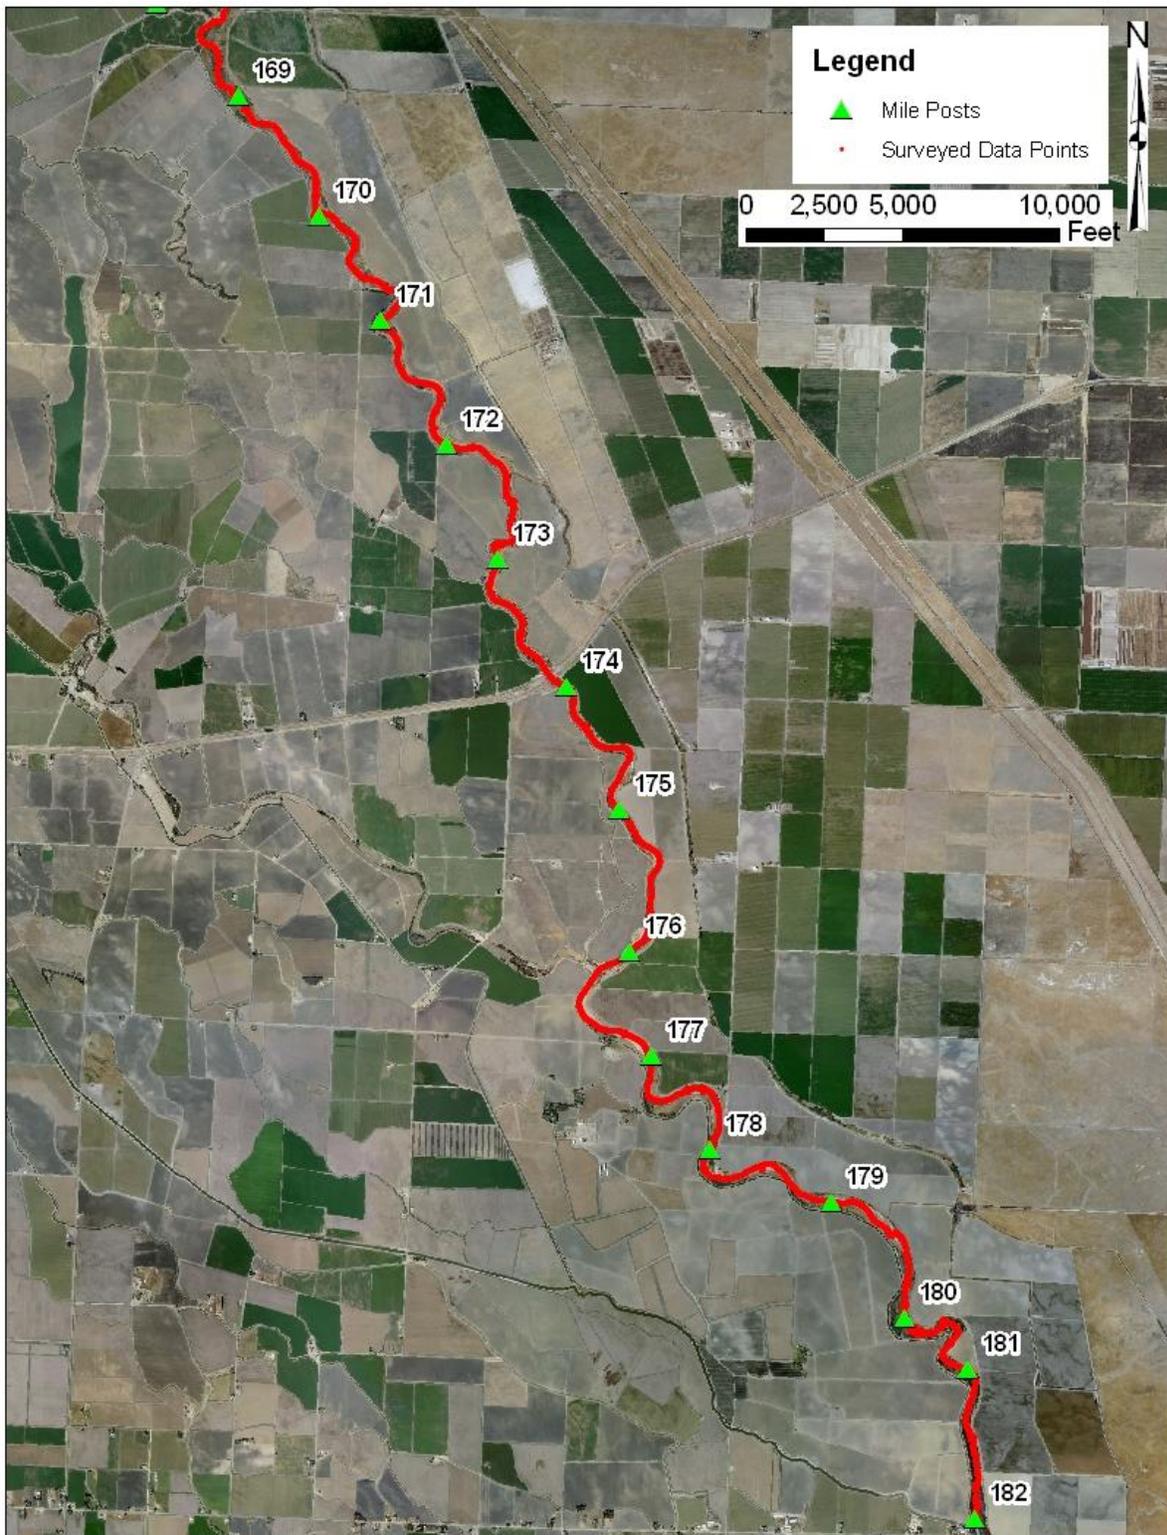
Figure B-63. Reach 4a bathymetric surveyed data points from Sack Dam (MP 182) to Sand Slough (MP 168.5). Data were collected on April 10, 2010.

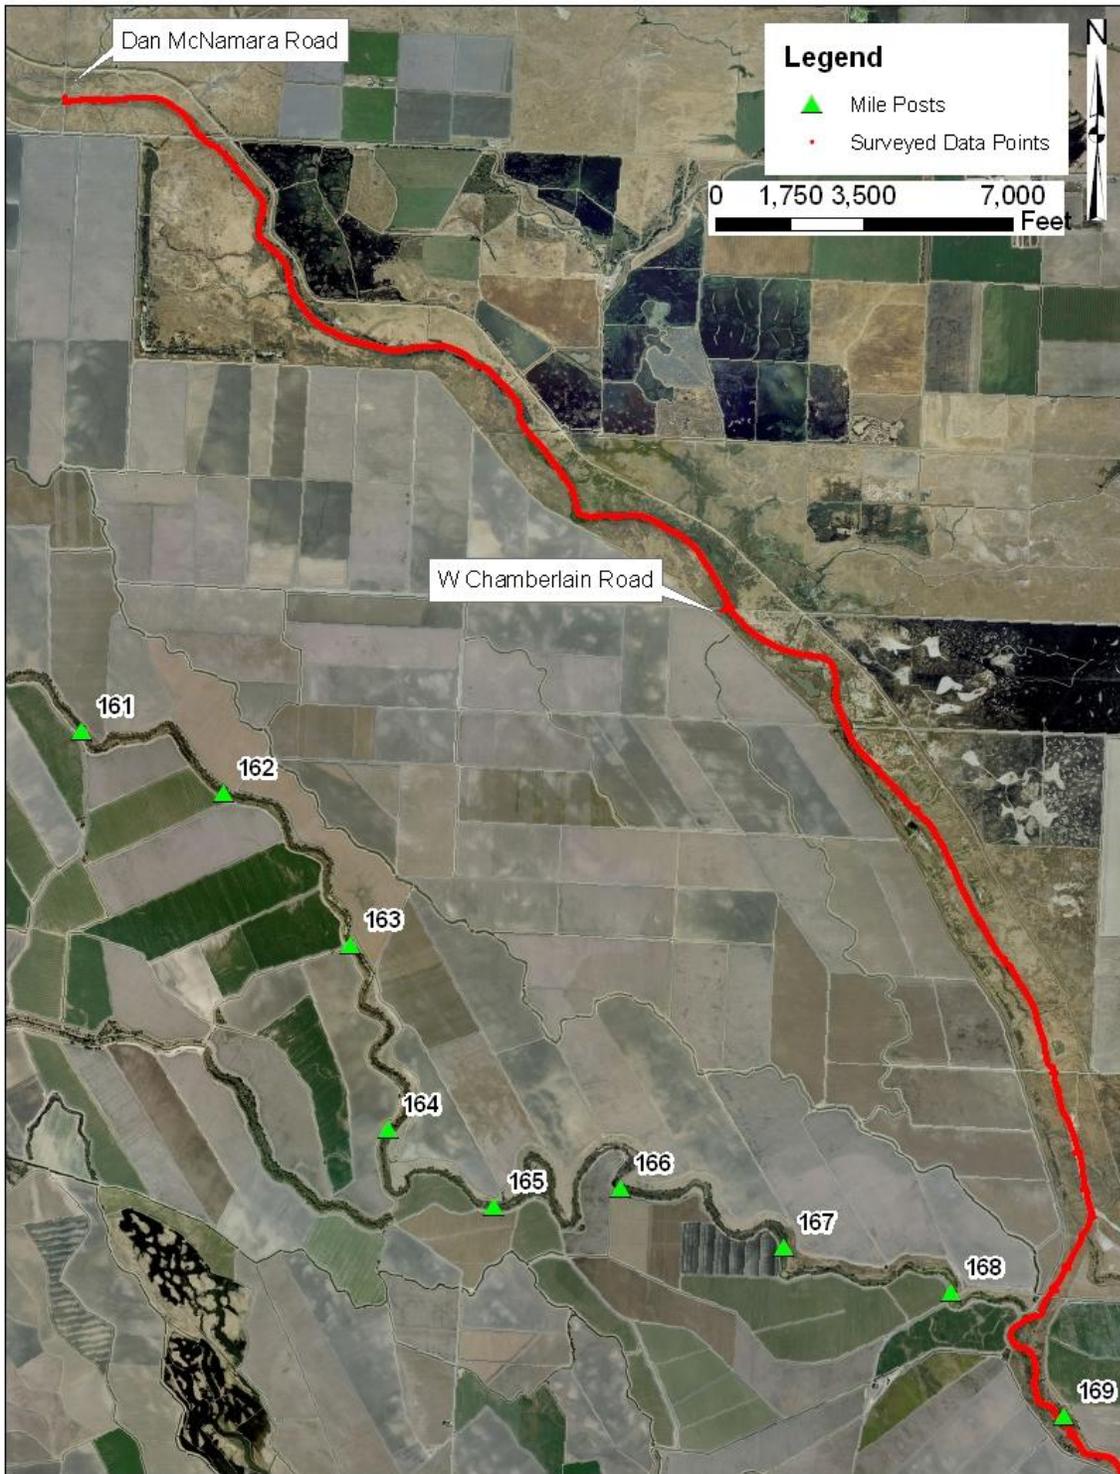
Figure B-64. Eastside Bypass bathymetric surveyed data points from Sand Slough (MP 168.5) to Dan McNamara Road. Data were collected on April 10, 2010.
