## 2010 Annual Technical Report

**SAN JOAQUIN RIVER**  
RESTORATION PROGRAM

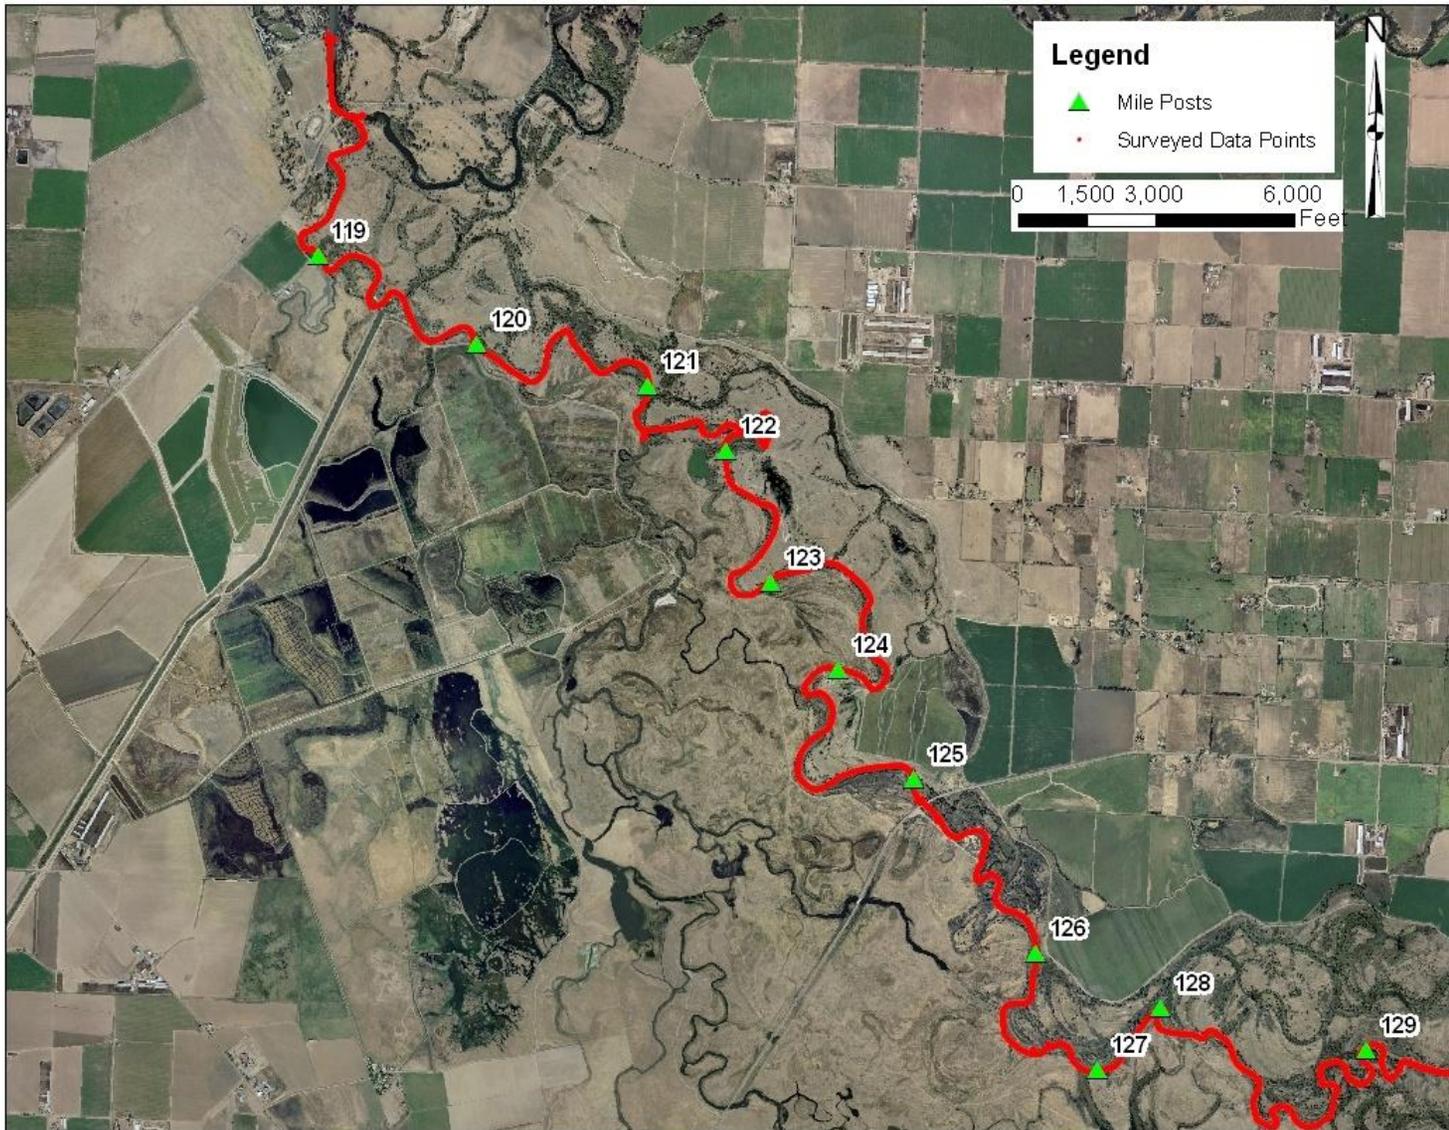
Figure B-68. Reach 5 bathymetric surveyed data points from MP 127 to confluence with the Merced River. Data were collected on April 14, 2010.
