Appendix C

Middle Eastside Bypass Geotechnical Assessment

August 2013

SAN JOAQUIN RIVER RESTORATION PROJECT DWR LEVEE EVALUATIONS

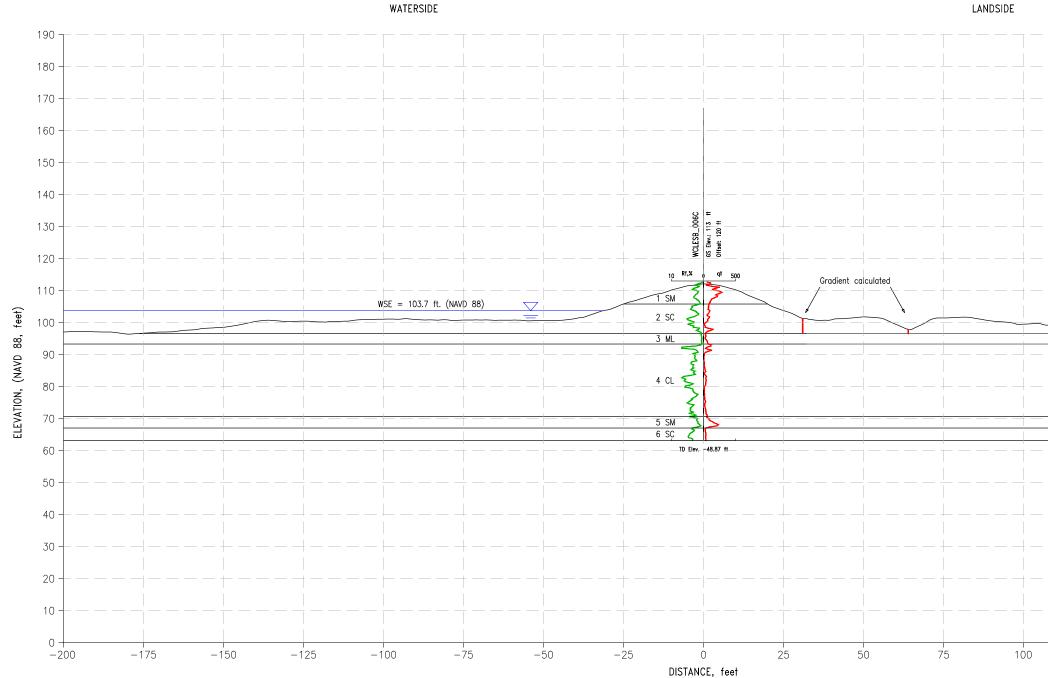
The analysis cross section for Site 1 is along the left bank of the levee at Station 1460+00. The levee in this portion of the system has a height of around 11 feet to 13 feet, with a levee crown width of 10 feet to 15 feet. Waterside and landside slopes are approximately 3.6H:1V and 2.5H:1V, respectively. This section of levee has a 3 feet to 4 feet deep landside ditch located approximately 30 feet from the landside levee toe. The analysis cross section is shown in Figure 2.

Based on the exploration data available, the levee embankment comprises a mixture of silty and clayey sand, silt and clay. Subsurface materials consist of silts and clays with interbeds of silty sand and clayey sand. A variable landside blanket thickness is indicated by the explorations. For the purpose of analysis, a base model was established using information from cone penetrometer test (CPT) WCLESB_006C, which indicates a landside blanket condition approximately 4 feet thick. Due to the presence of a landside ditch, the blanket thickness is reduced to a thickness of around 1.5 feet (Figure 2).

The analysis results show that underseepage is the controlling geotechnical failure mode for Site 1 assuming ditch empty conditions, but when modeling ditch full conditions landside slope stability controls. According to the levee maintenance district, the landside ditches normally run full during the wet season. However, given that it is not clear when water could be released from Friant dam, it is possible that the levee could experience water with ditch full or ditch empty conditions.

Based on the above, it is considered that sensitivity case 3 is representative for the ditch empty condition taking into account the potential for cracking of the blanket layer at the bottom of the ditch and that sensitivity case 4 is representative for the ditch full condition. Therefore, a WSE of between +100.7 feet (NAVD88) and+104.7 feet (NAVD88) is acceptable at this location for ditch empty and ditch full conditions respectively. This corresponds to between approximately 1-foot (ditch empty) and 4 feet (ditch full) of water on the waterside of the levee relative to the landside toe elevation.
