# Reach 3 Temperature Monitoring

### San Joaquin River Restoration Program

Reach 3                      Bank = Right  
 River Mile = 204.5  
 Site = Mendota Pool

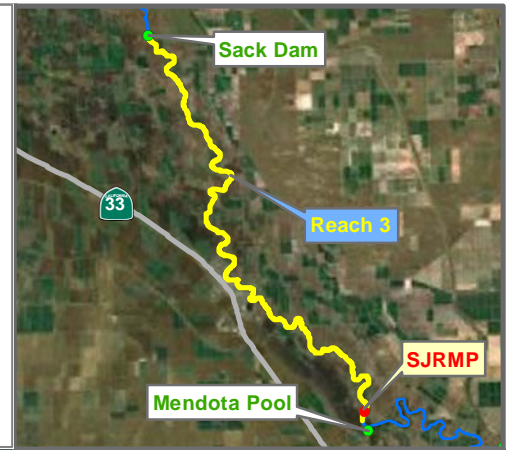
Description:  
 Downstream of Mendota Pool. Cabled to tree on RR.
