# Reach 4A

## Temperature Monitoring

### San Joaquin River Restoration Program

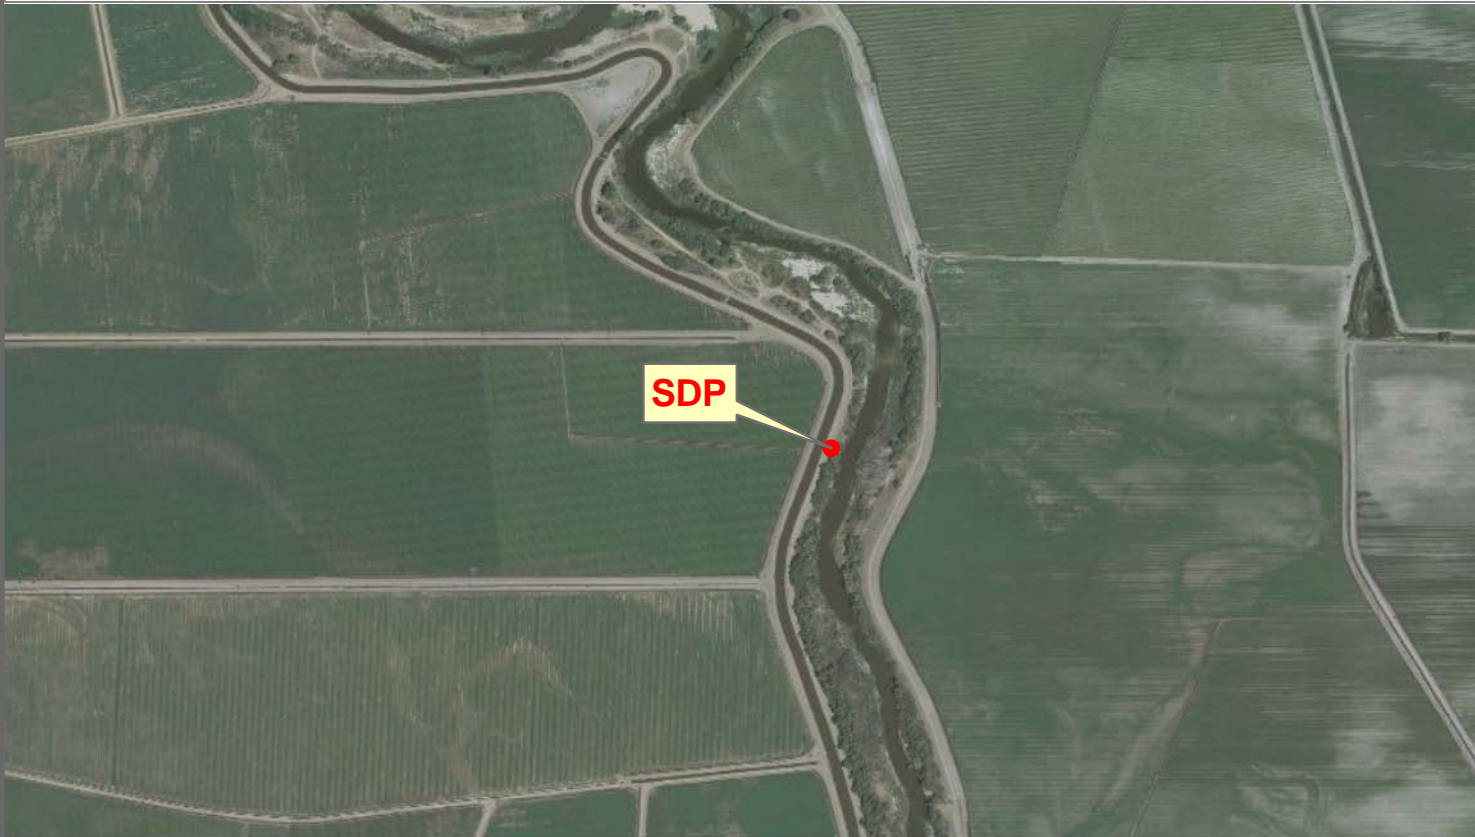
### Temperature SDP

Reach 4A                      Bank =  
 River Mile =  
 Site = Near Dos Palos  
 Latitude (NAD83) = 36.994  
 Longitude (NAD83) = -120.5015  
 Status = Existing  
 Depth =  
 15 min Telemetry  
 Habitat =  
 Organization = DWR  
 Most Recent Meas. = 02/16/2011  
 Description:  
 Sensor at real-time flow gaging station

— Hourly temperature (C)  
— Daily average temperature (C)

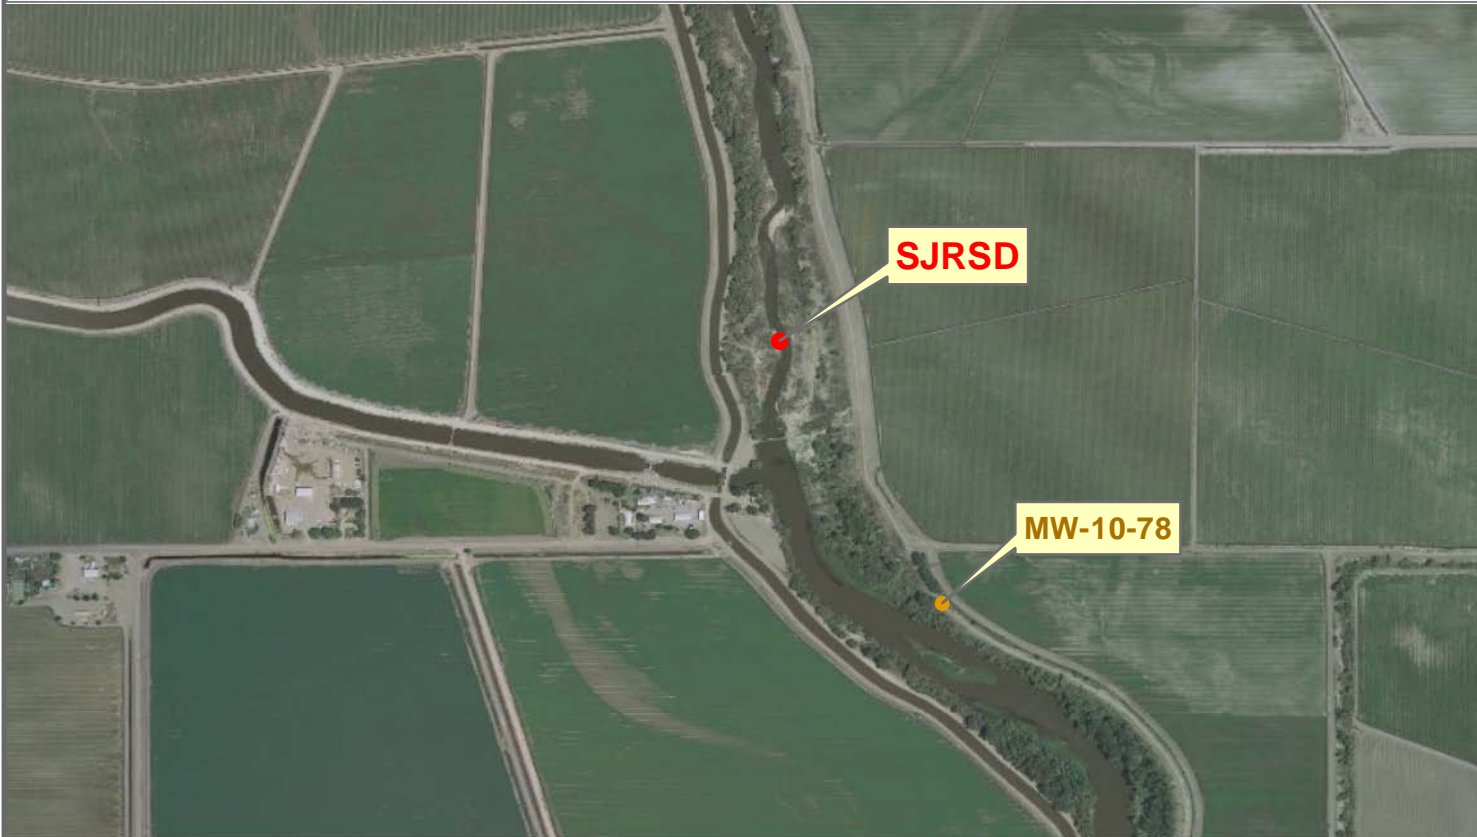
### Temperature SJRSD

Reach 4A                      Bank = Left  
 River Mile = 182  
 Site = Sack Dam

Status = Lost  
 Depth = 1 ft above gs

Description:  
 Downstream of dam. Cabled to rebar in MC. data lost during IFP 2010. Data lost during IFP 2010.

— Hourly temperature (C)  
 — Daily average temperature (C)

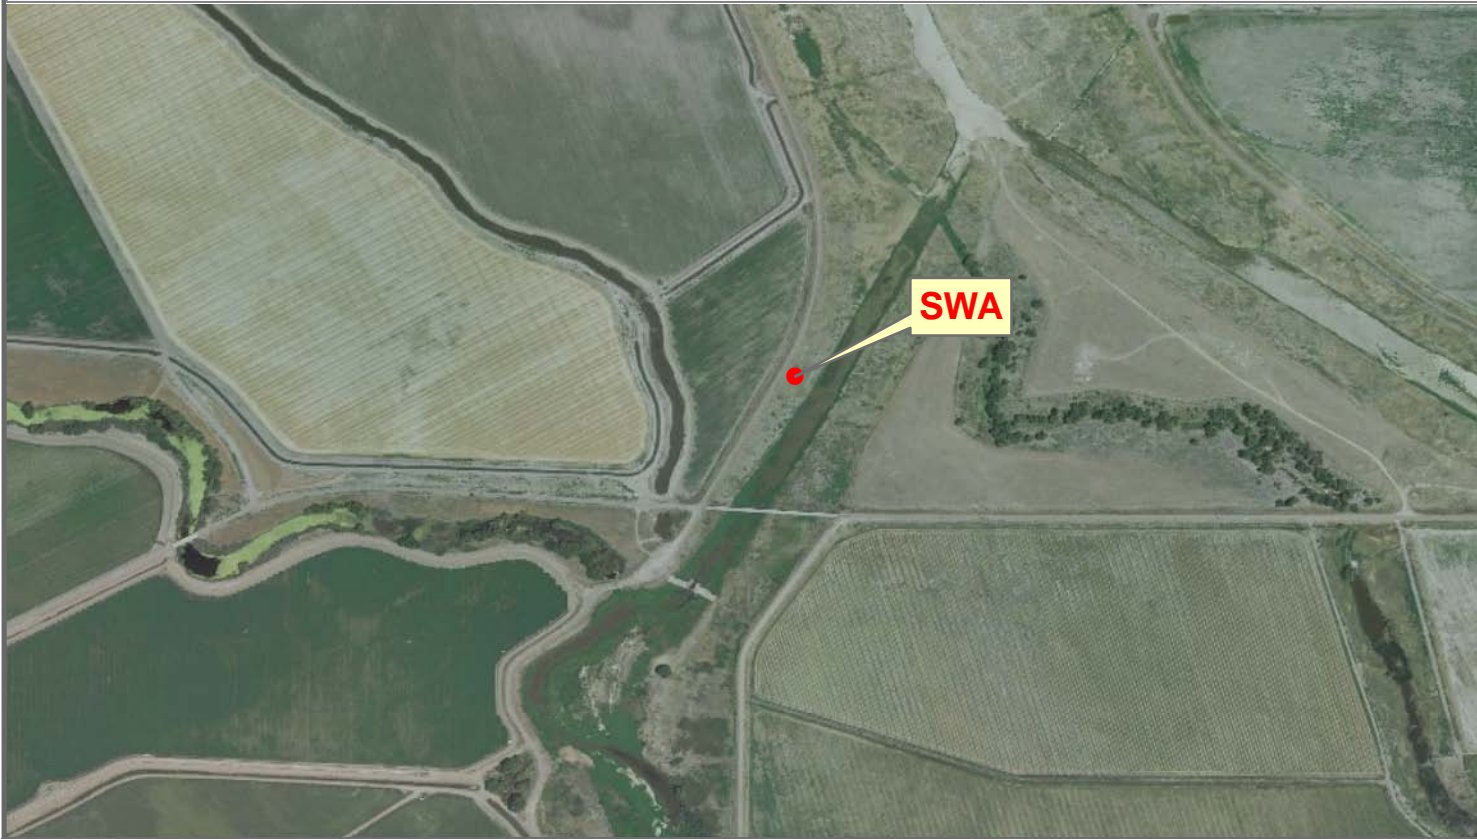
### Temperature SWA

Reach 4A      Bank =  
 River Mile =  
 Site = Washington Road  
 Latitude (NAD83) = 37.1153  
 Longitude (NAD83) = -120.587

Description:  
 Sensor at real-time flow gaging station

— Hourly temperature (C)  
 — Daily average temperature (C)
