Effects Of A Riparian Forest On Water Temperatures In The Restoration Area

2014 Annual Technical Report

SAN JOAQUIN RIVER
RESTORATION PROGRAM

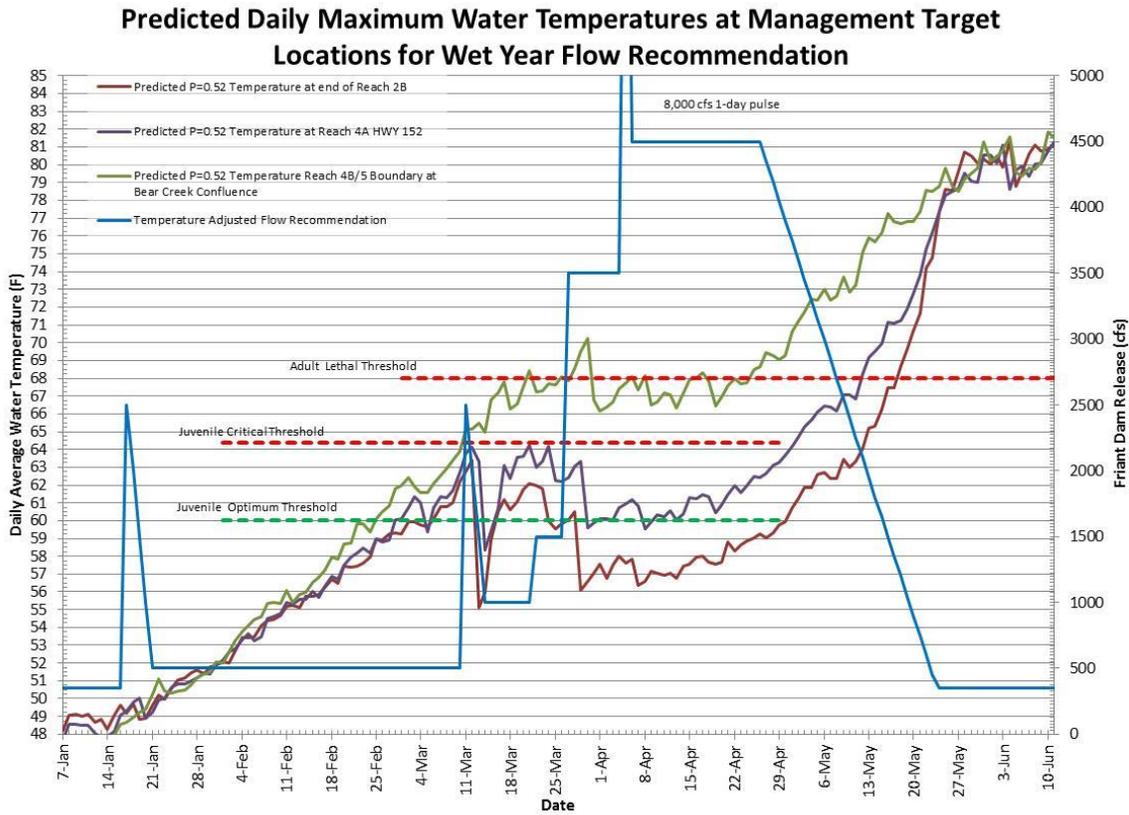
Figure 1. Possible Wet Year flow recommendation designed to maximize adult spring-run passage and two brief pulse flows for juvenile passage relative to the predicted daily maximum water temperatures (SJRRP 2008a) during average meteorological conditions from 1980 to 2005 ($P = 0.52$ exceedance) just upstream of Mendota Pool (Reach 2B), at Highway 41 (Reach 4A), and the confluence with Bear Creek (Reach 4B-5 boundary). The lethal threshold for adult salmon is a 7-day mean daily maximum temperature of 68°F and so temperatures that exceed the threshold for fewer than 7 days would not be lethal. The water temperature predictions in reaches 4B and 5 in this figure may exceed actual temperatures by about 2°F in April and by $1\text{-}2^{\circ}\text{F}$ in May (SJRRP 2012).

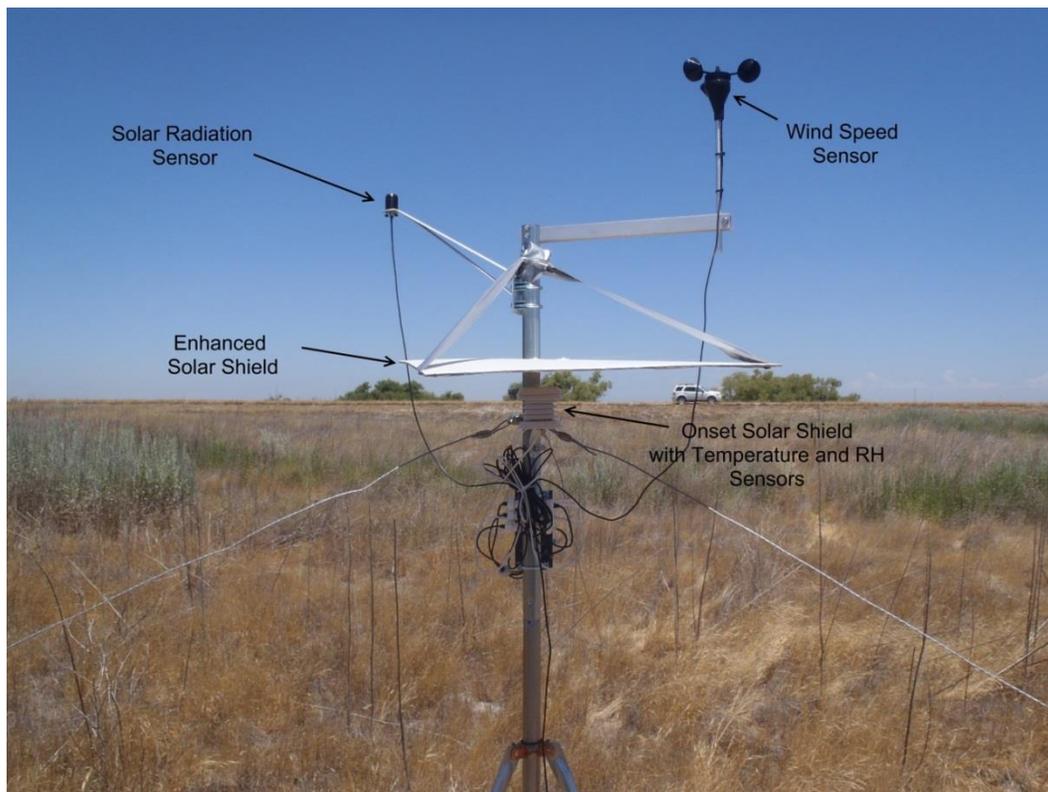
Figure 2. Weather Station with an enhanced solar shield constructed of a 2 ft² 1/8-inch plywood sheet painted white, an Onset solar shield with temperature and relative humidity sensors, a solar radiation sensor, and wind speed sensor in a non-forested site on the San Luis National Refuge.

Based on the preliminary studies, enhanced solar shields were installed for Phase 2 studies that began June 30, 2014. The enhanced solar shields were 2 ft² 1/8-inch plywood sheets painted white and suspended about 3 inches above the Onset solar shield (Figure 2). The enhanced solar shields were oriented toward the South to maximize shading. The enhanced shields were observed to completely shade the Onset solar shield (model RS3) containing the air temperature and relative humidity sensor between 10 AM and 4 PM during July 2014. The enhanced shields were installed, because the Onset shields are not

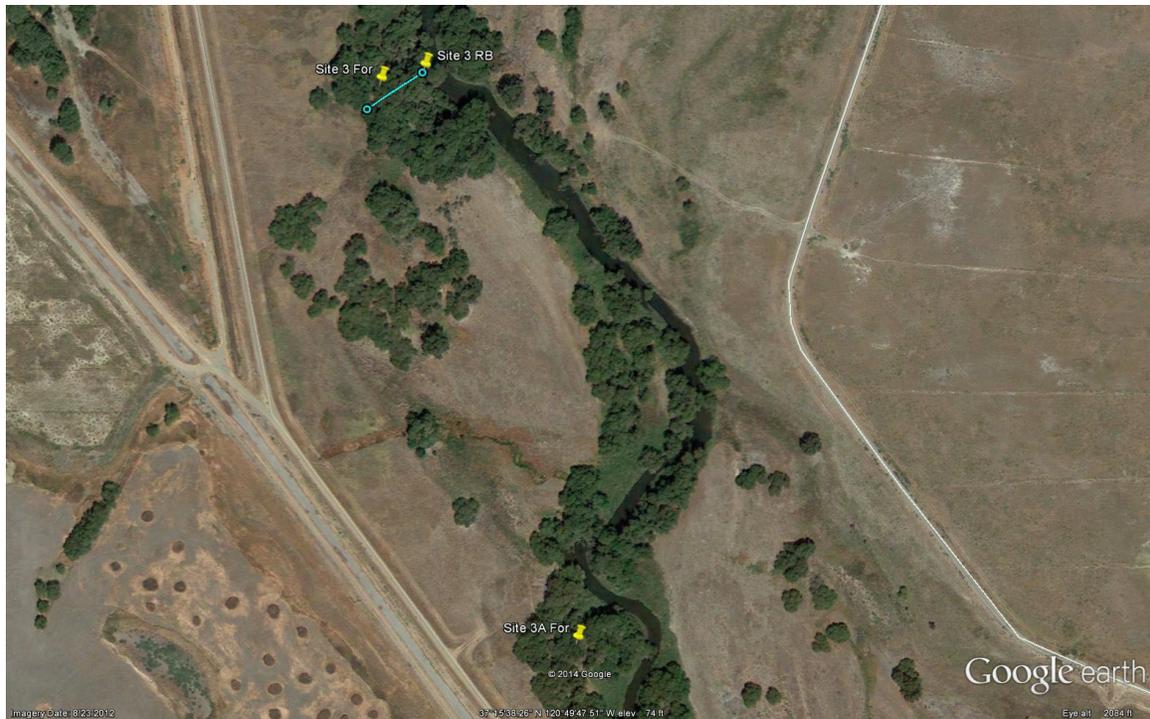
Figure 3. Google Earth image of Sites 3 and 3A in the San Luis National Wildlife Refuge near rivermile 138. The blue line shows the botanical transect, which was about 40 meters in length. The yellow pins show the locations of the weather stations near the riverbank (RB) and middle of the forest (For). The non-forested site, which is not shown, is about 1 mile downstream.

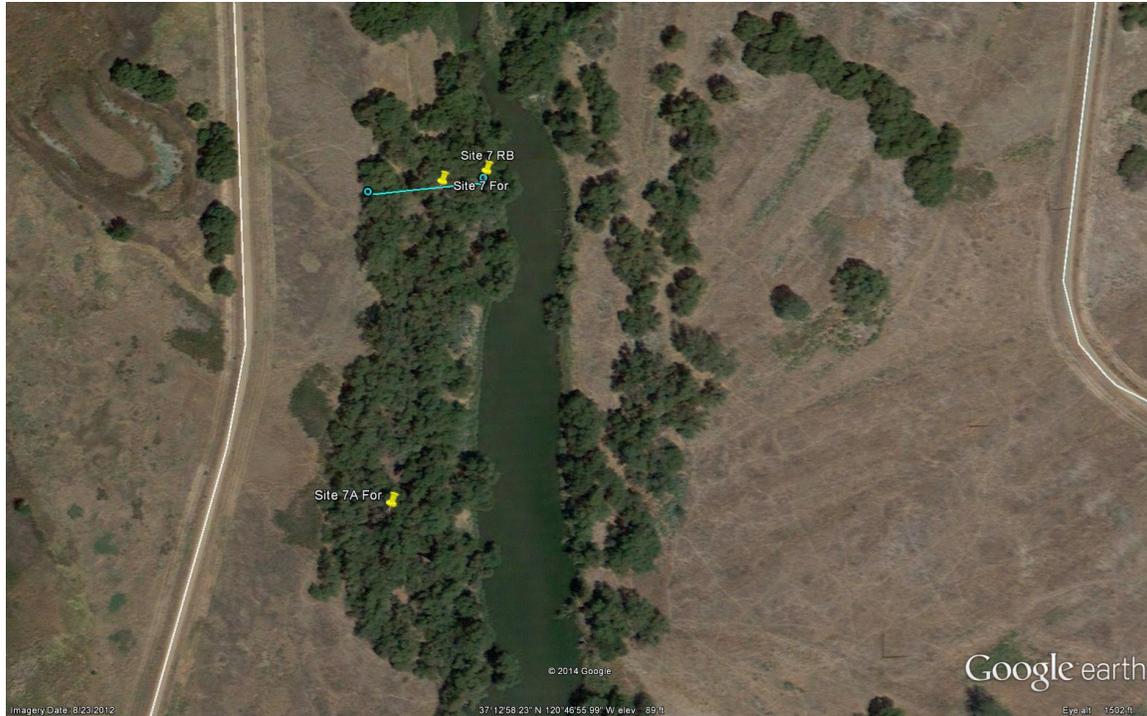
Figure 4. Google Earth image of Site 7 in the San Luis National Wildlife Refuge near rivermile 144. The blue line shows the botanical transect, which was about 50 meters in length. The yellow pins show the locations of the weather stations near the riverbank (RB) and middle of the forest (For). The non-forested site, which is not shown, is about 2 miles downstream.

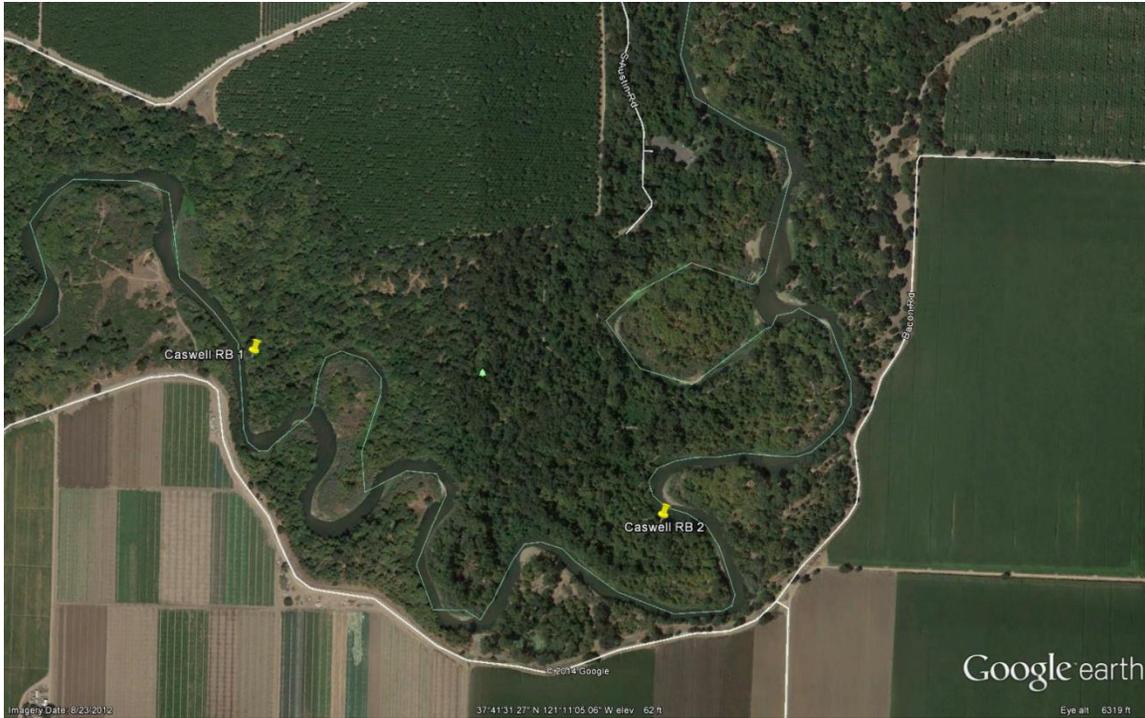
Figure 5. Google Earth image of Caswell Memorial State Park Sites 1 and 2 on the Stanislaus River near rivermile 7. The yellow pins show the locations of the weather stations near the riverbank (RB).

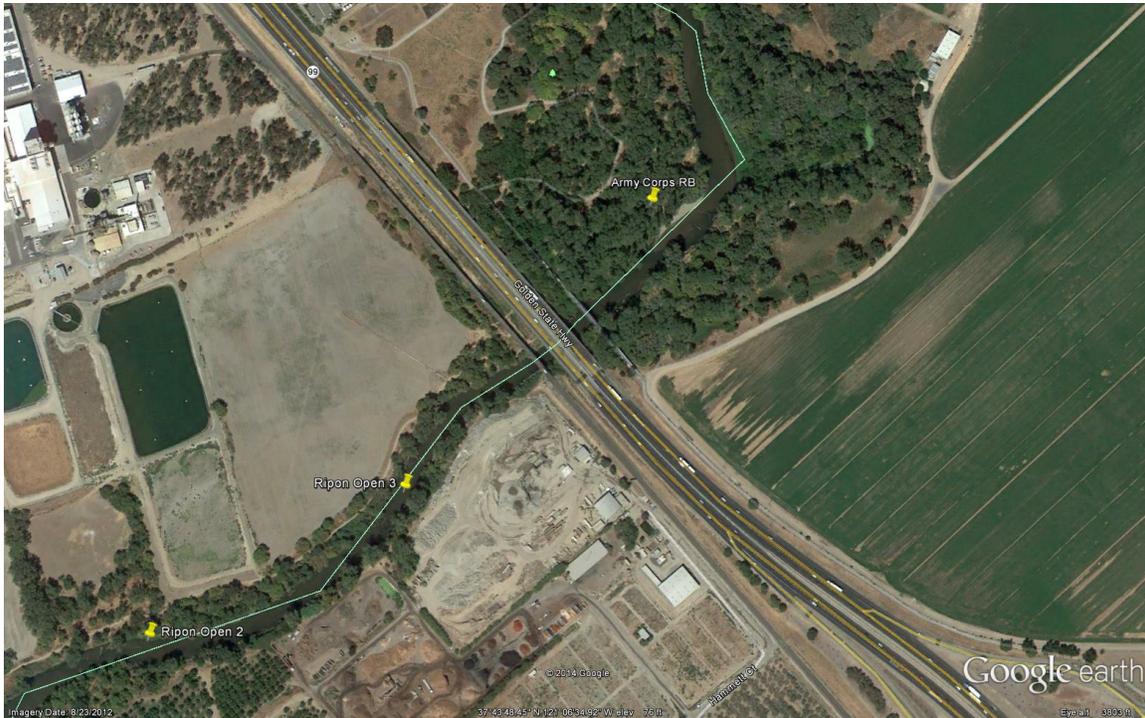
Figure 6. Google Earth image of the locations of three weather stations on the Stanislaus River at the Army Corp Park and two of three non-forested sites called Ripon Open 2 and 3. The sites are near State Highway 99 in the City of Ripon, California.

For Phase 2 studies, there were a total of 15 relocated weather station sites in the San Luis National Refuge and the Stanislaus River. The relocated stations included sensors for air temperature, wind speed, relative humidity, and solar radiation, but not soil moisture. Two stations were established in the center of forested areas, one near the riverbank, and two in non-forested sites at Site 3 in the San Luis National Refuge (Figure 3). Two more stations were established in the center of forested areas, one near the riverbank, and one in a non-forested site at Site 7 in the San Luis National Refuge (Figure 4). Sites 3 and 7 in the San Luis National Refuge are among the largest forested areas in the Restoration Area. Three weather stations were also established along the Stanislaus River near the riverbank within large forests at the Caswell Memorial State Park (Caswell) and the Army Corps Park Ripon River Crossing (ACOE Park). Caswell has a dense, old growth, valley oak woodland that is about 7.4 river kilometers (4.6 miles) long (Figure 5). The ACOE Park site is also a relatively large (300 meter diameter), old growth woodland (Figure 6). Three more stations were established in non-forested areas on City of Ripon property (Figure 6).

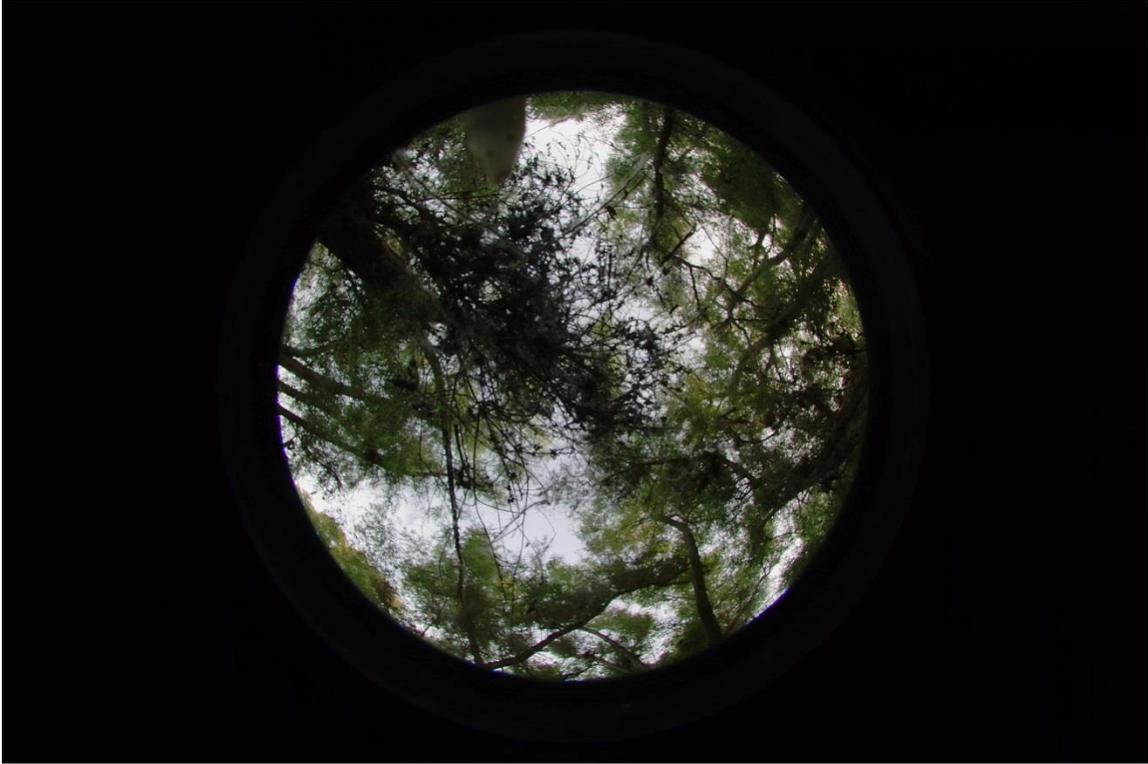
Figure 7. Hemispherical photo of the forested Site 3 in the San Luis National Refuge.

| Location | Photo | % Cover |
|---|---|---|
| Site 3 | 738 | 86.9 |

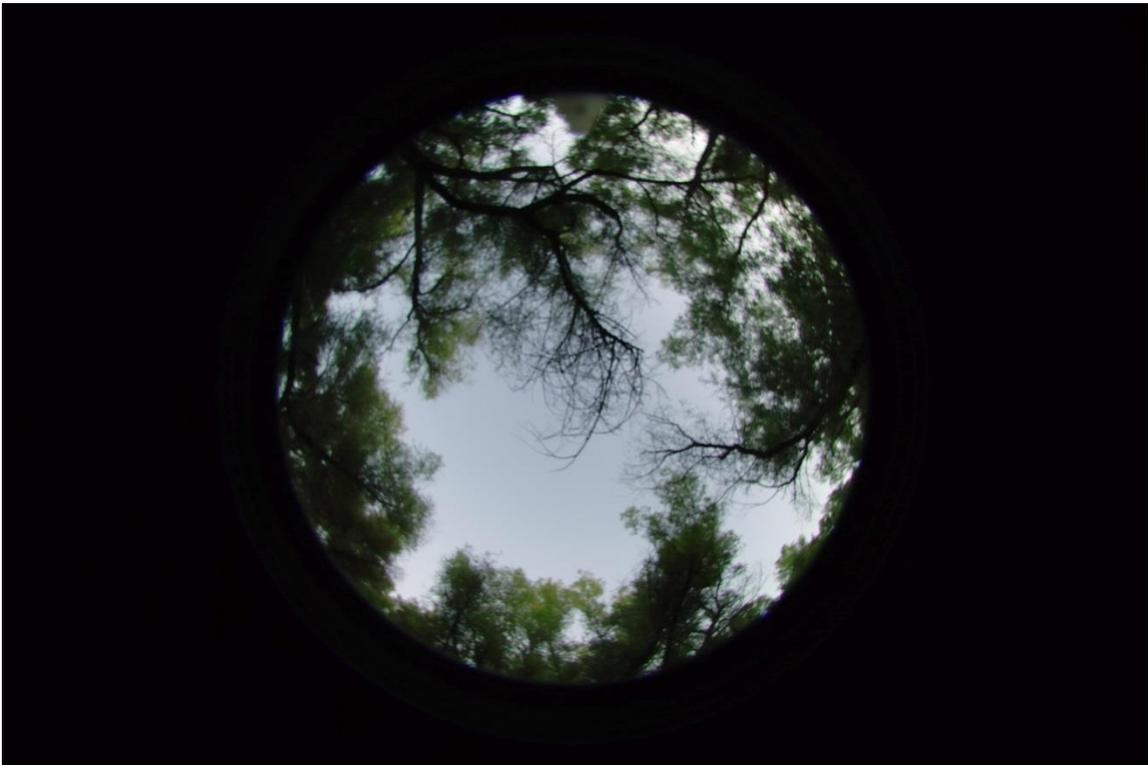
Figure 8. Hemispherical photo of the forested Site 7 in the San Luis National Refuge.

| Location | Photo | % Cover |
|---|---|---|
| Site 7 | 773 | 58.3 |

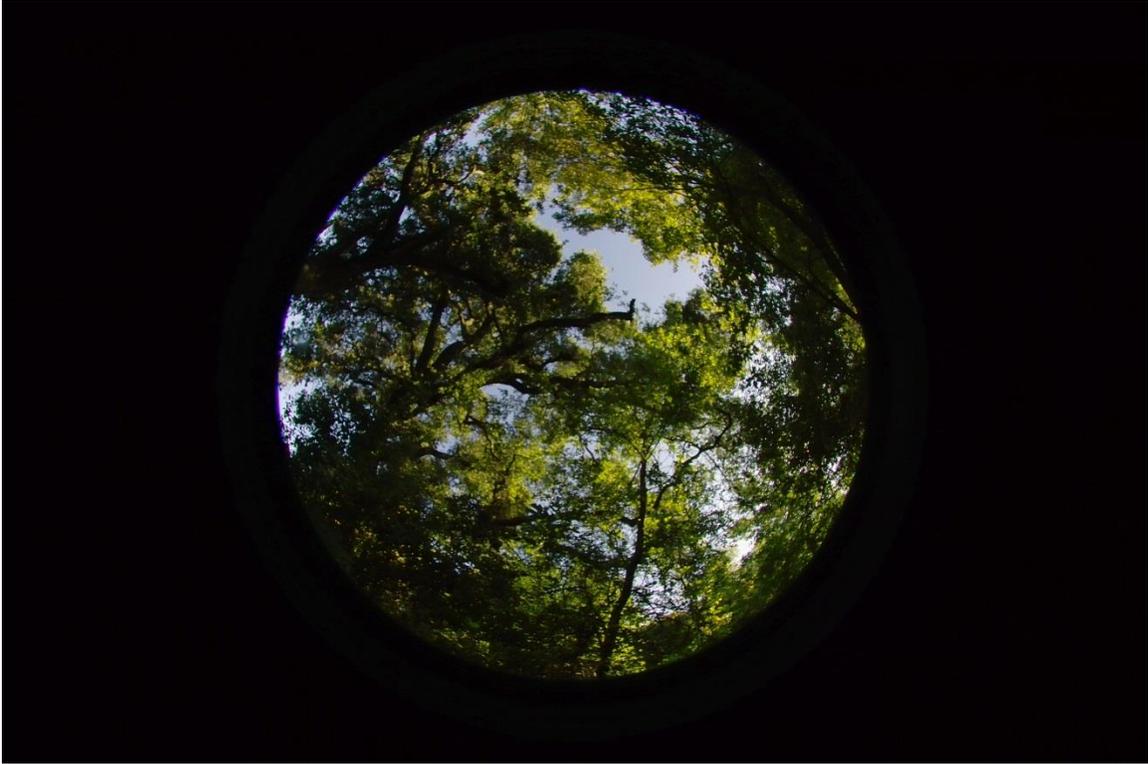
Figure 9. Hemispherical photo of Caswell Site 1 on the Stanislaus River.

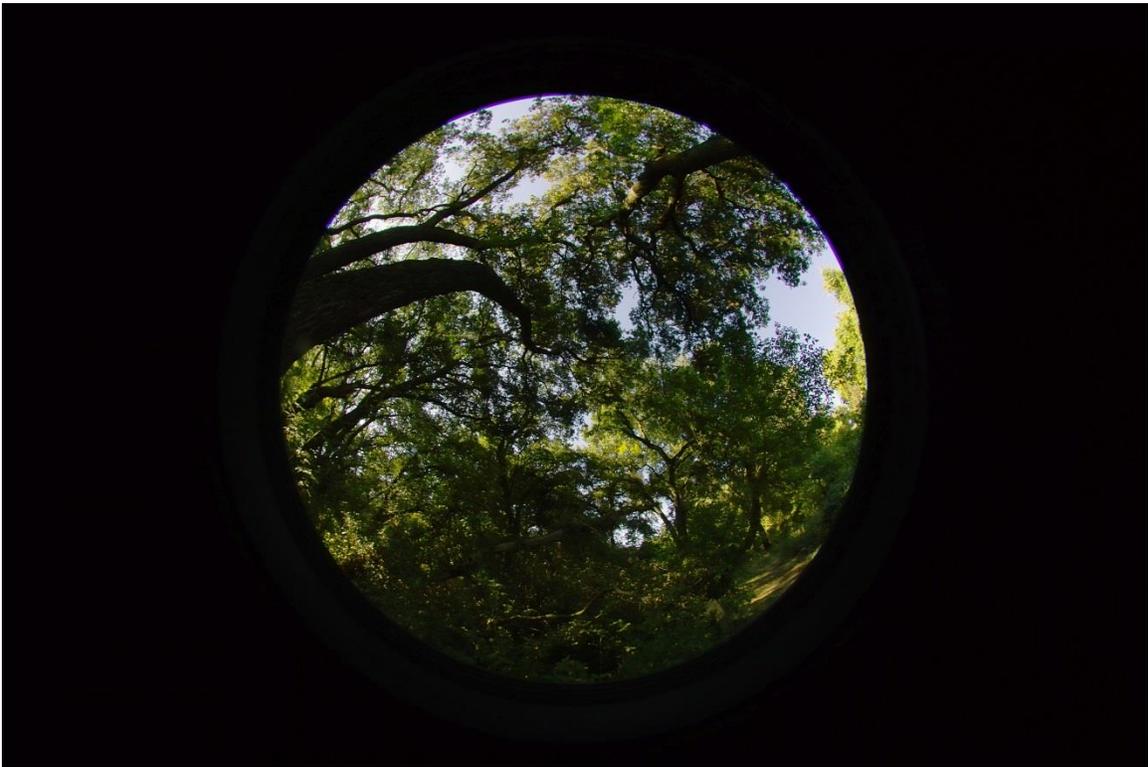
Figure 10. Hemispherical photo of Caswell Site 2 on the Stanislaus River.

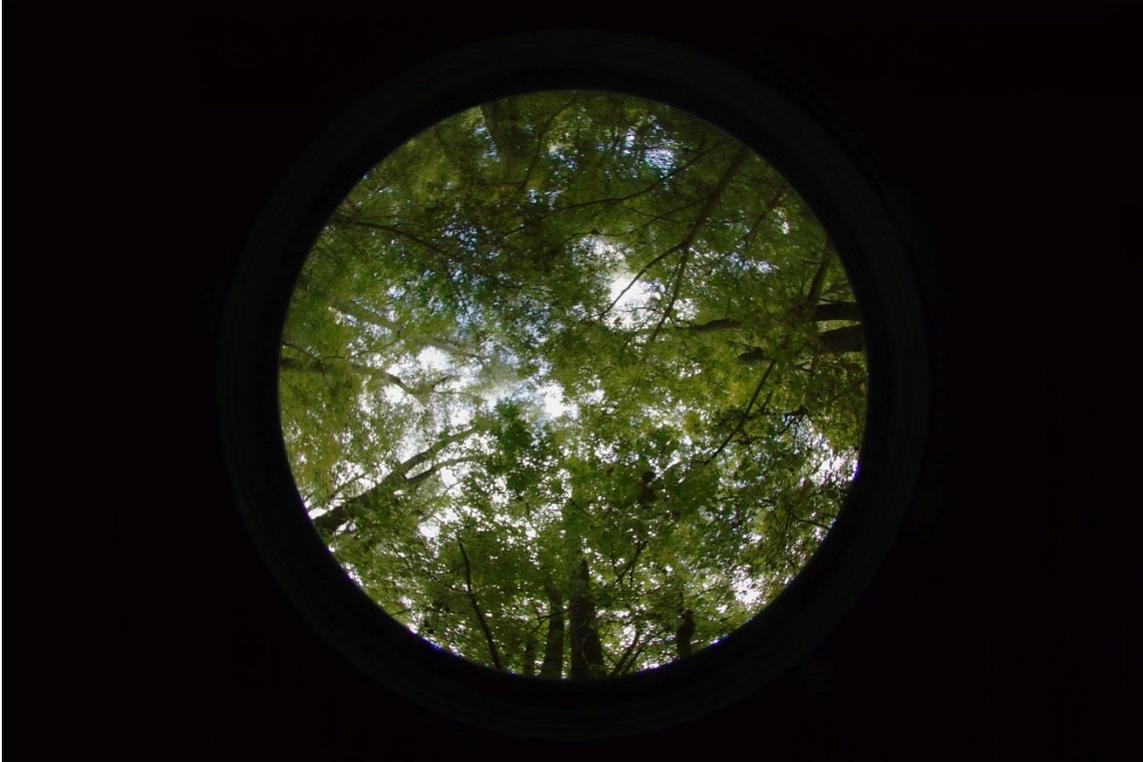
Figure 11. Hemispherical photo of ACOE Park Site 1 on the Stanislaus River.

Microclimate data collected after the stations were redeployed and enhanced solar shields were installed between June 30 and July 28 suggest that large valley floor forests like those at Caswell and the ACOE Park can consistently reduce air temperatures by 5-10°F and achieve a maximum reduction of 12.0°F, which is similar to the 8.6°F reduction observed in the upper watersheds (Moore et al. 2005). In contrast, even the largest forested areas in the Restoration Area (Sites 3 and 7) were too small to reduce air temperatures by more than a mean of 2.3°F (Table 2). The largest temperature reductions occurred at ACOE Park Site 1, which had the largest forest area (Table 2), minimal herbaceous understory, a very dense tree canopy (Figure 11), and no detectable wind speed from July 25 to July 27, 2014.

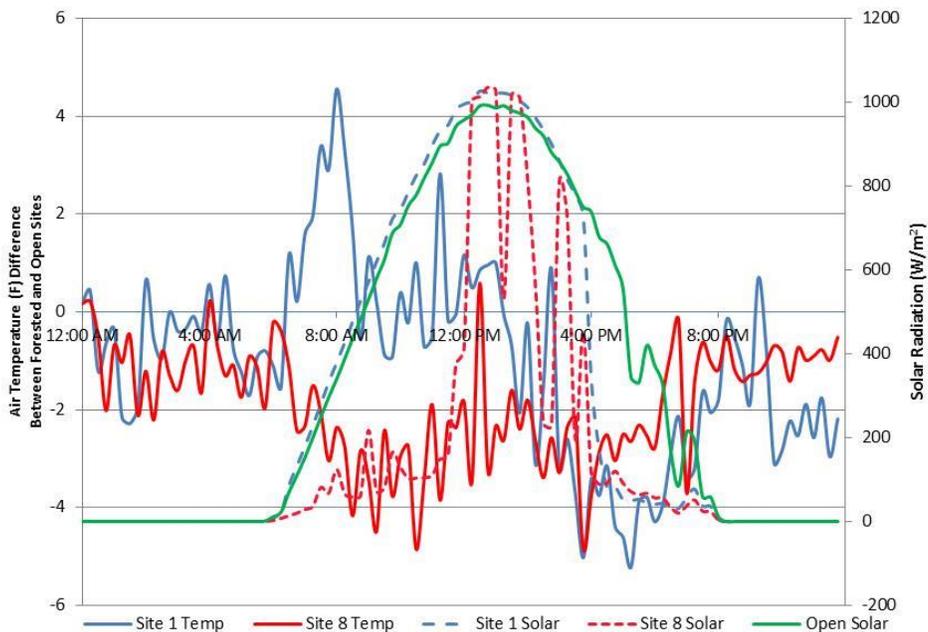
Figure 12. Difference in air temperatures (Temp) between the forested and non-forested areas and the observed solar radiation (W/m^2) at the forested and non-forested (Open) areas at Sites 1 and 8 in the San Luis National Refuge on May 23, 2014. Negative values indicate that the forested areas were cooler than the open areas.

Another concern that arose from the preliminary studies was that most sites in the Restoration Area had forested areas that were so small (e.g., Sites 1 and 8) that the degree of cooling was highly variable during the day (Figure 12). The high variability was presumably a result of the sensors alternately receiving warm air from open areas and cool air from the forest. To resolve this problem, some weather stations were relocated to the middle of the largest forests in the San Luis National Refuge and new sites were selected within large forests on the Stanislaus River as described in the Methods.

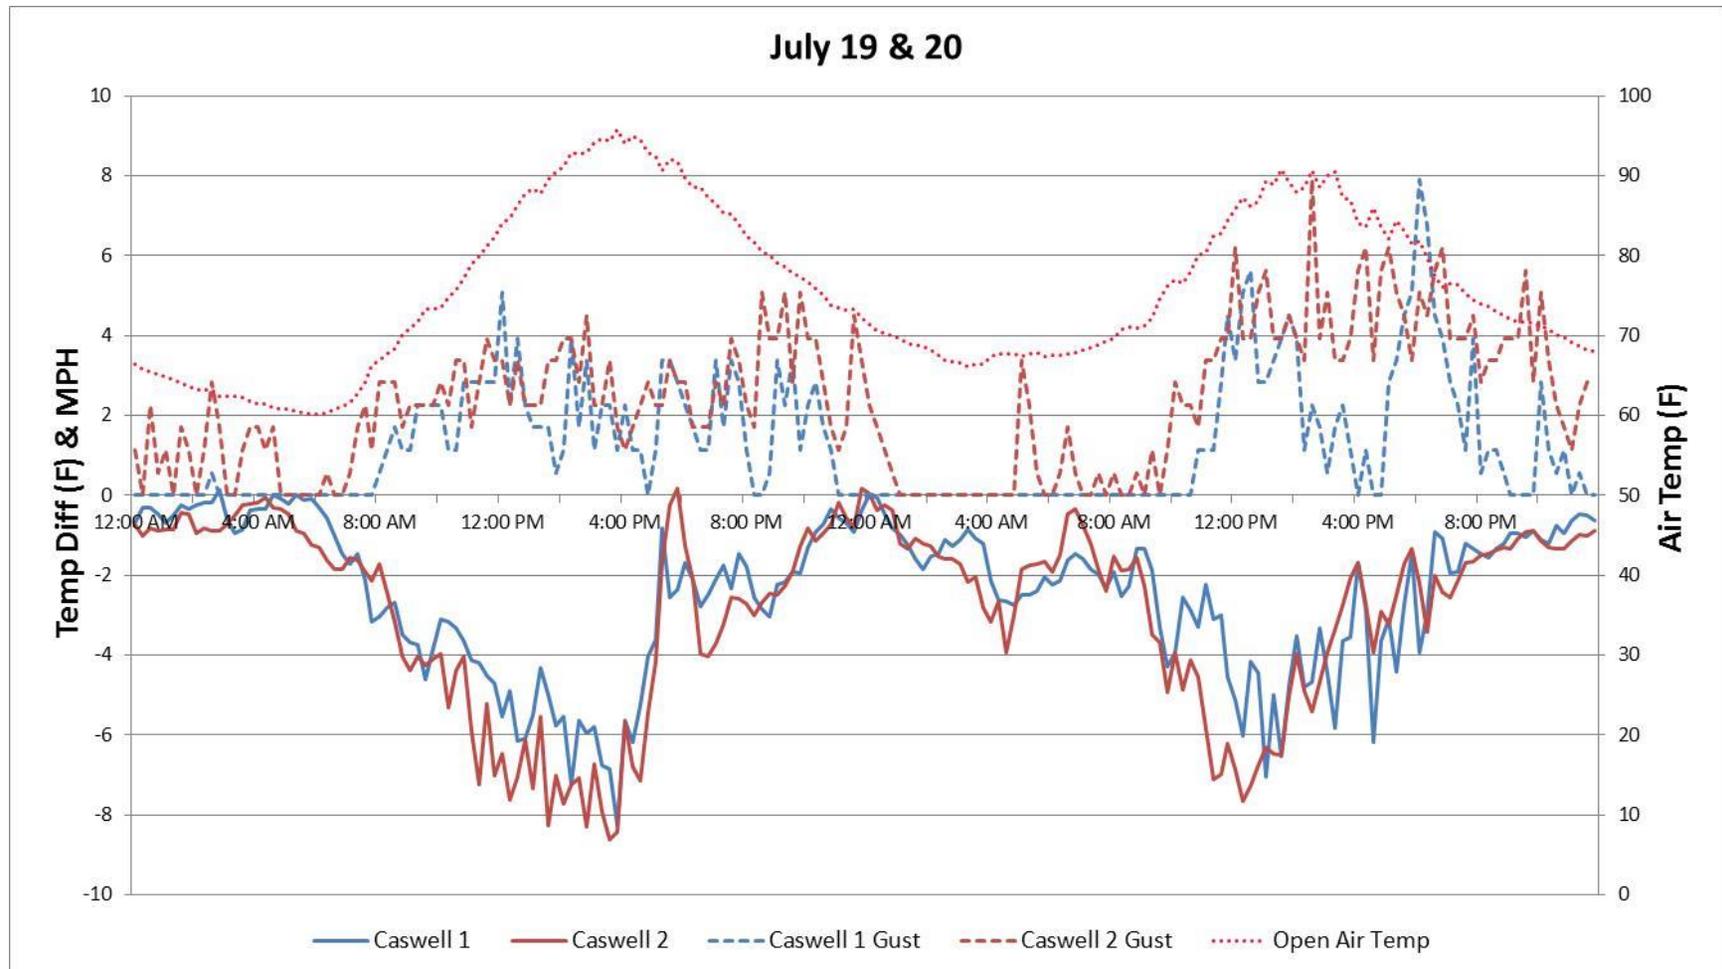
Figure 13. Air temperature at the non-forested Ripon Open Site 1, wind gust speeds (mph) at forested sites Caswell 1 and Caswell 2, and the difference in air temperatures between forested site Caswell 1 and the non-forested Ripon Open Site 1 and forested site Caswell 2 and the non-forested Ripon Open Site 2 in 15-minute intervals on July 19 and July 20, 2014.

The reductions in air temperatures at the forested sites at the Caswell and ACOE Park sites were relatively consistent during the afternoon (12 PM to 4 PM) compared to those at Sites 3 and 7 at the San Luis National Refuge. The following describes comparisons in microclimate data between two consecutive days that were selected to show a wide range in observed values. At the Caswell sites, the temperature reductions were usually greater at Site 2 than at Site 1 and greater on July 19 when wind gust speeds were relatively low and air temperatures were high compared to conditions on July 20 (Figure 13). Similarly, temperature reductions at Sites 3 and 3A in the San Luis National Wildlife Refuge were greater on July 7 when wind speeds were low compared to July 6 (Figure 14). There was a high degree of variability in the air temperature reductions at Site 7 in the San Luis National Wildlife Refuge on July 6 and 7 (Figure 15). On July 6, when wind gust speeds were higher than on July 7, air temperature reductions were greatest near the riverbank at Site 7 particularly when compared to the mid-forest weather station at Site 7. These data suggest that warm air from surrounding non-forested areas on the valley floor can readily overcome the cooling ability of small forested areas, particularly as wind speed increases. Additional data are required to quantify the temperature reduction in forested areas during the spring when most spring-run Chinook salmon would be expected to be migrating.

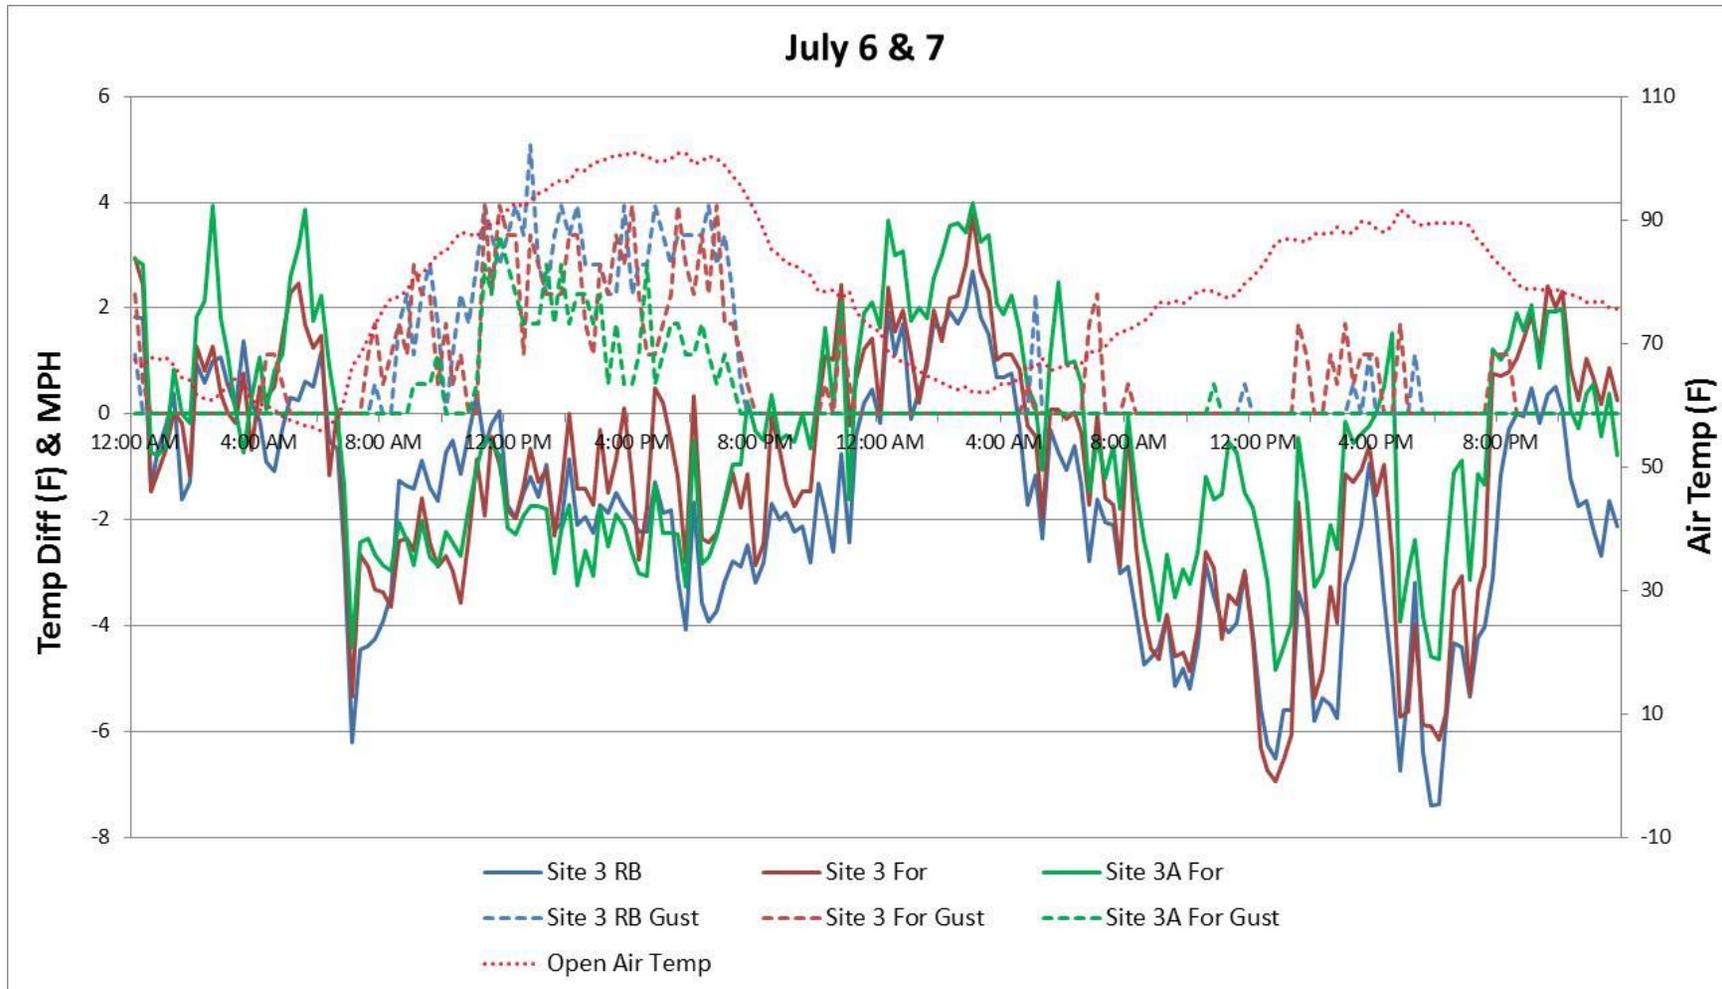
Figure 14. Air temperature at the non-forested open site, wind gust speeds (mph) at the riverbank (RB) and mid-forest (For) weather stations, and the difference in air temperatures between forested sites and the non-forested open site in 15-minute intervals at Site 3 in the San Luis National Wildlife Refuge on July 6 and July 7, 2014.

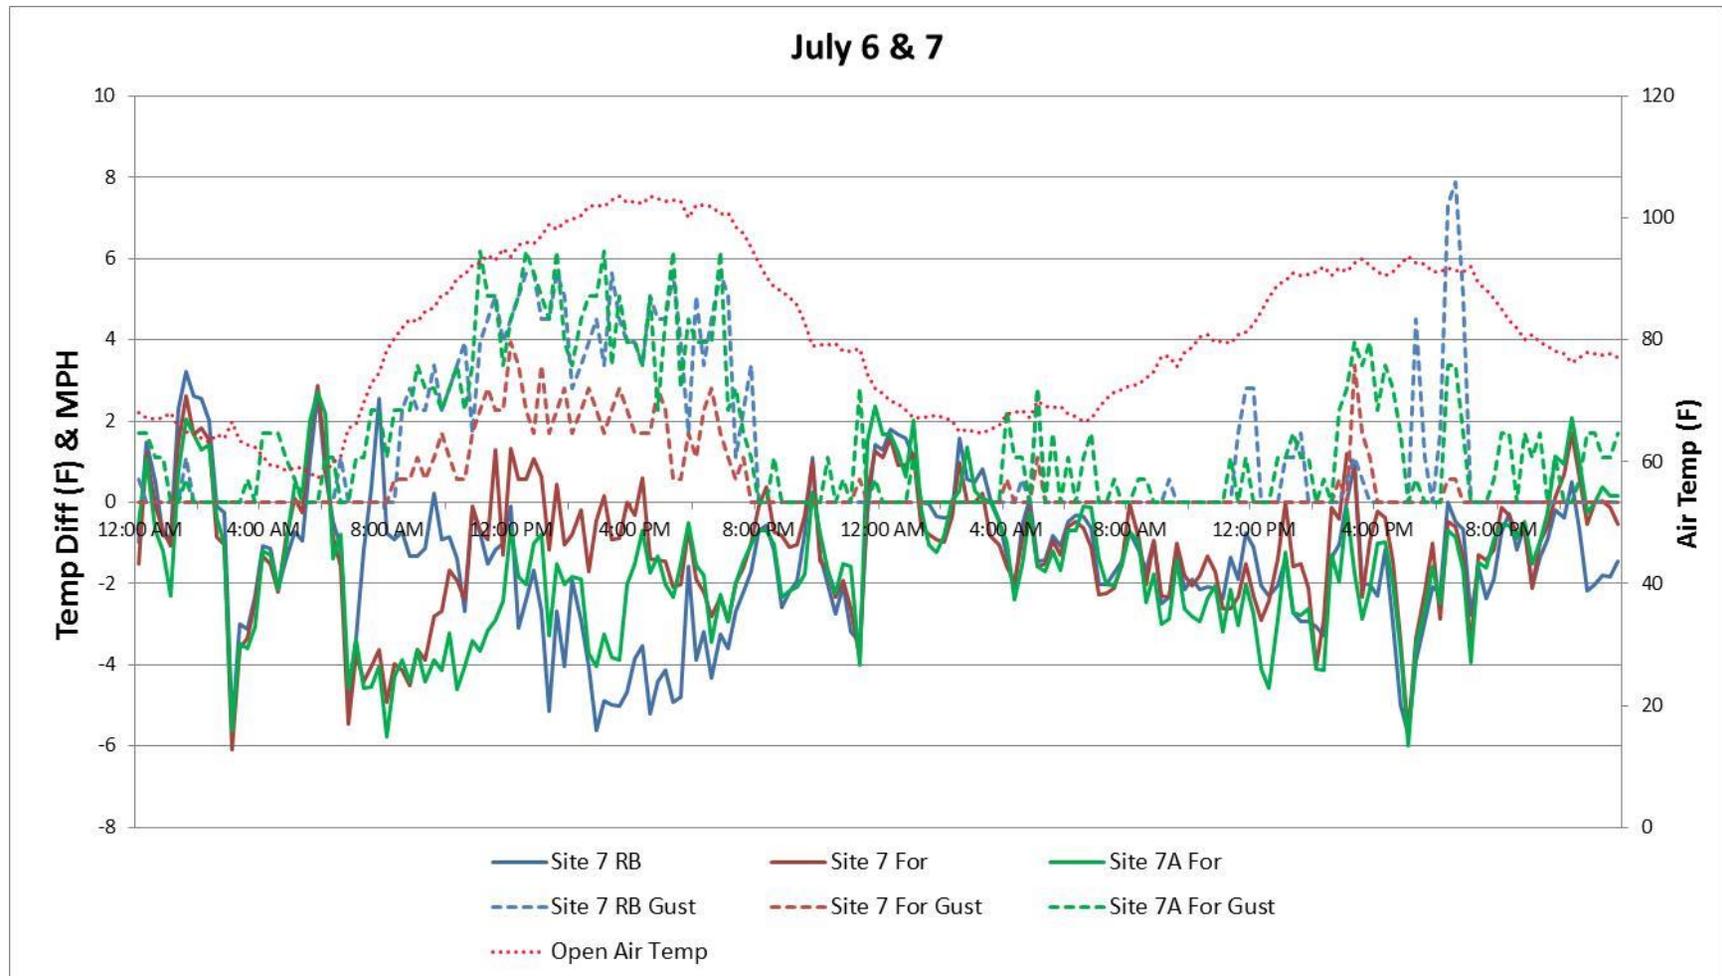
Figure 15. Air temperature at the non-forested open site, wind gust speeds (mph) at the riverbank (RB) and mid-forest (For) weather stations, and the difference in air temperatures between forested sites and the non-forested open site in 15-minute intervals at Site 7 in the San Luis National Wildlife Refuge on July 6 and July 7, 2014.
