San Joaquin River Restoration Program Fish Passage Evaluation

Draft Technical Memorandum

Evaluation of Partial Fish Passage Barriers

July 2012

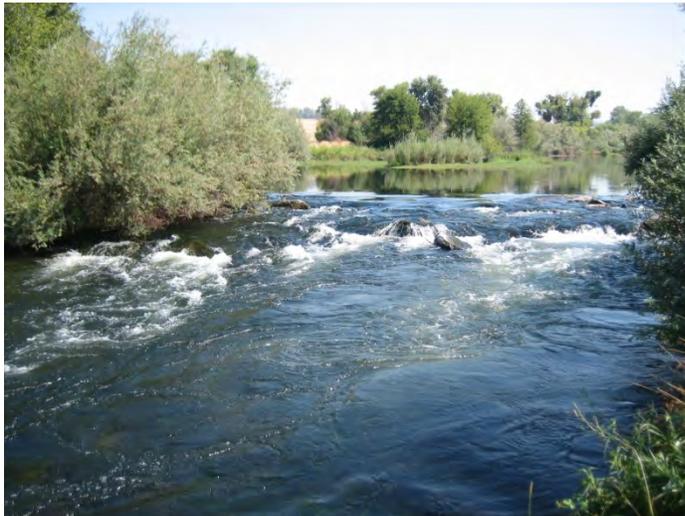
Lost Lake Weir #1 looking upstream at left bank

This weir is located upstream of Weir #2. The average weir elevation in the model is 299.0 feet. The depth over the weir was calculated by subtracting the average weir elevation with the water surface elevation over the weir. There is flow over the weir at all flows but the depth over the weir does not reach 1.2 feet until flows are around 900 cfs. For flows under 900 cfs jump would be the primary method to pass. Depth for jumping is not sufficient until flows are above 100 cfs. The jump pool is just downstream the weir and a jumping

height of 1.8 feet may be difficult for an adult Chinook salmon that is very close to its spawning grounds. Figure 1 did not include fish in poor condition ($C_{fc} = 0.50$) so the curves were developed and a jump of 80 degrees at the rock weir may be achieved with a maximum jump at 1.9 feet for a length of around one foot. There is a possibility that the fish will have problems passing with the height of the jump since the width of the weir is more than three feet and there are multiple rocks at varying depths. However, the model looks at the overall average weir height but the weir actually is varied in height so jump height is varied. Flow velocities are below 10.8 fps for all flows. Ultimately, the average jump height is within the criteria at 100 cfs. If the primary spawning grounds are going to be located upstream this structure, it is

recommended that the structure be observed at flows from 100 cfs – 900 cfs to make sure fish passage is not an issue.

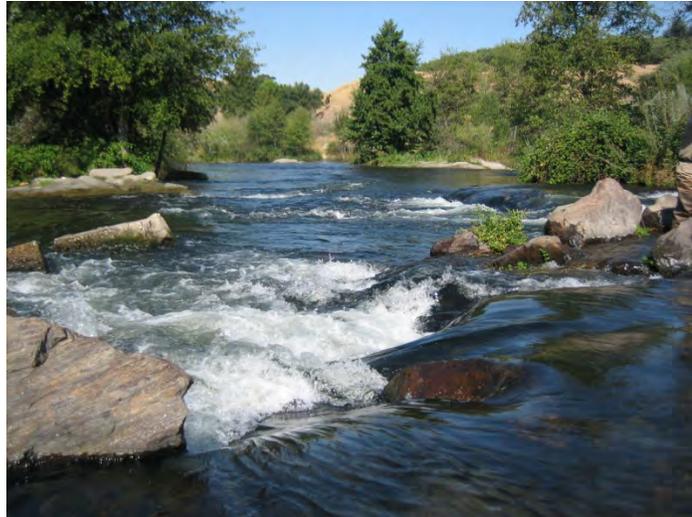
The average weir elevation in the model is 297 feet. There is flow over the weir at all flows but the depth over the weir does not reach 1.2 feet until flows are around 500 cfs. For flows less than 500 cfs jump would be the primary method to pass. The hydraulic one-dimensional model was not able to duplicate the complexity of the flow over the varied weir so the drop was not modeled. More data collection may be required to evaluate the structure.

Lost Lake Weir #2 looking downstream from left bank

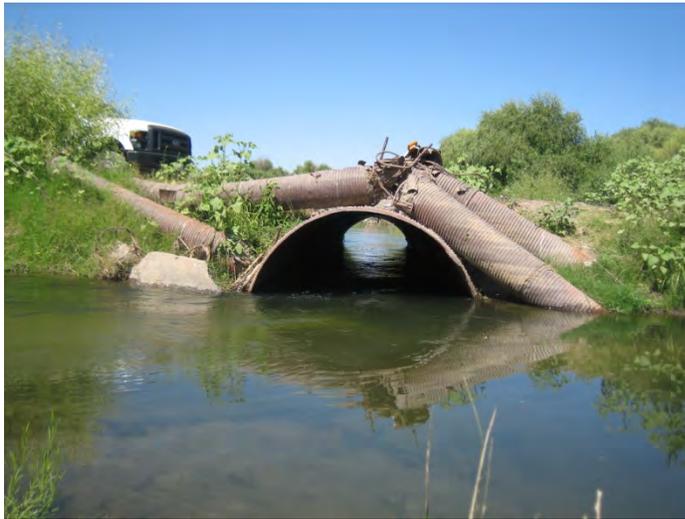
San Mateo is a low flow crossing that is publicly accessible. It is an earthen structure that spans the width of the channel with a culvert. The crossing was evaluated for passage at the culvert for flows up to 200 cfs. At flows that exceed 200 cfs the road is overtopped and acts like a weir.

San Mateo Avenue culvert looking downstream

The criteria for minimum depth of 1.2 feet is compared for the culvert and then as a weir when flows overtop the road. The culvert is imbedded so jump was not evaluated at the outlet since even the lowest flows would be at bed level. Minimum depth within the culvert is at 1.8 feet for 25 cfs; this exceeds 1.2 feet so depth does not exceed criteria within the culvert. Minimum depth over the road for flows from 200 – 700 cfs is less than 1.2 feet, but fish can pass in the culvert since it is fully submerged.

length is less than 60 feet. Velocities of 6 fps within the culvert are not exceeded for any flows but are equal to 6 fps at the outlet for flows at 200 cfs. The maximum velocity over the weir is estimated from Figure 3 at just over 3 fps for the road length estimated at 44 feet wide. The cross sections just upstream and downstream the road average around 1 fps for all flows. Based on these criteria for passage, this structure does not exceed criteria at any passage flows.

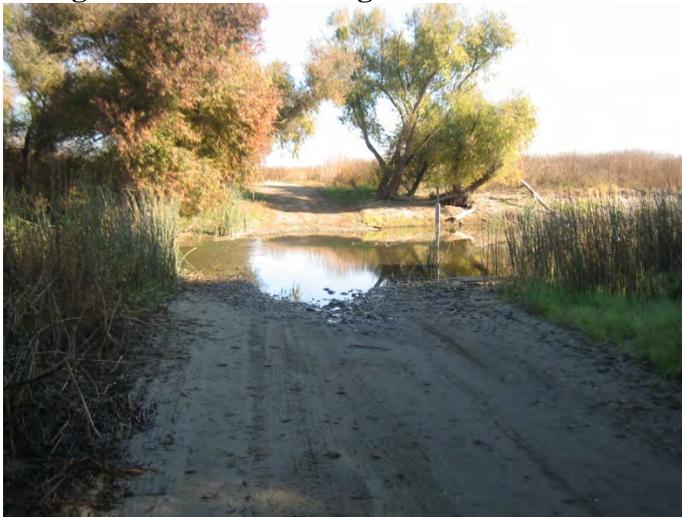
Refuge Low Flow Crossing

San Luis Wildlife Refuge low flow crossing looking east

The low flow crossing on the San Joaquin River is located within the San Luis Wildlife Refuge. It is maintained by the U.S. Fish and Wildlife Service. The crossing is used to access the East Bear Creek units. The crossing does not have any culverts and is constructed of mostly cobble. Vehicle crossing is limited to lower flows since it is almost always submerged. The width of the roadway top was measured around 14 feet. Since the structure is submerged most of the time, jump was not calculated but depth over the road should be at least 1.2 feet.

According to Figure 3, for a roadway width of 14 feet the velocities over the road should not exceed the burst speed of 8 fps. Velocities over the road are well below 8 fps. The crossing does not meet criteria for depth until flow reach 50 cfs.

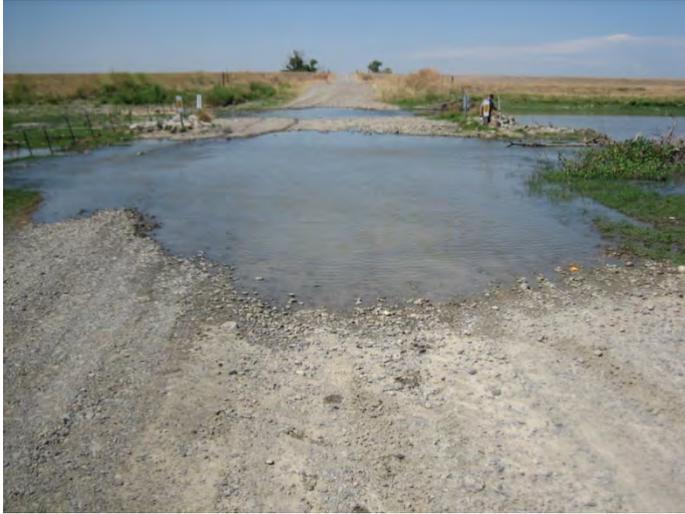
Dan McNamara Road is a low flow crossing within the Eastside Bypass near the Merced National Wildlife Refuge that is located upstream the Eastside Bypass bifurcation structures. Due to the proximity of the crossing to the bifurcation structures the hydraulics are affected by the boards-in at the Eastside Bypass and would be affected by gate closure. Both scenarios for boards-in and out with gates fully open were compared for fish passage to determine how changes at the Eastside Bypass Control Structure would change passage at Dan McNamara

Dan McNamara Road looking north

Road. The crossing is an earthen embankment with a gravel armored top. There is an incised channel at the culvert. The culvert is located in the center of the crossing with another culvert in the upper floodplain for an overflow channel that is silted in.

at the outlet for flows between 25 and 50 cfs. Based on Table 3 the velocity in the culvert should not exceed 6 fps since the culvert length is less than 60 feet. For flows at 25 through 50 cfs the salmon would need to jump the road since the culvert exceeds criteria, but do not have sufficient depth just downstream the road for jumping until 100 cfs. The maximum depth over the road does not meet the 1.2 feet criteria for passage until 600 cfs. Flow velocity over the road, when compared to Figure 1, is within criteria for burst speed.

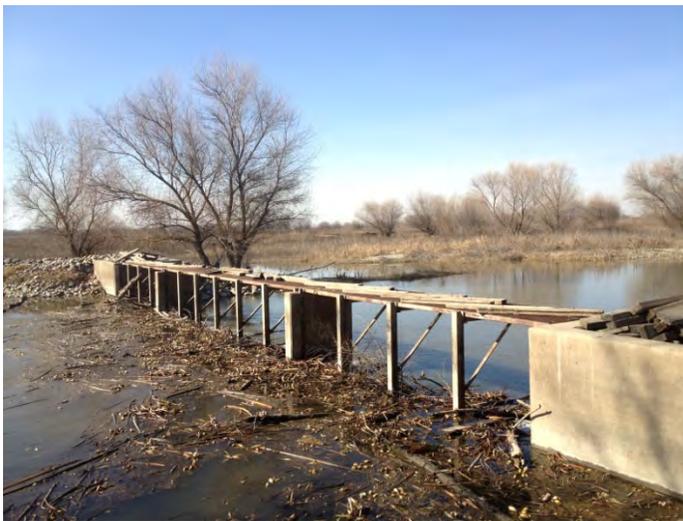
This structure is located downstream of Weir #2. The structure has concrete abutments on the banks with cobble armoring the banks and a cobble levee on the left bank. The cobble levee is overtopped before the weir is overtopped. The weir has a three foot wide metal grate for access to the metal I beams that are designed to accommodate the wood stop logs. There are two concrete pier walls that support the metal grate. There is a concrete apron on the bottom of the structure with a small concrete sill just downstream the structure that is submerged at all flows. There appears to be a higher sill at the inlet or stop logs that are in place that is about two feet higher than the concrete apron.

Merced Refuge Weir #1 looking west at left bank

The depth over the inlet is 1.2 feet when flows reach 500 cfs. The inlet can be jumped at 100 cfs mostly due to sufficient depth for jumping not due to the height of the jump, but with the many beams for the stop logs there is a risk of injury to the fish. The pool upstream is over four feet deep at 25 cfs. The weir is overtopped at flows above 3,000 cfs but the cobble bank is overtopped at 2,000 cfs. Depths over the cobble bank do not reach 1.2 feet until 3,000 cfs. The weir may not be passable at 3,000 cfs but the cobble bank is passable at 3,000 cfs. Velocities do not exceed cruising speed

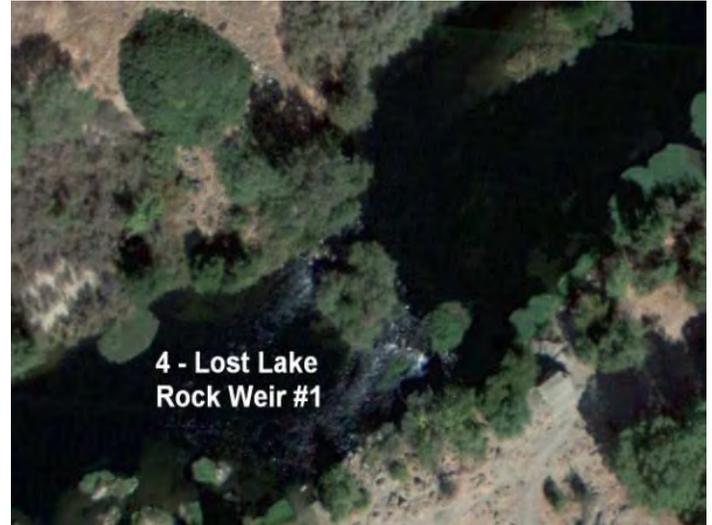
Photo 4_B. Rock weir from upstream looking downstream from the weir

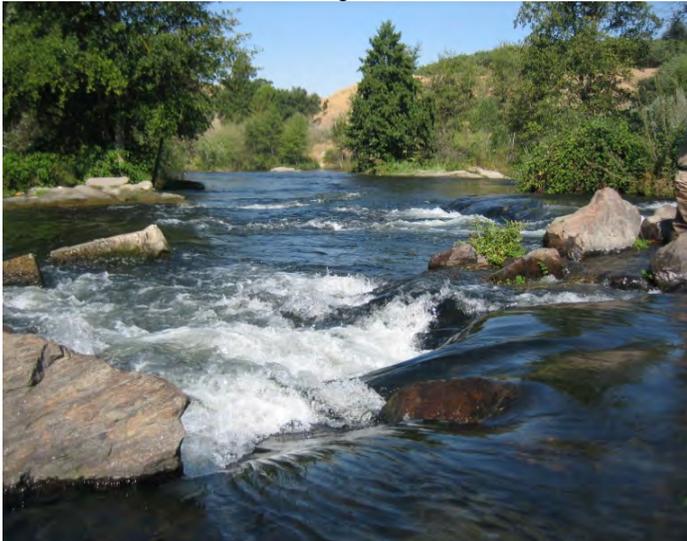
Photo 5_A. Rock weir looking downstream

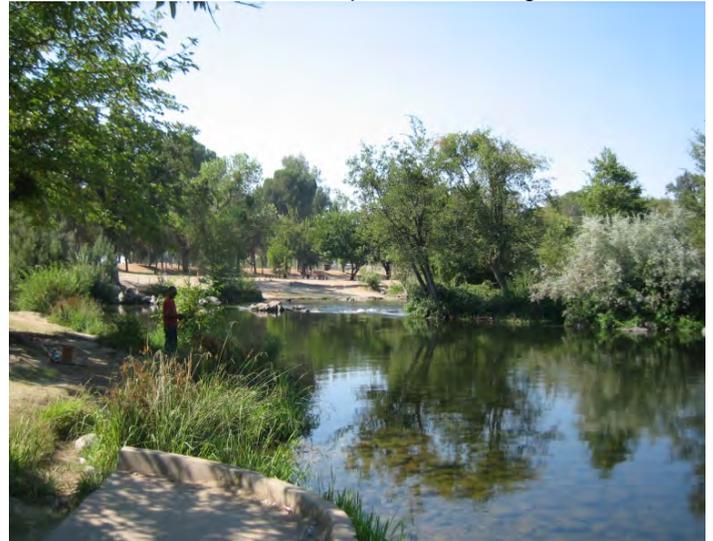
Photo 5_B. Rock weir from upstream looking downstream

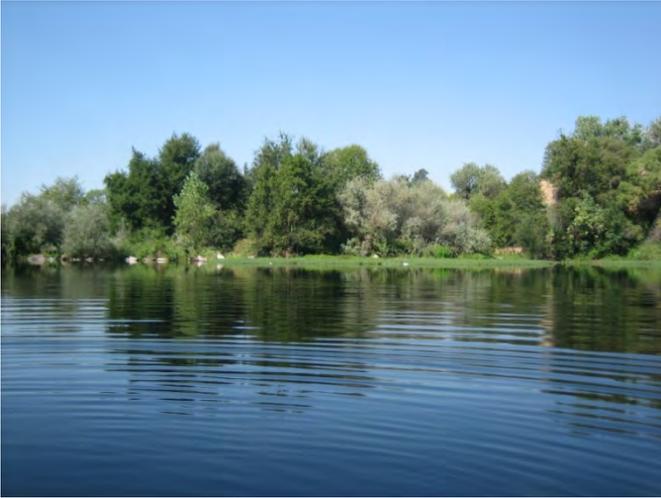
Photo 5_C. Rock weir vegetation from upstream looking downstream

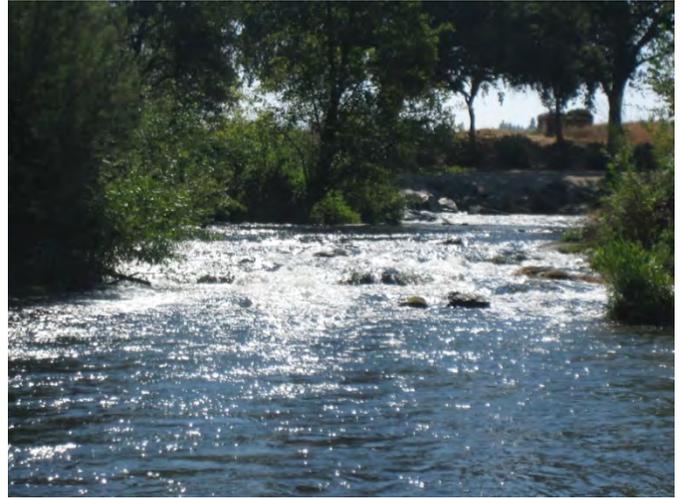
Photo 5_D. Rock weir from downstream looking upstream

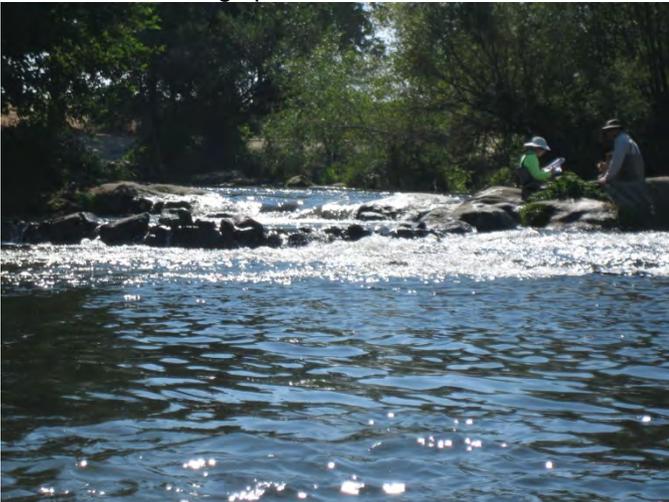
Photo 5_E. Cascades downstream of weir from downstream looking upstream

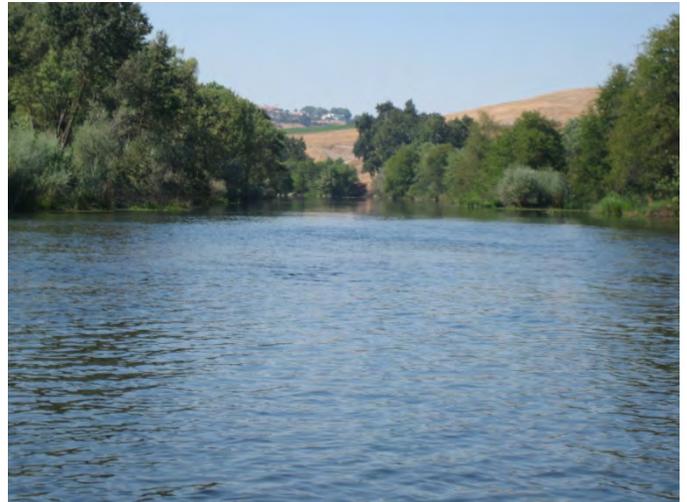
Photo 5_F. Channel downstream falls and weir

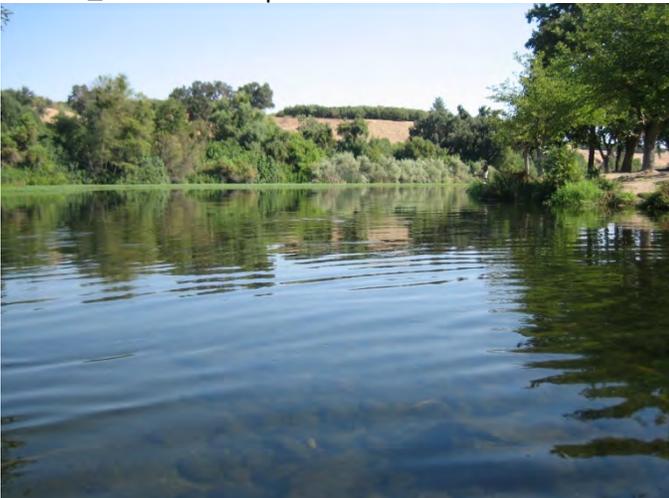
Photo 5_G. Channel upstream weir

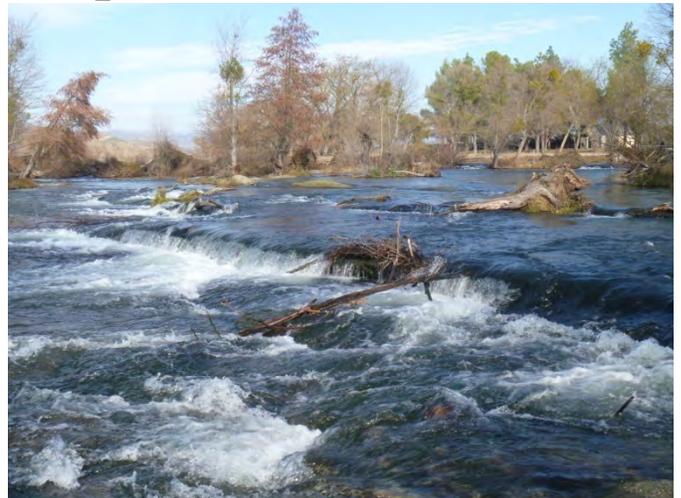
Photo 5_H. Cascades downstream at 350 cfs

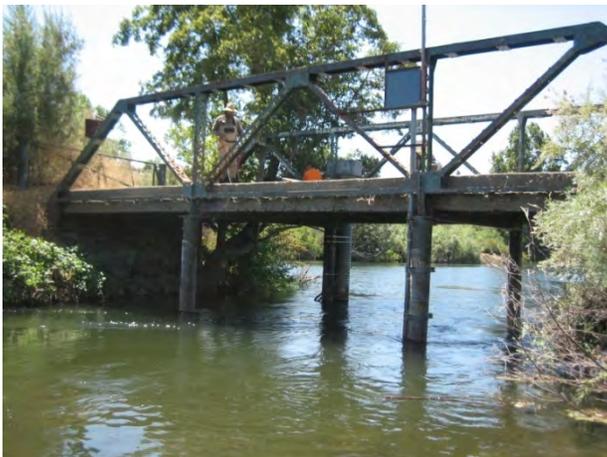
Donny Bridge has private access and does not look like it is currently in use, but appears to be maintained for water data collection (Photo 17_A). The bridge was likely used for private equipment crossing. There is a concrete bridge deck with a metal truss and 12 inch diameter steel pipes for the piers. The bridge height was measured as 13.4 feet from the channel thalweg with a width of 16 feet and a span of about 52 feet. The total number of bridge piers is four and measured 17.1 feet apart.

Photo 17_A. Bridge looking downstream

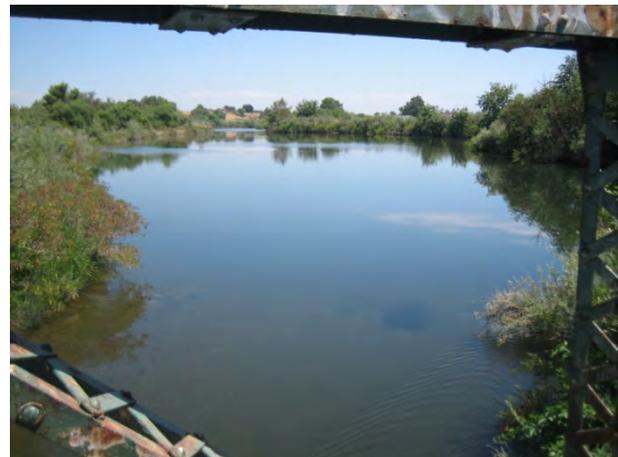
The channel substrate is mostly sand with gravel and some cobble and boulders. The channel is clean with brush and large woody trees on the banks with tall annual grasses in the floodplain. The active channel width at the bridge measured as 37.5 feet. The channel upstream and downstream is much wider and was estimated at about 150 feet (Photo 17_B).

Photo 17_B. Channel looking upstream

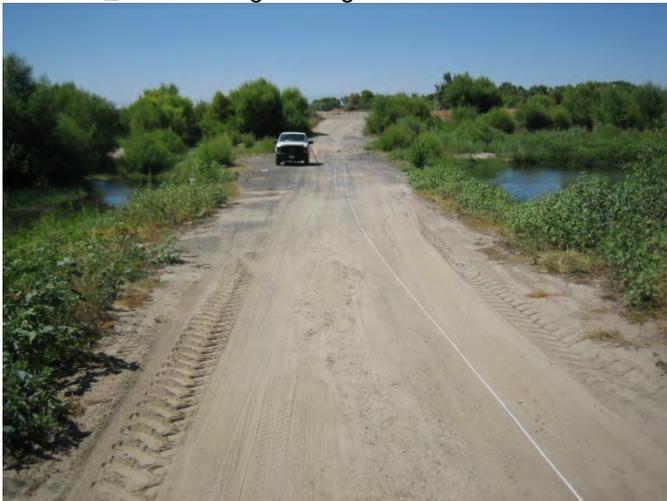
San Mateo Avenue is an earthen low flow crossing with a culvert that is located on the San Joaquin River (Photo 23_A). During high flows the crossing is submerged, so the crossing geometry typically changes after high flows. It is unknown if and when road improvements are made after high flows. The upstream crossing slopes and culvert inlet are armored with old corrugate metal pipe that is filled with concrete and rebar (Photo 23_B and C). At this time, the pipes appear to be acting as bank protection for the crossing upstream.

Photo 23_A. Crossing looking south

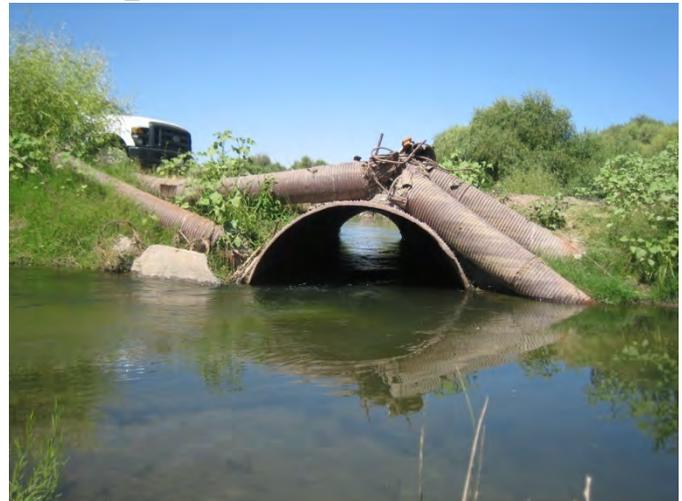
Photo 23_C. Culvert inlet looking upstream

Photos 23_B. Culvert inlet

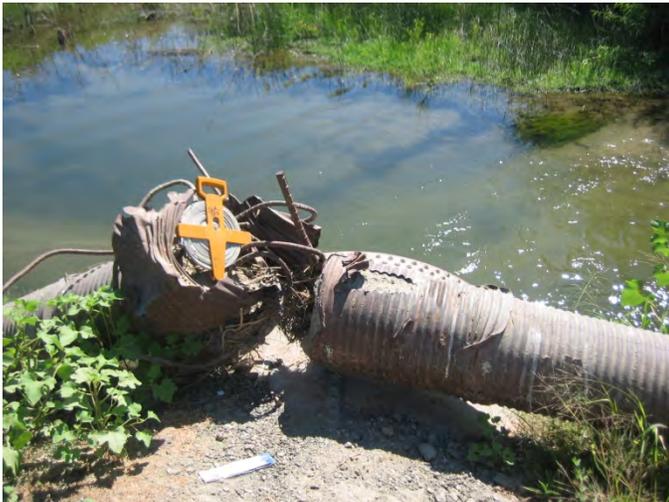
Photo 23_D. Culvert outlet looking downstream

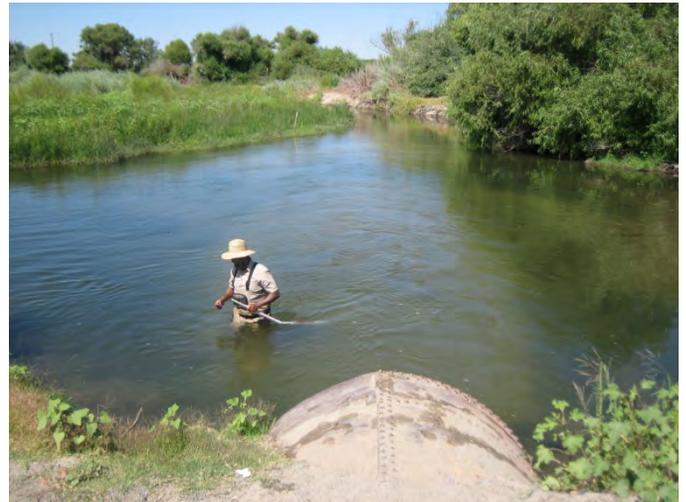
The crossing has a 407 foot span and is 44 feet wide with an average height measured from upstream at 4.6 feet. The active channel width was measured as 230 feet downstream. The culvert is a 7.2 foot circular pipe constructed of riveted and welded structural plate with a projecting inlet/outlet configuration (Photo 23_D). The rustline was located at the current water surface elevation with a rustline height measured at 4.5 feet from the bottom of the culvert inlet. The culvert is partially embedded and has natural substrate with a depth of 1.7 feet at the outlet. There was no outlet drop and the outlet was aligned to the centerline of the channel downstream. The inlet alignment was at a near 90 degree angle with the centerline of the channel (Photo 23_E).

Photo 23_E. Channel, 90 degree angle, upstream inlet

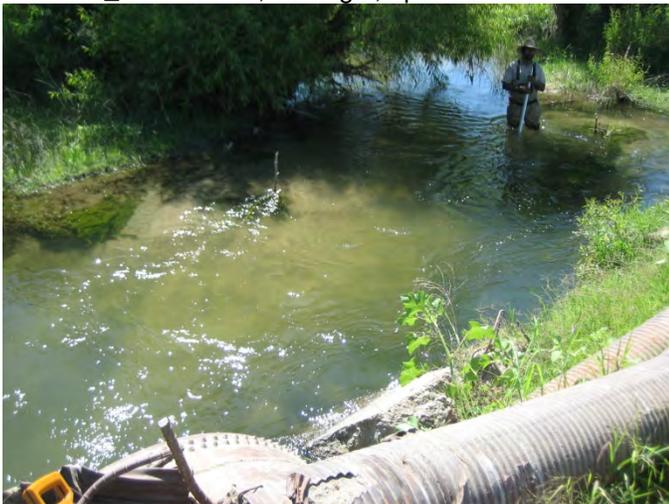
Photo 23_F. Culvert inlet

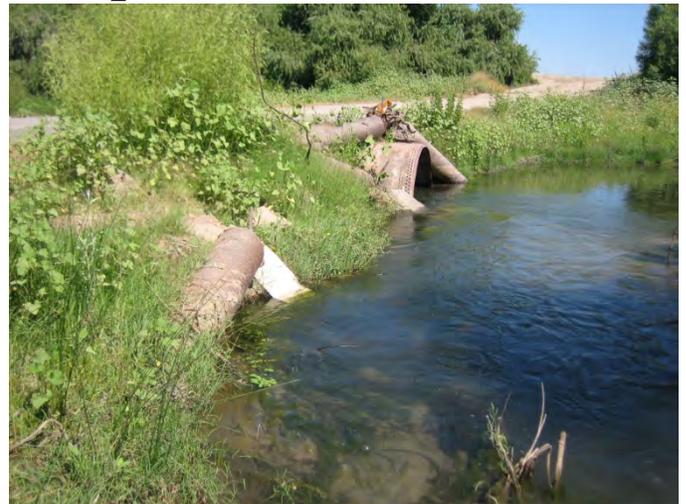
Photo 23_G. The culvert outlet

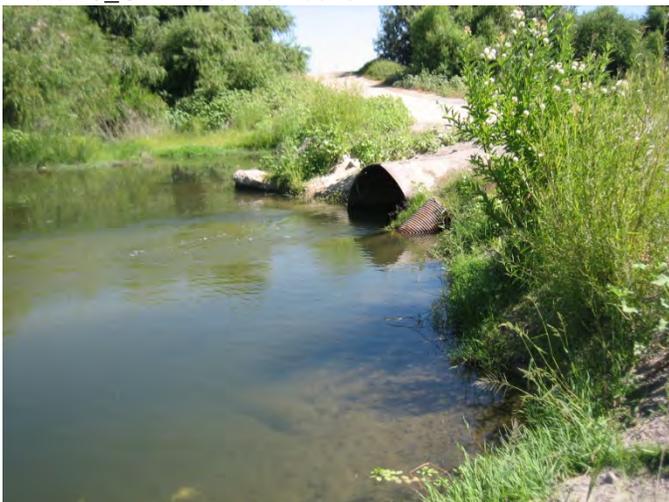
Photo 23_H. The channel looking upstream

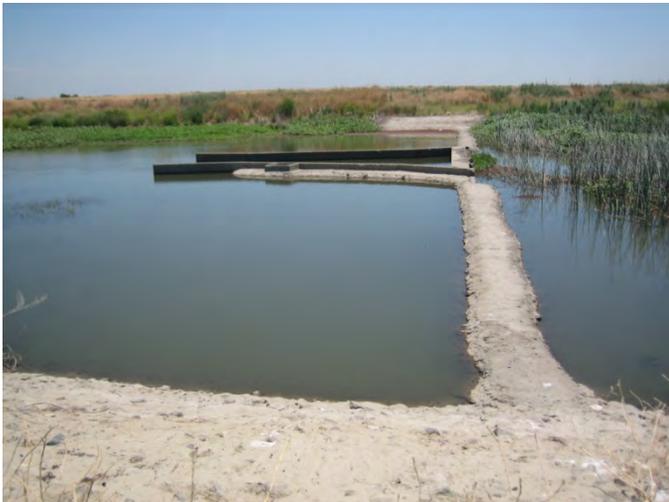
The Sand Slough Connector is located at the apex of the San Joaquin River and the Sand Slough near river mile 168.47 (Photo 29_A). The headgates to Reach 4B are located upstream on the right bank. The control structure is currently acting like a broad-crested weir with 6 rectangular openings each 5.1 x 5 feet (Photo 29_B). Each opening is designed for slide gates or stop logs that are manually dropped. At the time of the survey the openings were open. The structure has a cobble and concrete headwall that extends the structure to the right and left banks of the channel for a total length of 186 feet from bank to bank. The structure is about 2.5 feet wide and about 5.1 feet high.

Photo 29_A. Sand Slough Control Structure from the left bank

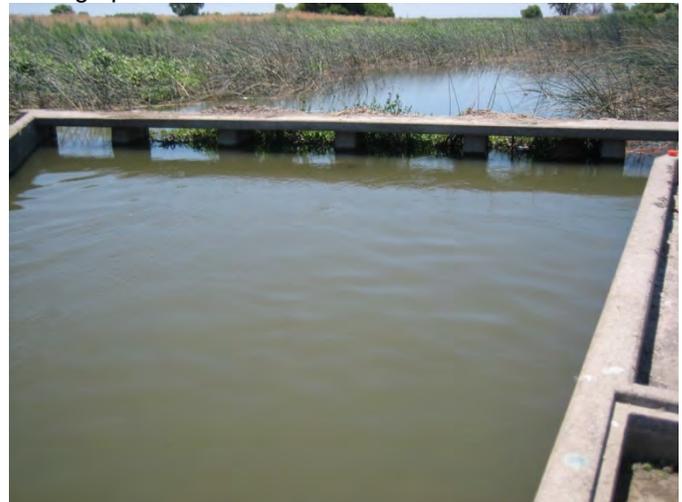
Photo 29_B. Sand Slough Control Structure openings looking upstream

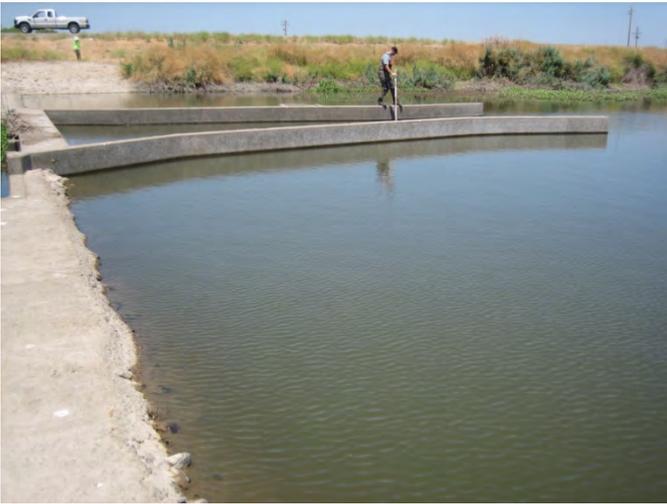
The channel upstream had heavy weeds with tall annual grasses in the floodplain and vegetation growing in the openings of the weir (Photo 29_D). Downstream the channel had light weeds with tall annual grasses in the floodplain (Photo 29_E).

Photo 29_D. Looking upstream from structure headwall bank

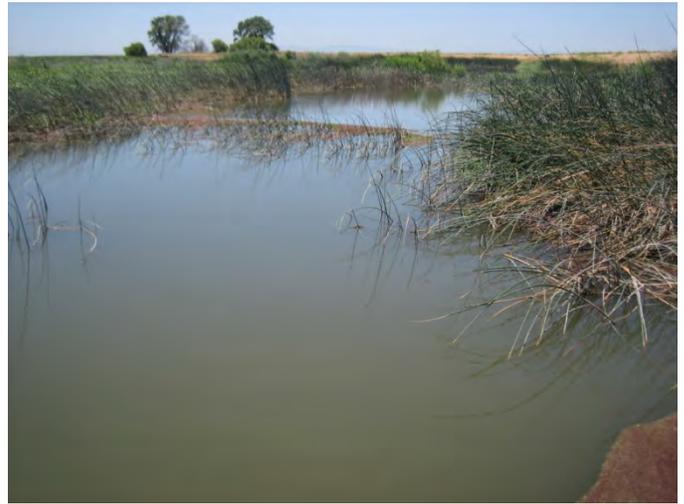
Photo 29_E. Looking downstream from flume

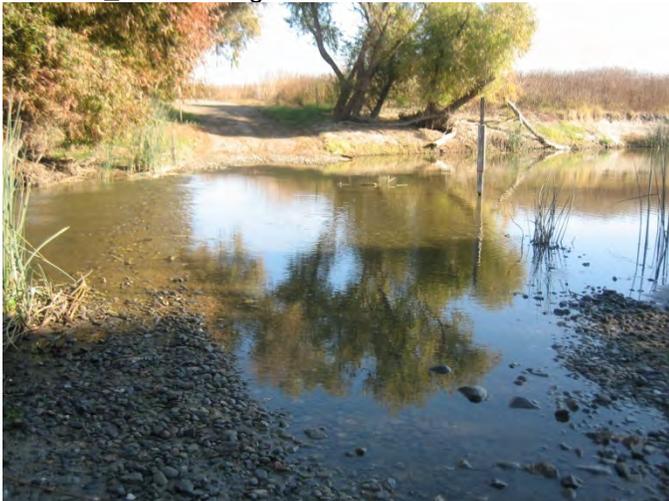
There is a gravel armored low flow crossing (Photo 38_A) located on the San Joaquin River near river mile 143.2 within the San Luis Wildlife Refuge that is likely used to provide access to the eastern Bear Creek units. The gravel road appears to be well maintained. The road cannot be bypassed.

Photo 38_A. Crossing from left bank

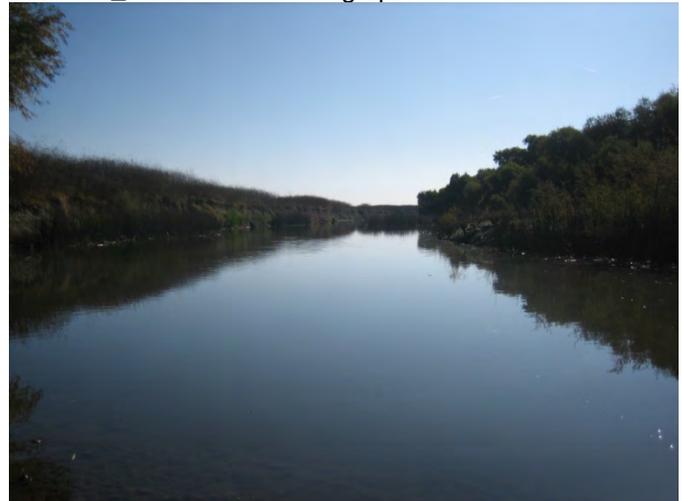
The channel upstream (Photo 38_B) is clean with some tall reeds on the left bank and tall woody trees on the banks located upstream and downstream the crossing. The reeds were choking the channel downstream and may be creating a fish barrier according to DFG (Photo 38_C) during the first pass but were cleared during the second pass. The crossing is about 138 feet from bank to bank and 24 feet wide. The crossing was submerged during the survey and no culverts were found. The active channel width was estimated at 73 feet.

Photo 38_B. Channel looking upstream from road

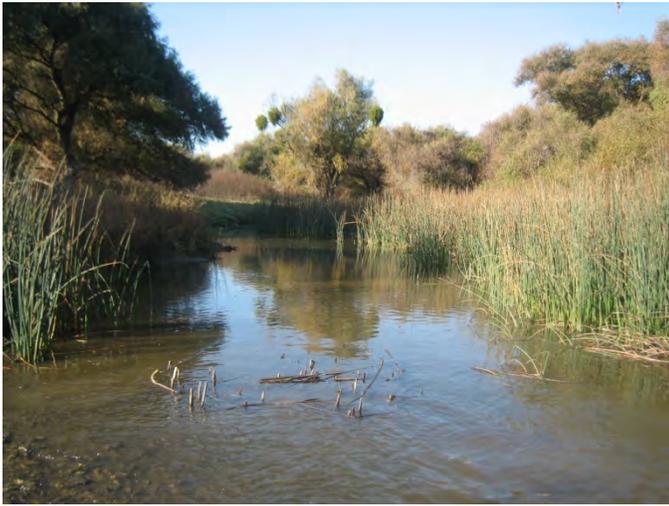
Photo 38_C. Channel looking downstream at center line of channel

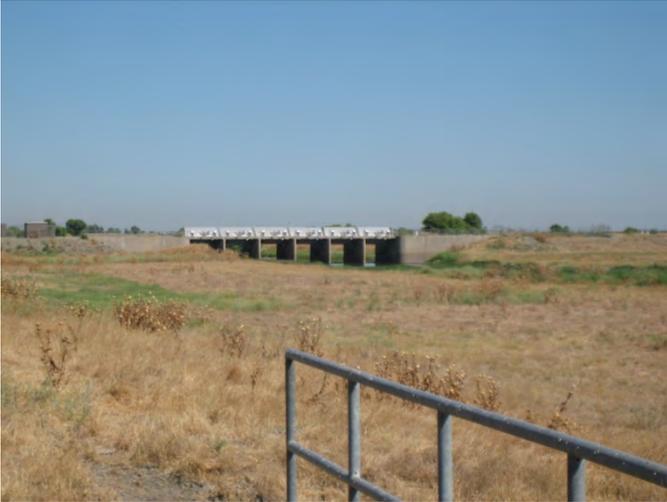
The Eastside Bypass Control Structure is part of the bifurcation structure located at the apex of the Eastside Bypass and the Mariposa Bypass (Photo 48_A). The control structure was surveyed during Task 1 and Task 2, during both surveys the six radial gates were open with stop logs in place. This structure is very similar to the Chowchilla Bifurcation structure located on the San Joaquin River upstream.

Photo 48_A. Structure, upstream looking downstream

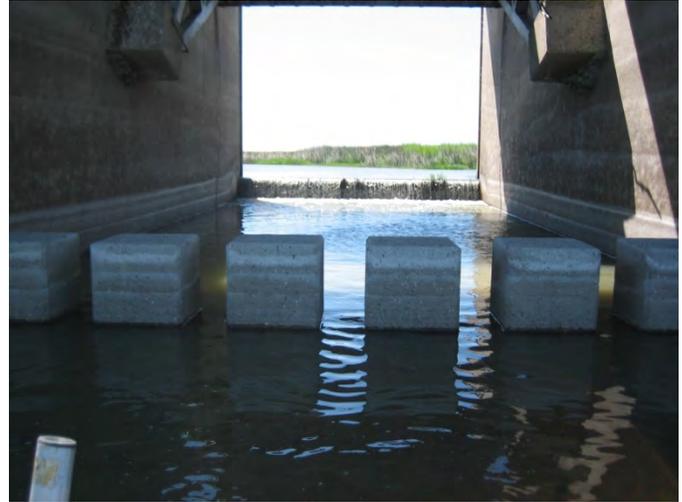
There are a total of six gated bays opening that measure 19 feet in height and 20 feet wide. The structure height is about 21.5 feet and measures 130.3 feet in total length from the top deck. The structure has a maintenance road that crosses over the rear of the gate bay with an opening in the center to access the radial gate arms. The hoist motors are located at the top of each bay on the upstream end. There is a solid concrete headwall that extends from the levee to the east and west. The bays are 45.5 feet in length with a 15 foot concrete apron downstream. There are six 2 x 2 x 4 foot concrete block diffusers (baffles) about 55 feet from the radial gate (Photo 48_B). The concrete apron has a short weir (sill) downstream that is about 2 feet tall and 1 foot wide.

Photo 48_B. Downstream looking upstream from end of bay

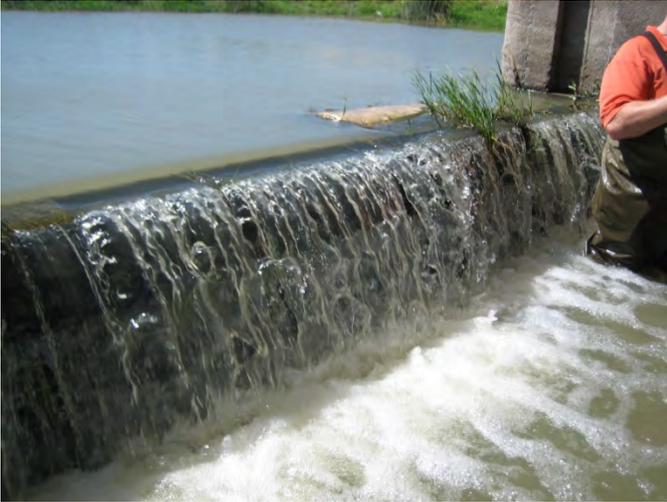
There is a large pool just downstream the sill that is armored with rip rap to protect the concrete apron and weir from erosion (Photo 48_D). The rip rap protection extends about 30 feet downstream. The depth of the pool was not determined during Task 1 due to the depth exceeding what was able to be waded. Upstream there are stop logs in place that act like a weir at the inlet that averages 4 feet tall (Photo 48_C).

Photo 48_C. Weir upstream radial gate seal

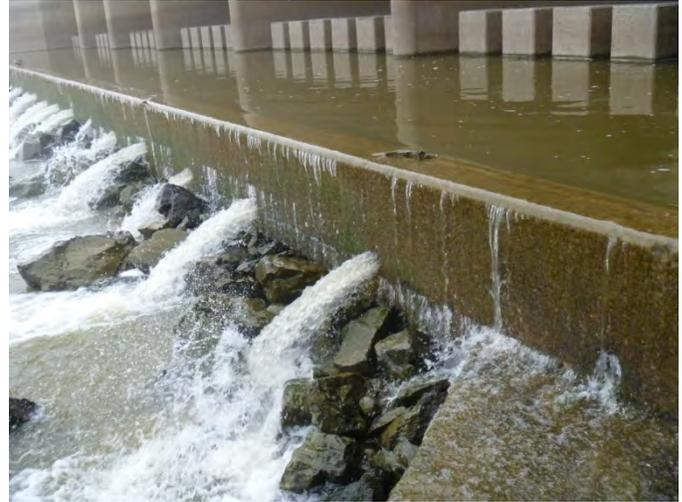
48_D. Sill and rip rap at outlet

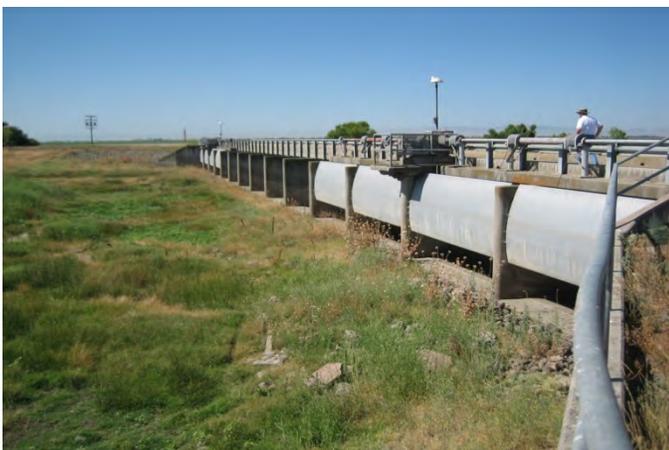
The bifurcation structure is located at the apex of the Eastside Bypass and the Mariposa Bypass (Photo 49_A). The Mariposa Bypass control structure has 14 bays with 8 radial gates that were partially open during the survey. The radial gates were located on each end of the structure, four at each end. Each bay opening is 10.5 feet in height and 20 feet wide. The structure height is about 20.6 feet, downstream, and measures 295.8 feet in total length from the top deck. The height of the outlet drop was surveyed over 7 feet. In addition, there is no staging pool just downstream because there is a hardened apron.

Photo 49_A. Structure upstream looking downstream

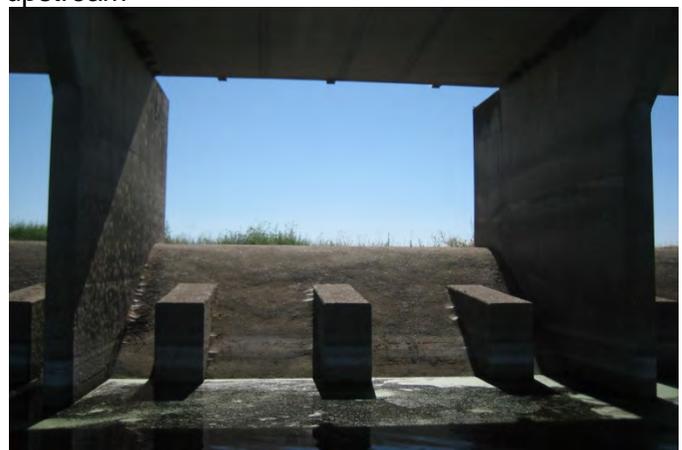
Photo 49_B. Ungated bay, downstream looking upstream

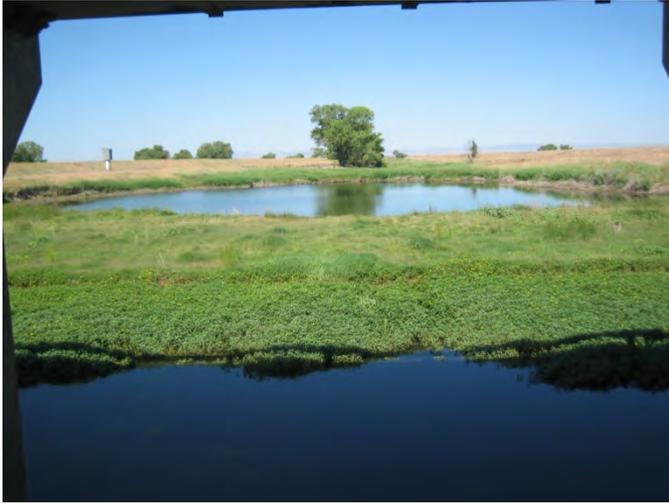
Photo 49_C. Structure, upstream looking downstream

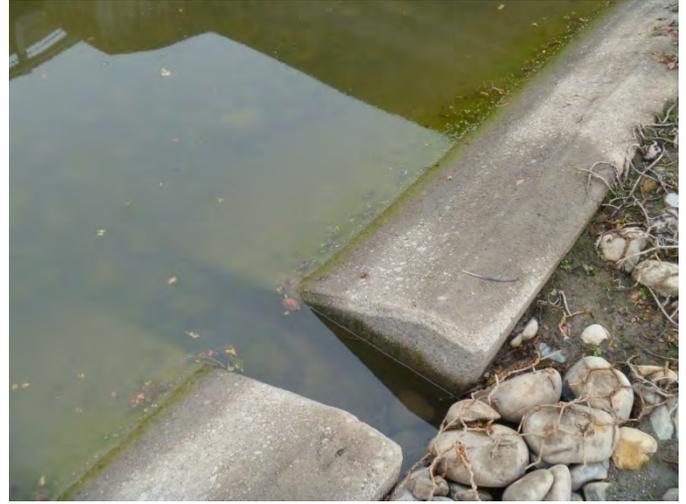
The structure has a maintenance road that crosses over the gate bay. The hoist motors are located at the top of each bay on the upstream end. There is a solid concrete headwall that extended to the north levee that had a gated culvert with a low flow channel. The bays have a roughly five foot drop with concrete diffusers that are 4.4 feet tall and 7.8 feet long (Photo 49_B). There is a concrete apron downstream for a distance of 45 feet to a short sill with a height of 2 feet and a width of about 1 foot (Photo 49_D). The concrete apron had a positive 30 degree angle to the weir.

Photo 49_D. Downstream sill

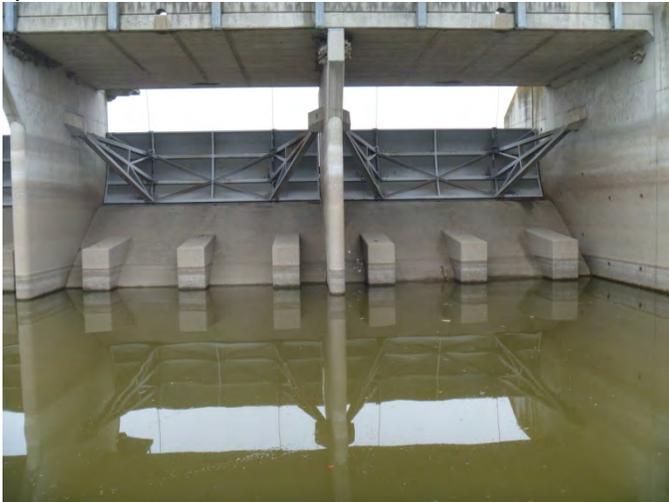
Photo 49_E. Gated bay, downstream looking upstream

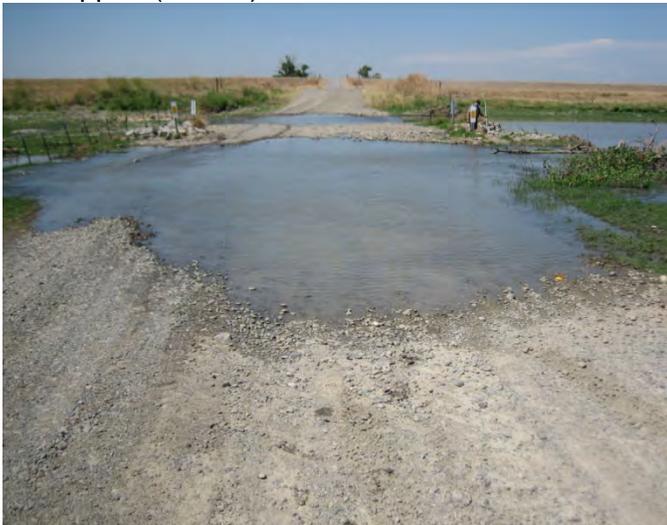
Dan McNamara Road is a cobble/gravel armored low flow crossing in the Eastside Bypass accessed from Sandy Mush Road (Photo 51_A). The road is publicly accessible, and at the time of the first pass survey the road was partially submerged. The road was not submerged during the second pass topography survey. The road width was measured at 50 feet with one culvert in the center of the channel. The crossing is an earthen embankment with a gravel armored top that averages about 1 foot height in the channel from the embankment toe to the top at the downstream. There is an incised channel at the culvert that has about 3 feet height at the culvert outlet. The bankfull channel width was measured at 175 feet. There was barbed wire fencing just upstream (Photo 51_B) and downstream of the crossing (Photo 51_C).

Photo 51_A. Dan McNamara Road when partially overtopped (Task 1)

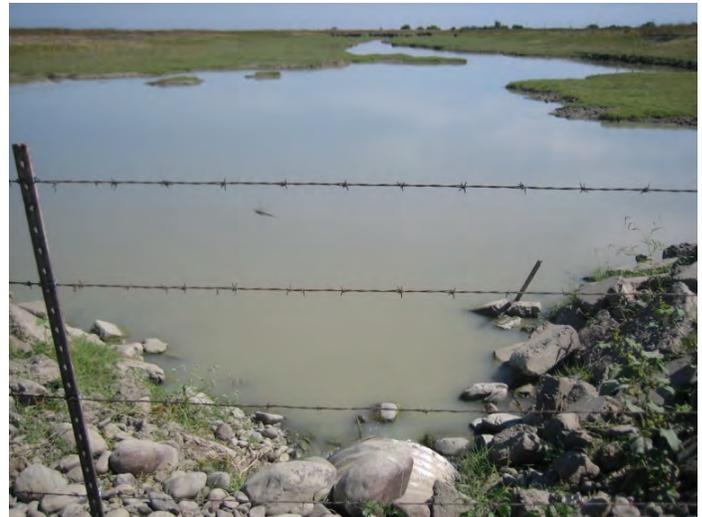
Photo 51_B. Looking upstream from the crossing near the culvert inlet

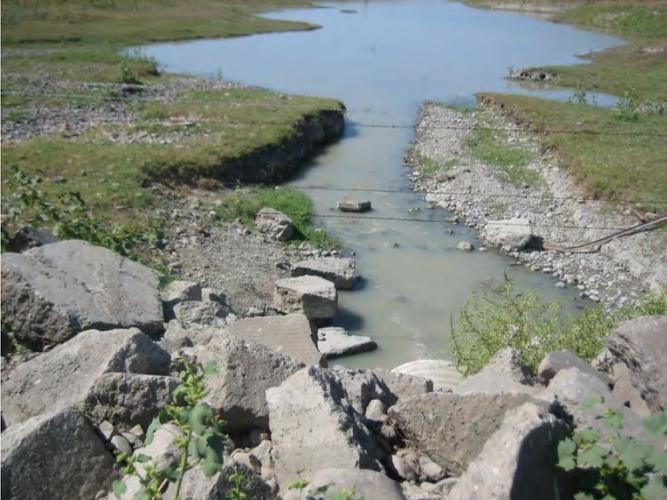
Photo 51_C. Looking Downstream from the crossing at the culvert outlet.

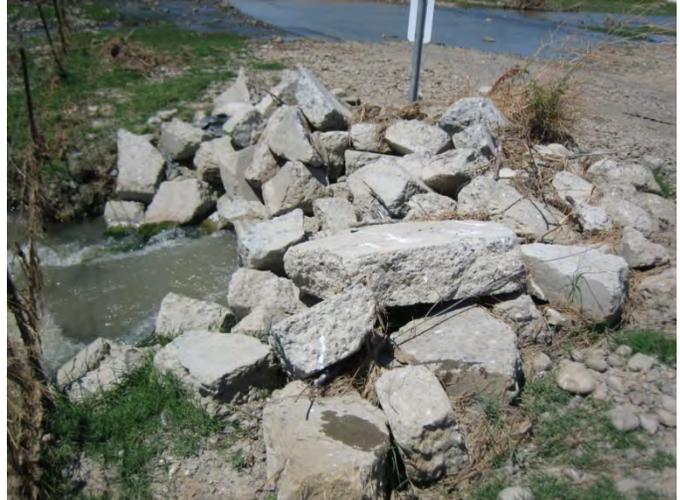
The culvert is a circular corrugated metal pipe that is located in the center of the crossing that measured 30 inches in diameter. The culvert length was measured at 50 feet with an inlet/outlet design with no apron. The culvert inlet and outlet is armored with cobble and concrete rip rap (Photo 51_D through F). There is another culvert in the upper floodplain for an overflow channel that is silted in (Photo 51 G).

Photo 51_D. Culvert outlet when road is submerged (Task 1)

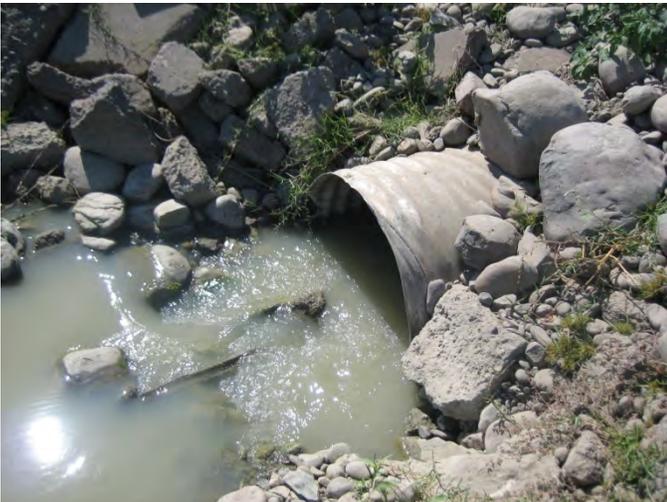
Photo 51_E. Culvert inlet at flows less than 25 cfs

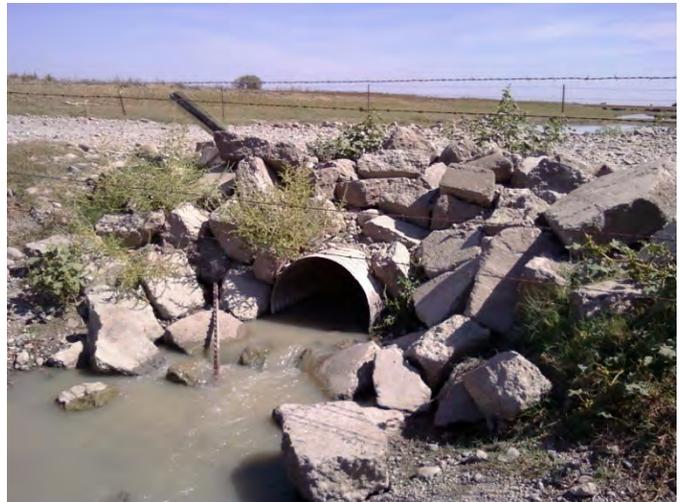
Photo 51_F. Culvert Outlet at flows less than 25 cfs

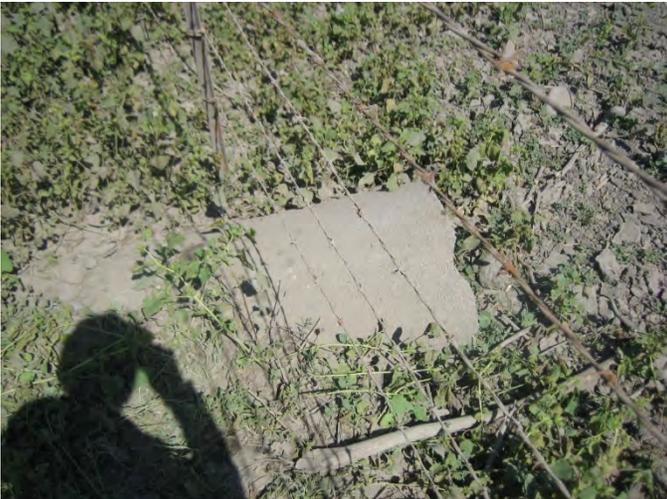
Photo 51_G. Culvert for overflow channel

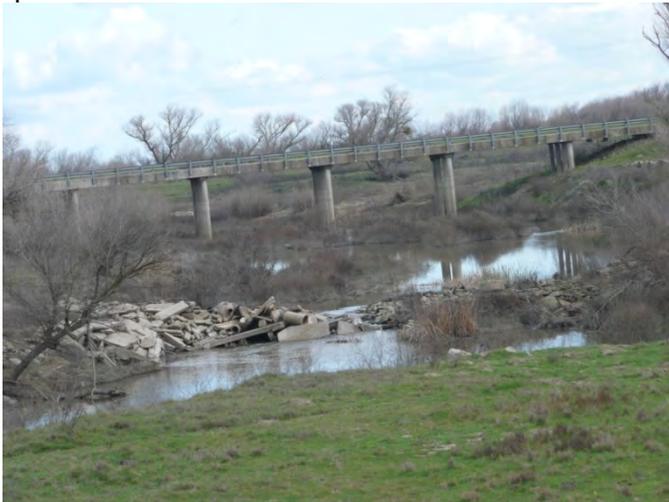
Photo 69_A. Rock weir from downstream looking upstream

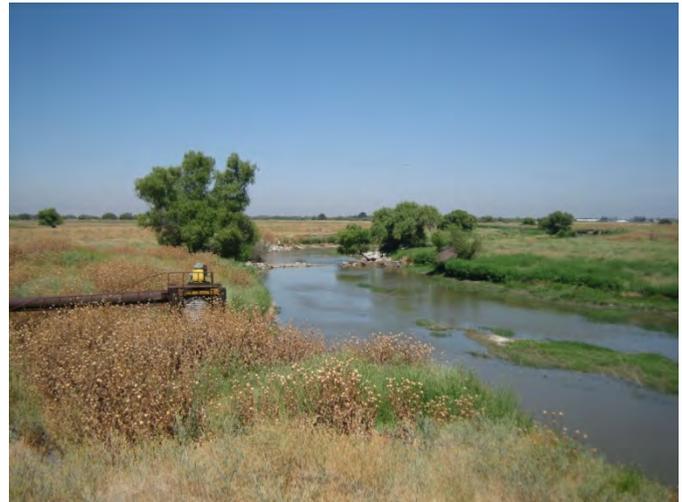
Photo 69_B. Rock weir from upstream looking downstream

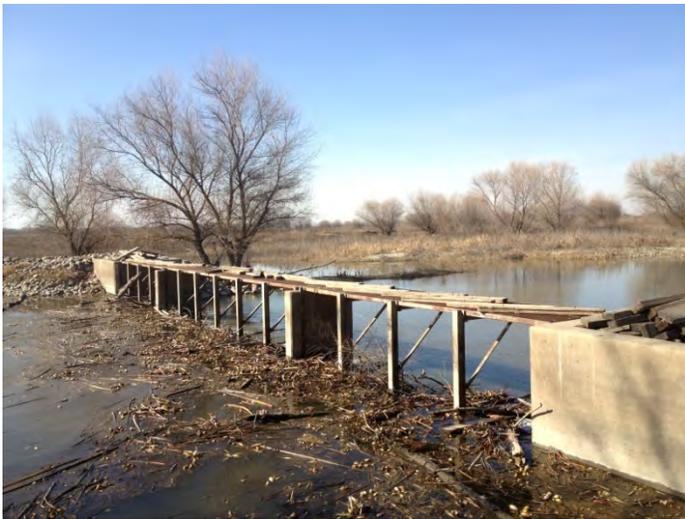
The Merced Refuge Weir is located in the Eastside Bypass within the Merced National Wildlife Refuge (Photo 70_A). The weir is used to divert flows from the Eastside Bypass to the Refuge. In order to divert flows boards (stop logs) are installed to raise the water surface elevations in the pool upstream the weir (Photo 70_C). The weir total height is about 6.5 feet and is capped by a metal grate for access while installing the stop logs. The stop logs are located on the upstream side of the weir and are able to be installed up to an elevation of 100.0 feet or a height of 6 feet. The weir has 14 bays that average a width of 4.5 feet. There is a concrete apron for a distance of about 6 feet that has a short 1 foot tall 10 inches wide sill at the outlet of the apron. The weir has a hardened cobble levee on the left bank and right bank (Photo 70_B).

Photo 70_A. Weir, upstream looking downstream

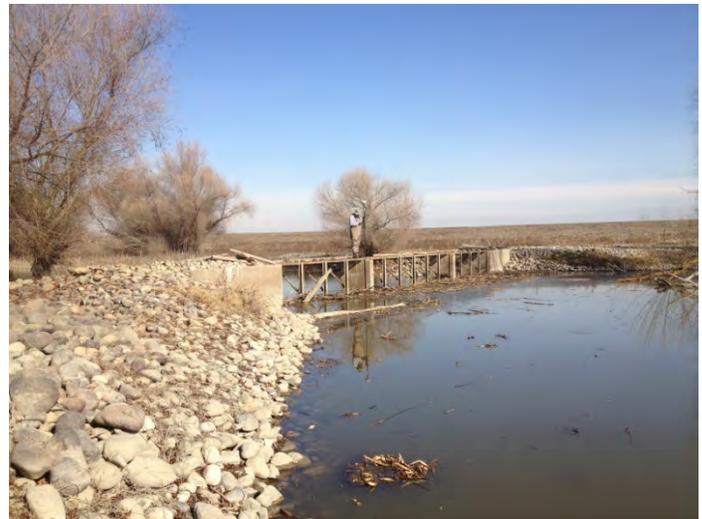
Photo 70_B. Upstream looking downstream from cobble levee

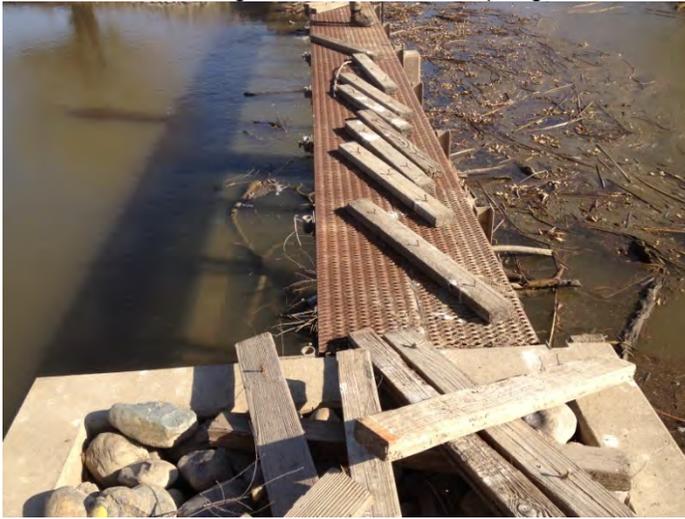
Photo 70_C. Metal grate catwalk with stop logs
