San Joaquin River Restoration Program Fish Passage Evaluation

Draft Technical Memorandum

Evaluation of Partial Fish Passage Barriers

July 2012

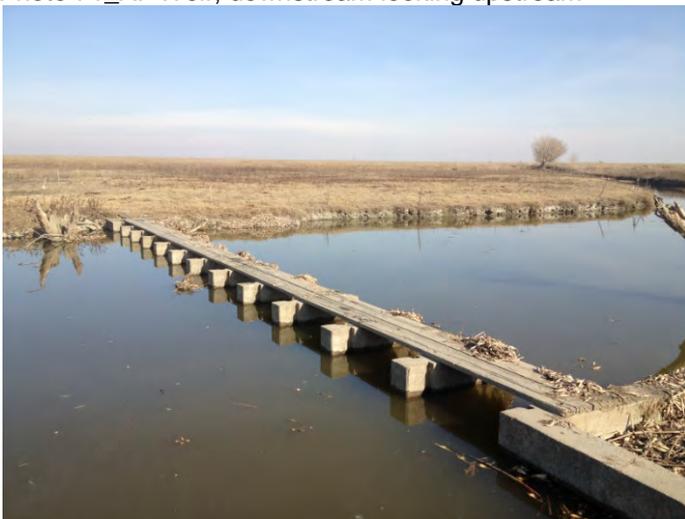
The Merced Refuge Weir is located in the Eastside Bypass within the Merced National Wildlife Refuge (Photo 71_A). The weir is used to divert flows from the Eastside Bypass to the Refuge. In order to divert flows boards (stop logs) are installed to raise the water surface elevations in the pool upstream the weir. The weir total height is about 6 feet and is capped by wooden planks for access while installing the stop logs. The stop logs are located on the upstream side of the weir and are able to be installed up to an elevation of about 97.0 feet or a height of 5.5 feet. The weir has 12 bays that average a width of 4 feet. There is a concrete apron for a distance of about 4 feet but more could be buried under sediment. The weir has concrete abutments that tie into the banks of the channel (Photo 71_B).

Photo 71_A. Weir, downstream looking upstream

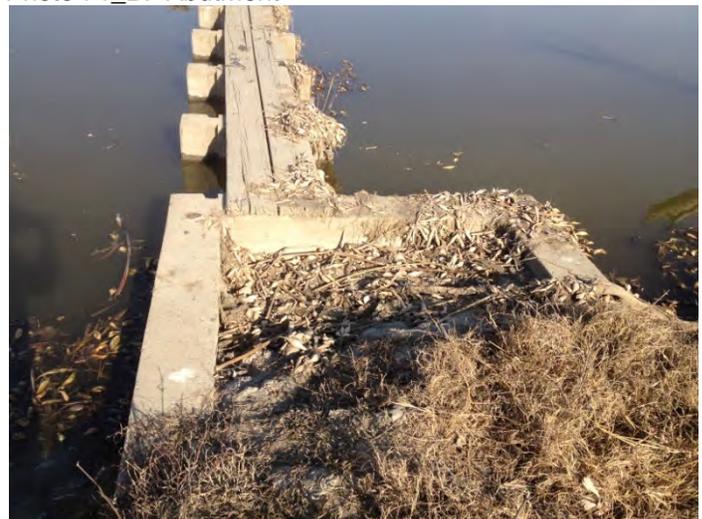
Photo 71_B. Abutment

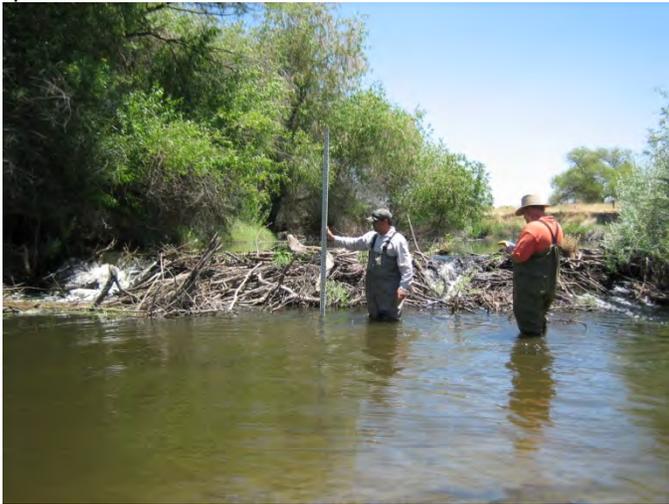
The beaver dam is located on the San Joaquin River near river mile 137.7 in the San Luis National Wildlife Refuge. The dam is constructed of large woody tree branches that have been placed in the channel (Photo 41_A). The dam has been there for some time, it was seen in the 2007 aerial photos. Refuge staff was not sure of its age. There are several Beaver Dams upstream, so this structure was chosen to be the typical construction.

Photo 41_A. Beaver Dam from downstream looking upstream

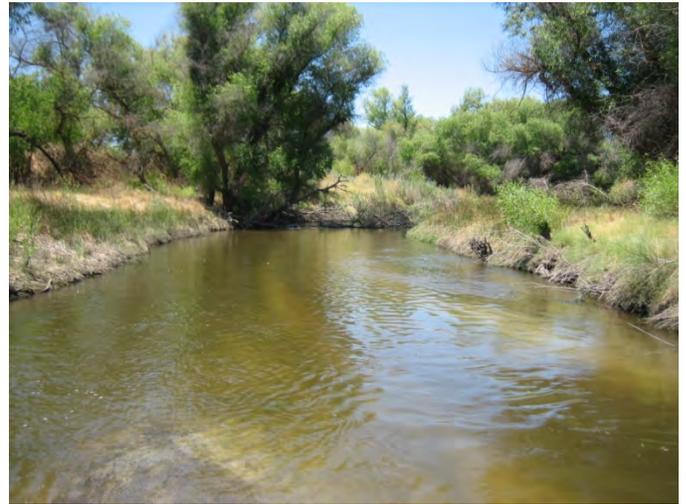
The channel downstream (Photo 41_B) was clean but shallow in some areas. A small staging pool on the right bank was present adjacent to a sand bar in the center of the channel. Upstream the channel was clean with a large pool from the backwatering created by the beaver dam (Photo 41_C). The backwatering goes up the channel for some distance. The channel banks have large woody trees and tall annual grasses with scatter large woody trees in the floodplain. The staging pool location on the right bank may not be practical since there are some overhanging tree limbs upstream the beaver dam that may impede safe passage. Small minnows were observed just downstream and upstream. Unidentified larger fish were observed downstream and upstream of the dam. One was downstream near a large woody tree limb that was in the channel and two were observed upstream in the pool. The channel bottom majority is silt/clay/sand.

Photo 41_B. Looking downstream from sand bar

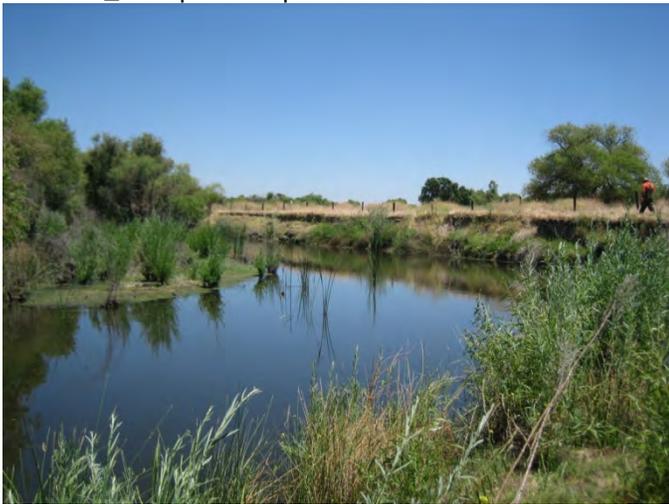
Photo 41_C. Upstream pool from left bank
